May 11<sup>th</sup>, 2018

**CM3 File No. TLW-1928**

**Pre Demolition Designated Substance Survey  
24 Hawthorne Avenue  
Ottawa, Ontario**

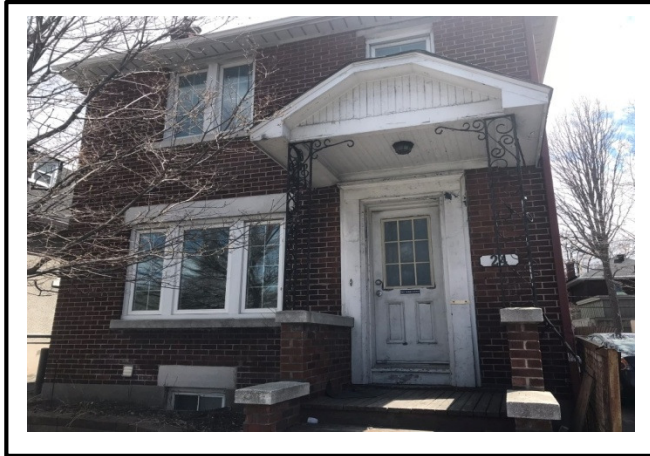
Photograph 1: 24 Hawthorne Avenue  
– Exterior

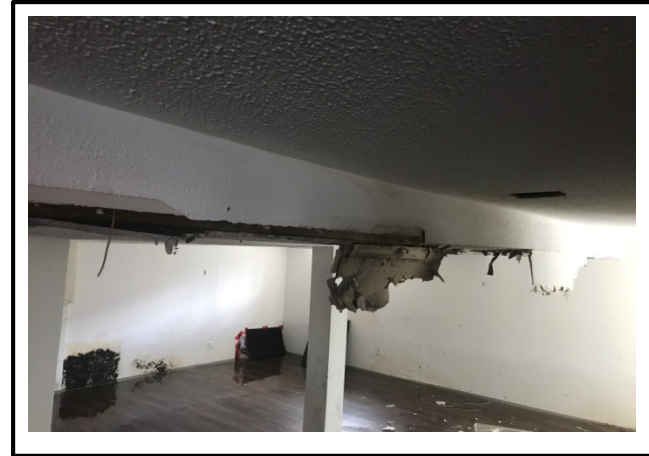
There is a significant amount of visible mould located in the basement. During the assessment it was noted that the basement had flooded and there was approximately eight inches of water throughout the basement.

Photograph 2: Mould impacted drywall located in the  
basement.

- Due to the extensive visible mould contamination throughout the basement. Persons entering the premises should wear a half-face piece air purifying respirator fitted with replaceable filters (N95 minimum), suitable eye protection and disposable coveralls and dust impermeable gloves as well as disposable boot covers prior to entering the residence.
- During demolition activities dust suppression measures must be taken to reduce the release spores and other mould derived particulate matter.

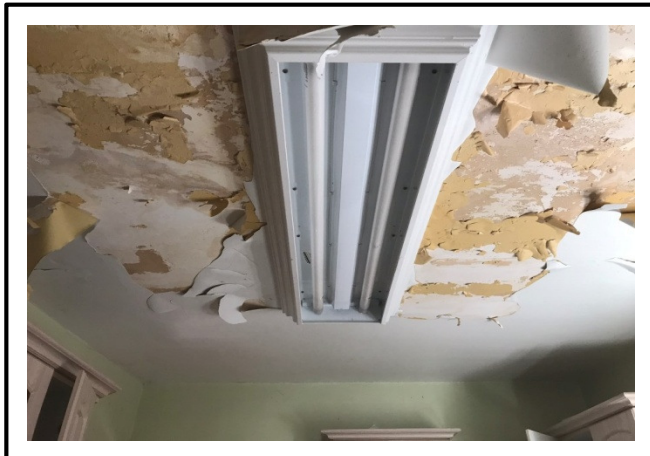
Mercury containing fluorescent light tubes are present throughout the residence. In addition, mercury may also be used as a preservative in paint applications.

Photograph 3: Mercury containing fluorescent light tubes  
located throughout residence.

- Best management practices dictate that the fluorescent light tubes be carefully removed, containerized and picked up and disposed of by a licensed hazardous materials contractor in accordance with Ontario Regulation 347/09 (as amended) prior to demolition.
