**re: Existing Building Assessment**  
**Existing Dwelling - 935 Wellington Street West - Ottawa**

**date:** August 13, 2019

**file:** PG5023-MEMO.01

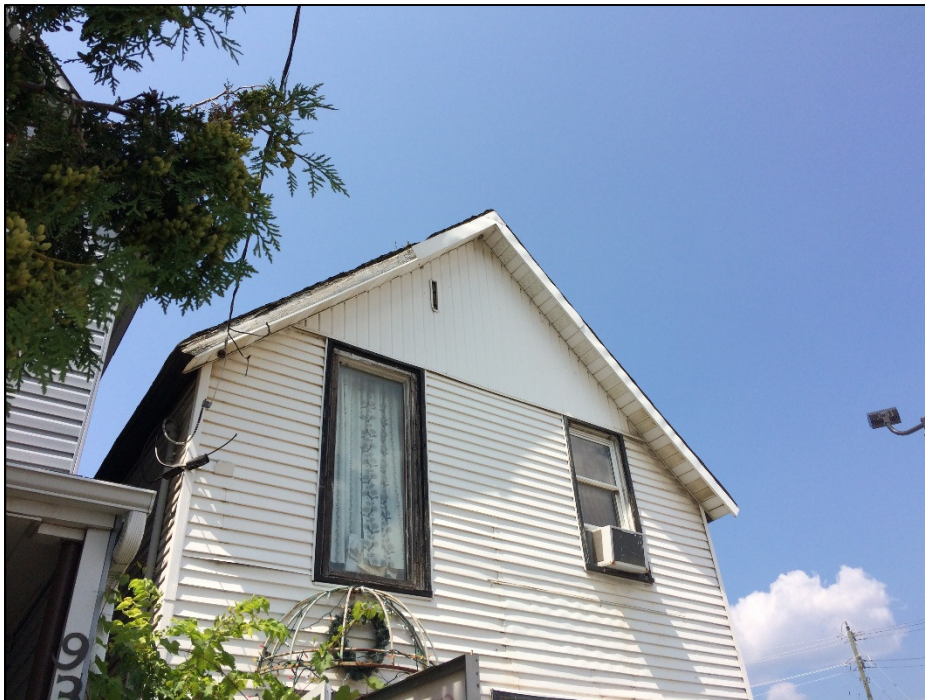
- The exterior of the building cladding was observed to be faded with extensive damage.
- The windows and doors are damaged and deteriorated which is affecting the building envelope.

Photo 1: Exterior of building showing deterioration.

The structural integrity of the building elements has been affected which makes the building unsafe. Based on our assessment, it's our recommendation that the structure be condemned and demolished.

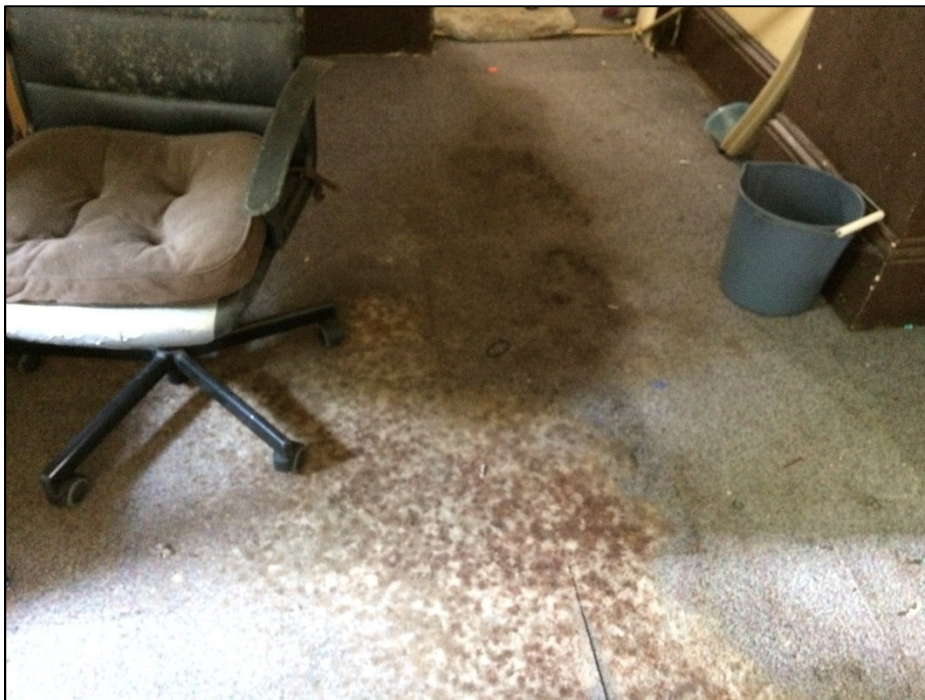
- The roof of the building is in very poor condition and no longer waterproof allowing water to penetrate the structure.
- The interior of the building was in extremely poor condition, including damage from leaks and an excessive amount of mould. The moisture has caused to deterioration of the wood framing affecting the structural integrity of the building.

Photo 2: Signs of water damage on the first floor of the building.

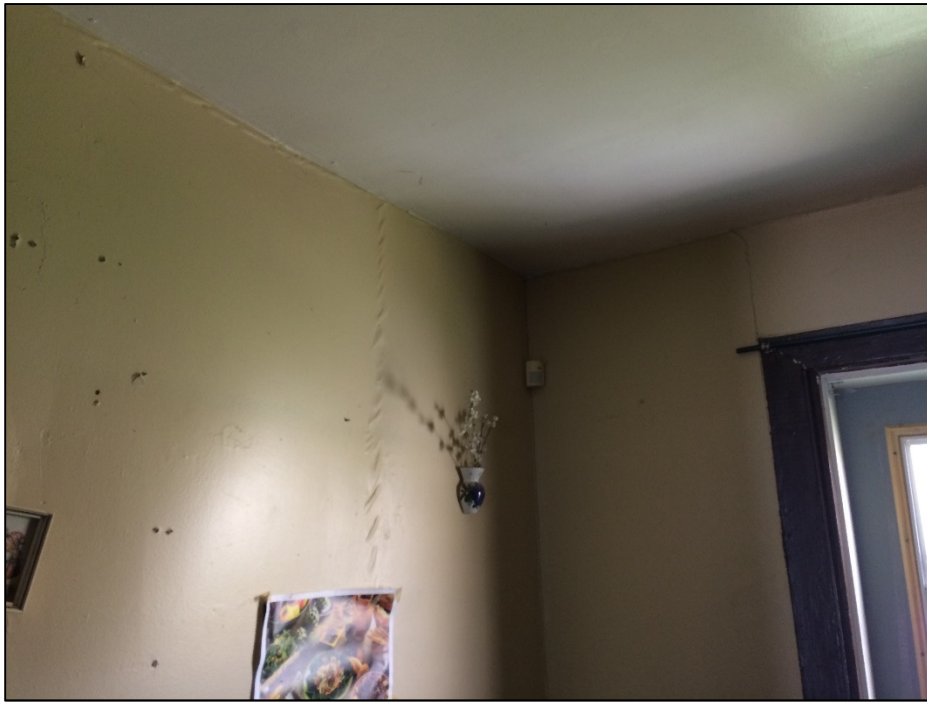
Photo 3: Visible damage to drywall on the first floor as a result of leaking from above.

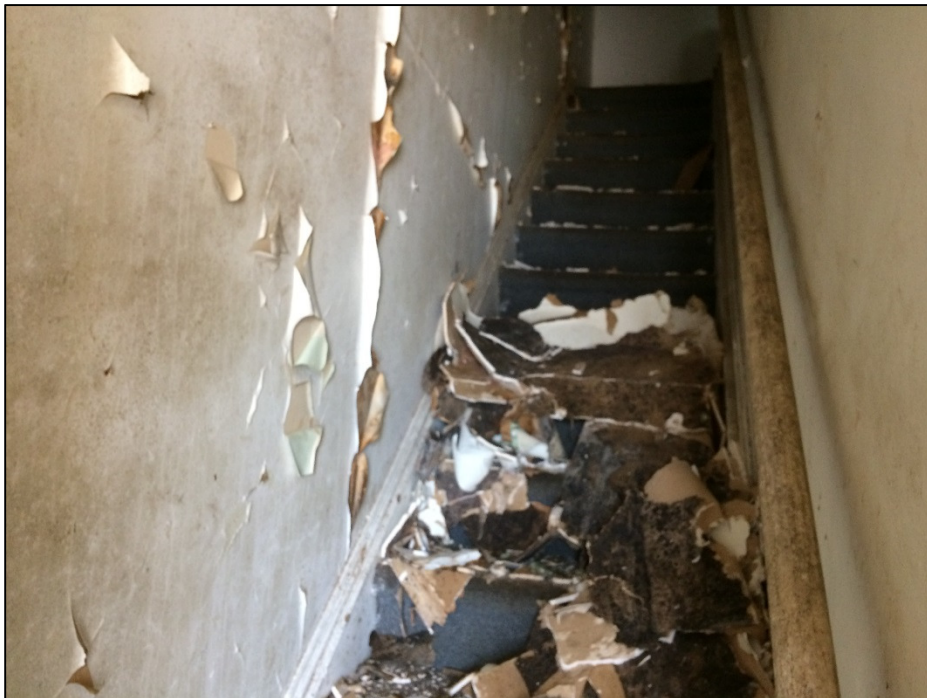
- Looking up the staircase to the second level, it was visible that the roof had lost its structural integrity and excessive leaking is occurring. As a result, the drywall and insulation was mouldy, had become saturated and was scattered on the staircase from falling off the walls and ceiling.

Photo 4: Drywall and insulation which had fallen from the roof and the walls and accumulated on the staircase leading to the second floor.

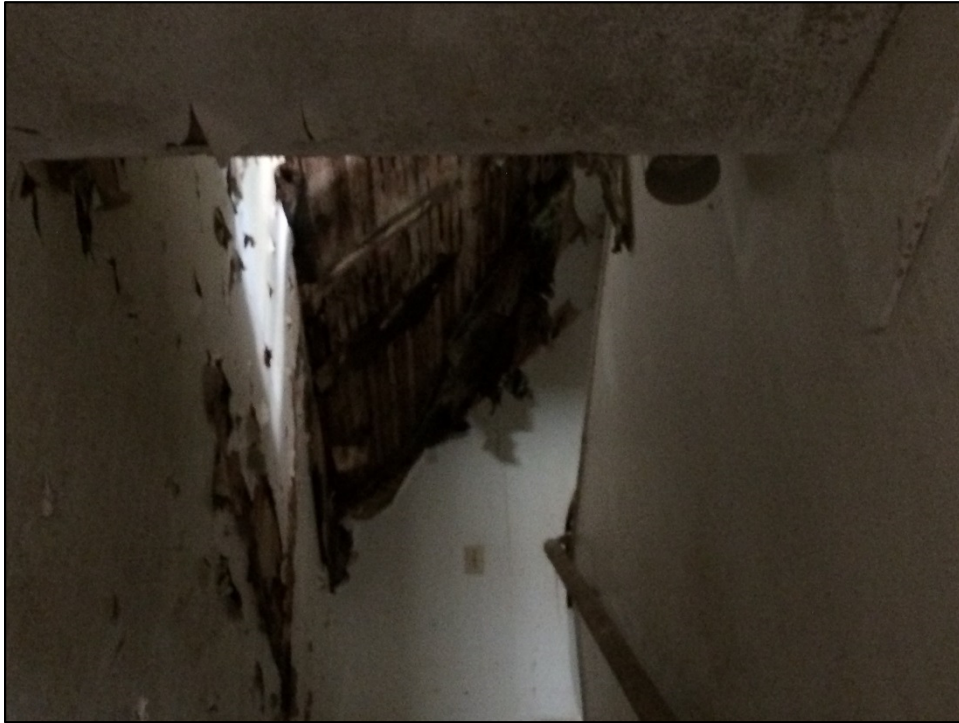
Based on our review of the existing building, the structure has deteriorated to a state such that it is no longer salvageable due to excessive leaks and lack of maintenance. The building materials have been severely damaged due to saturation and mould.

Photo 5: Illustrating the damage to the existing roof which is causing excessive leaking into the building and deterioration of the building compon
