October 3rd, 2024 (Rev. 1)

Subject: 269-281 Bell Street South – Building Reviews | Condition Report

Appendix A: Photos

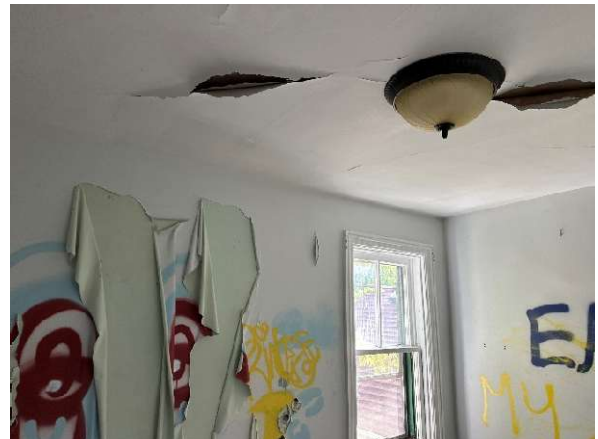
Photo 4: 281 Bell St - Interior paint peeling and ceiling damage

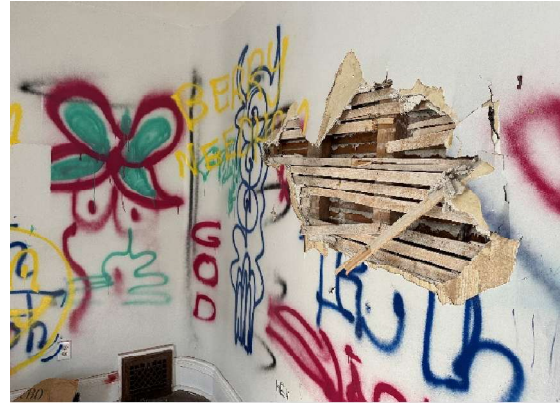
Photo 6: 281 Bell St - Interior wall damage

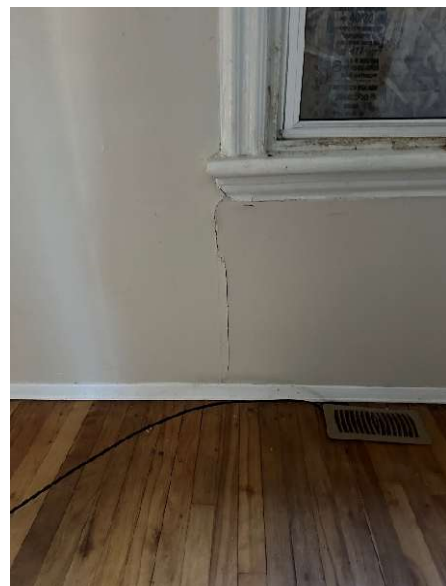
- Cracking in finished walls.
 - Several locations of cracking were observed throughout the finished ceilings and walls. These were located across mid spans of ceiling and at windows, door frames and vertically within walls at locations where floor deflections were noted.

Photo 8: 275 Bell St - Interior cracking in finishes at window

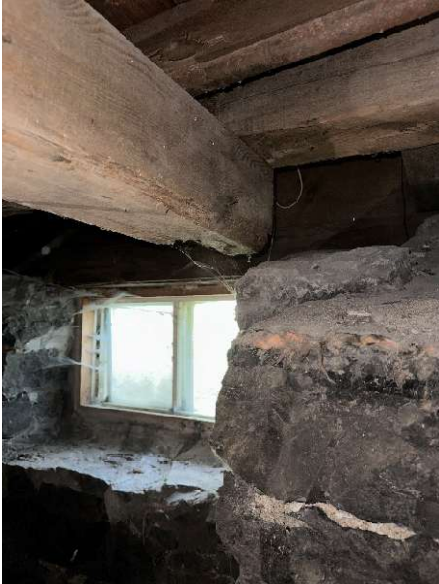
- Localized damage observed along the wood beams (missing cross sectional area, checking, etc.)
- Unsupported wood floor framing.
 - A primary wood beam was observed to have shifted away from the foundation wall and floating above the wall.

- The deterioration of the foundation walls has resulted in the loss of bearing at localized beam and joist locations.
 - Wood floor framing was observed to be inadequately supported and missing posts.

Photo 9: 281 Bell St - Primary ground floor beam shifted and unsupported

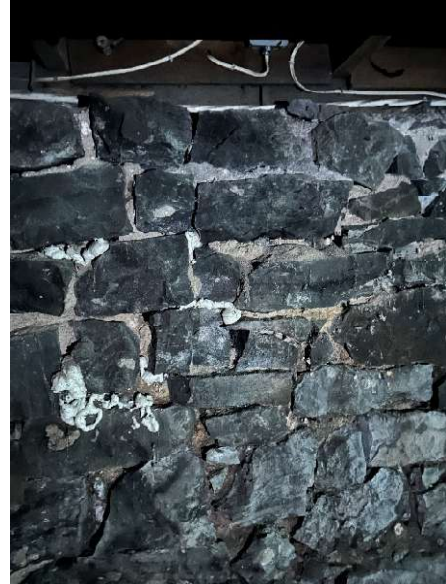
- Cracking in foundation walls on the interior and exterior.
 - Significant cracking resulting in v-shaped gaps were observed within the concrete foundation walls.
 - Step cracking was observed within the mortar joints of the rubble stone and block foundation walls
- Deterioration of the mortar joints within the rubble stone and block foundation walls.

Photo 10: 281 Bell St - Deteriorated and Missing mortar in rubble stone wall

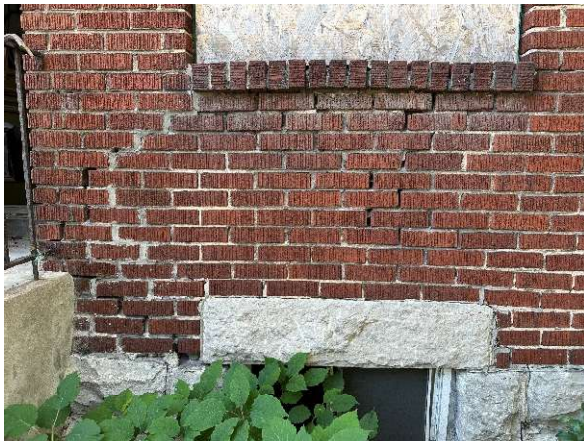
- Exterior brick cladding damage.
 - The houses containing brick cladding contained areas of significant step cracking within the mortar joints at several locations.

Photo 11: 281 Bell St - Exterior Brick damage – Step cracking

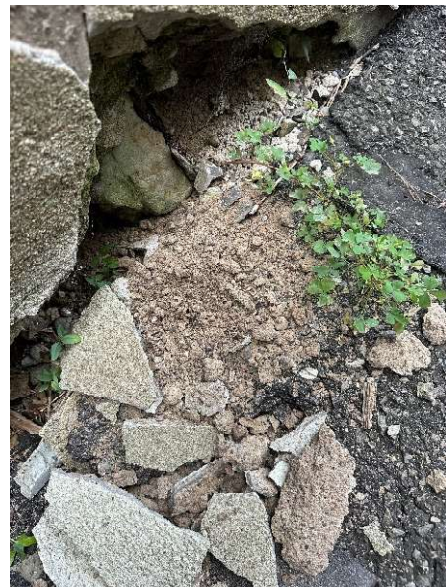
- Significant deterioration of the concrete foundation walls.
 - The deterioration of the concrete foundation walls was observed above grade on the exterior of the walls and below grade on the interior of the walls.

Photo 12: 273 Bell St - Concrete foundation deterioration at grade (exterior)

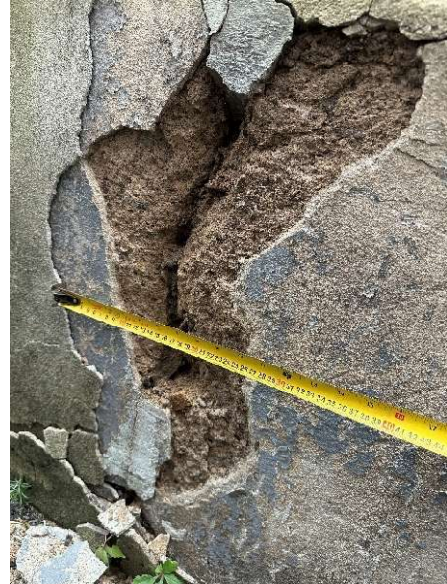
Photo 14: 273 Bell St - Concrete foundation large crack (exterior)

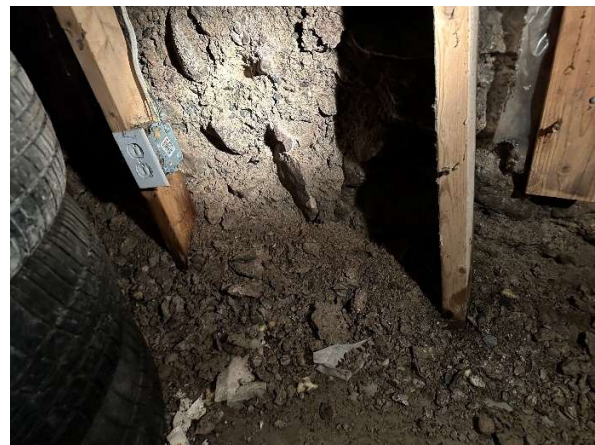
- The concrete was observed to be deteriorating to a sandy material that was able to be easily removed from the walls by hand. Piles of the sandy material and the stone aggregate from the wall was observed on floors around the interior of the foundation walls indicating that the wall deterioration is occurring without physical disturbance.

Photo 16: 275 Bell St - Concrete foundation deterioration (interior)

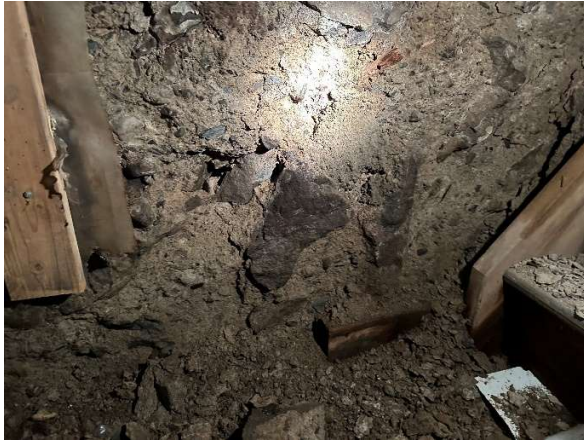
Photo 17: 275 Bell St - Concrete foundation deterioration (interior)

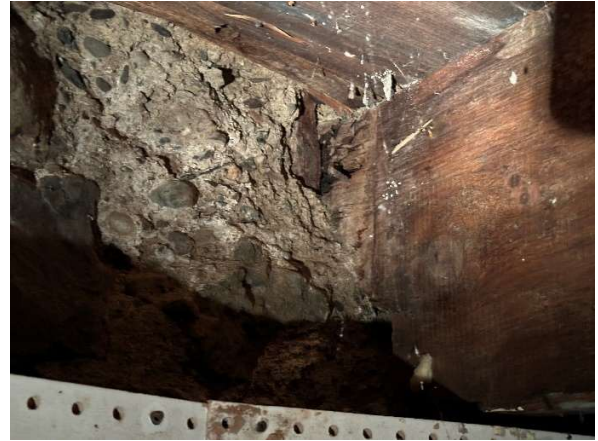
- Ground floor framing was observed to contain localized dry rot at the ends of joists and beams at the locations where they are pocketed into the foundation walls or bearing on the walls.

Photo 18: 275 Bell St - Wood beam Dry rot

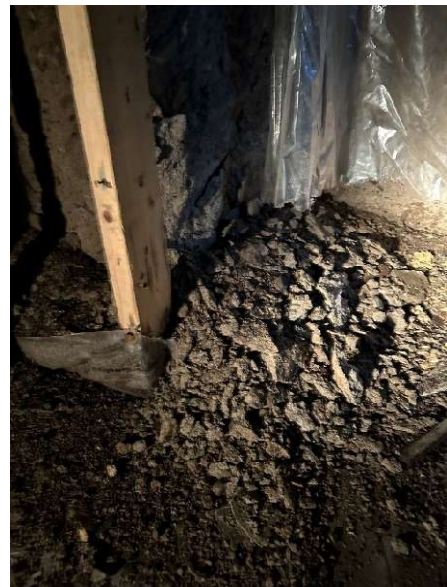
Photo 20: 275 Bell St - Foundation wall debris at base of wall (interior)

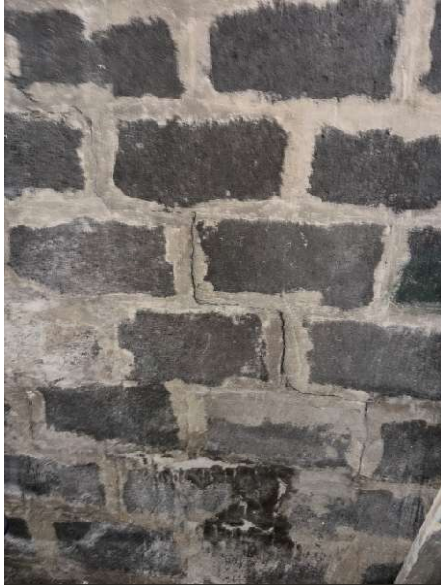
Photo 21: 277 Bell St - Step cracking in interior foundation wall
