October 3rd, 2024

Subject: 269-281 Bell Street South – Building Reviews | Condition Report

As requested, BPA Inc. has completed a structural condition review of the seven buildings with the civic addresses of 269, 271, 273, 275, 277, 279, and 281 Bell Street South, Ottawa, Ontario.

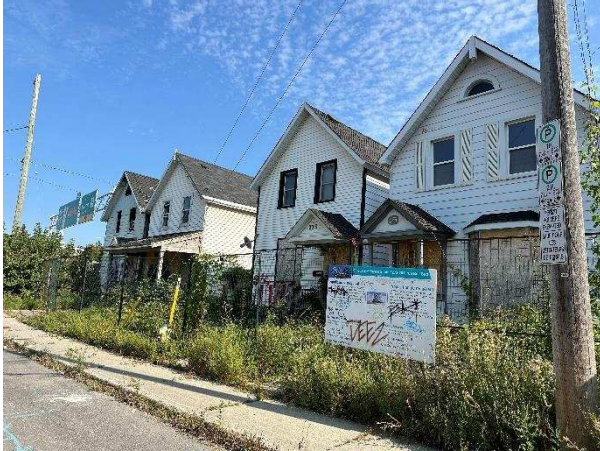
Photo 1: 269, 271, 273 and 275 Bell St S.

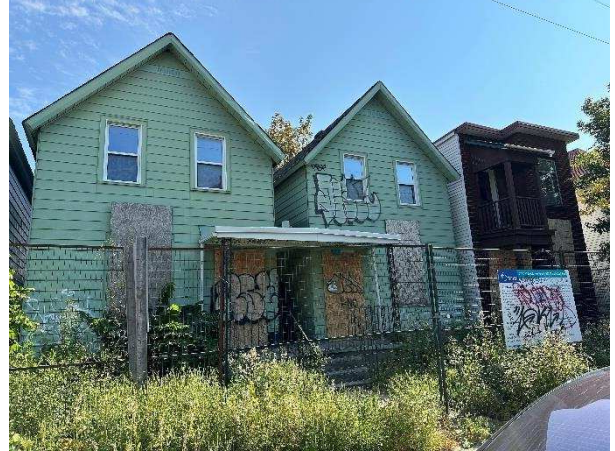
Photo 2: 277, 279 and 281 Bell St S

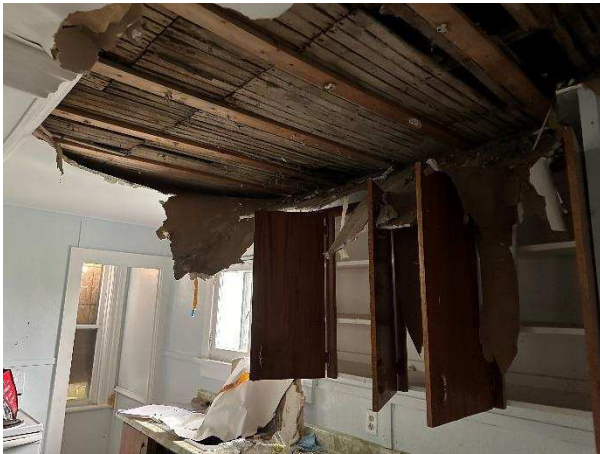
Photo 3: Failed Interior Ceiling

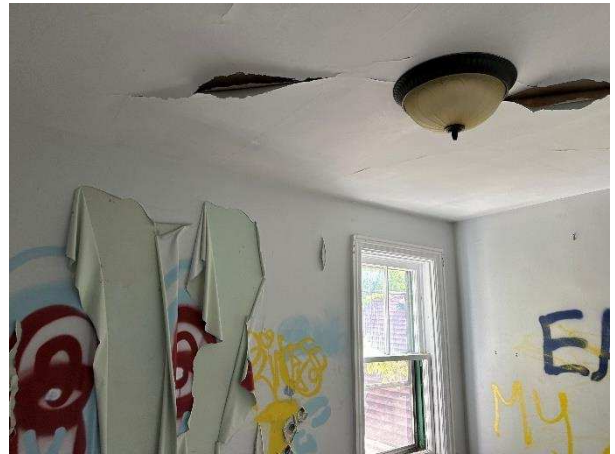
Photo 4: Interior paint peeling and ceiling damage

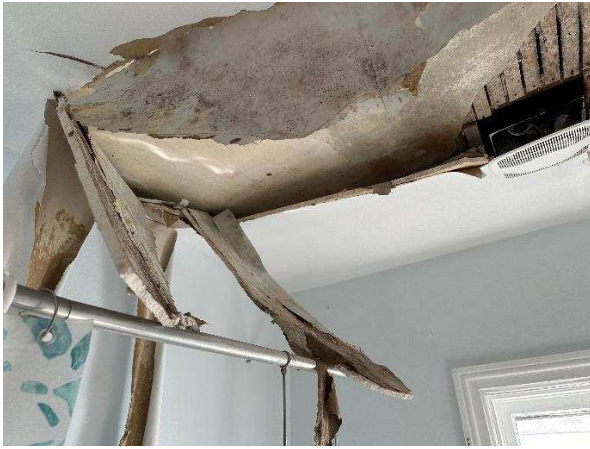
Phot 5: Interior Failed Ceiling

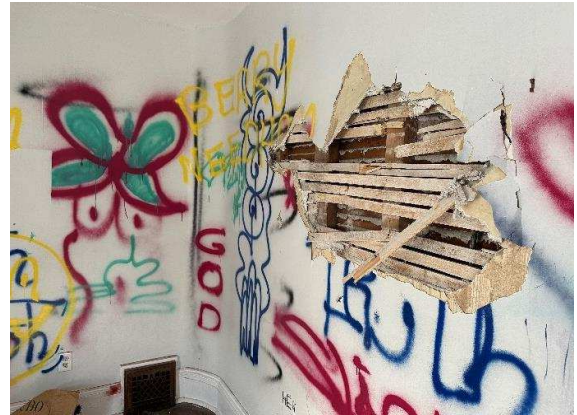
Photo 6: Interior wall damage

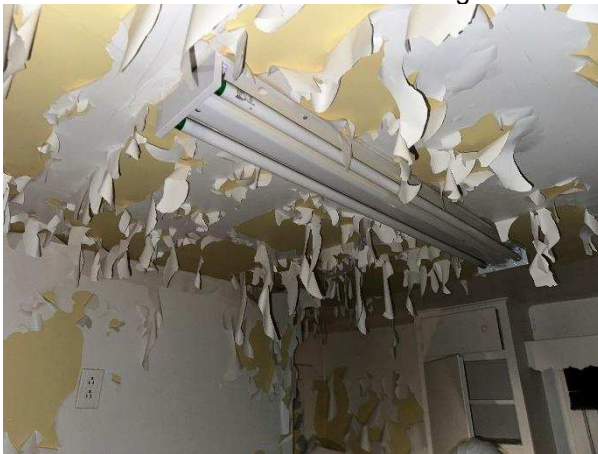
Photo 7: Interior finishes deterioration

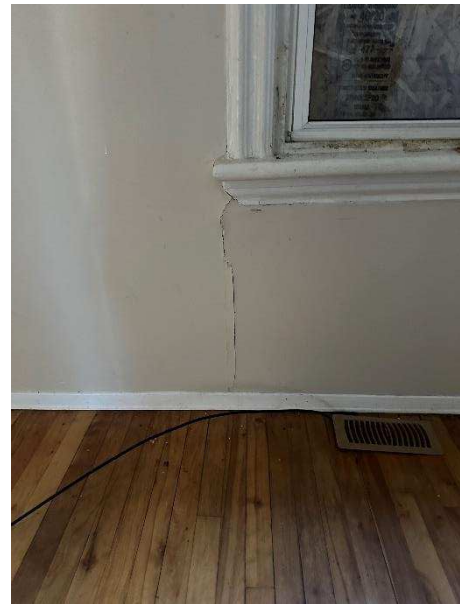
- Cracking in finished walls.
 - Several locations of cracking were observed throughout the finished ceilings and walls. These were located across mid spans of ceiling and at windows, door frames and vertically within walls at locations where floor deflections were noted.

Photo 8: Interior cracking in finishes at window

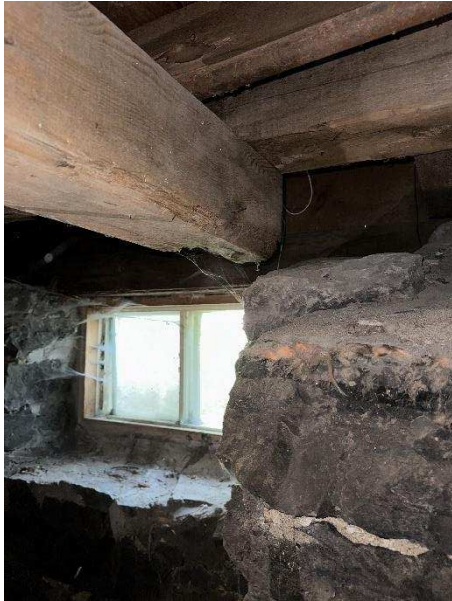
- Localized damage observed along the wood beams (missing cross sectional area, checking, etc.)
- Unsupported wood floor framing.
 - A primary wood beam was observed to have shifted away from the foundation wall and floating above the wall.

Photo 9: Primary ground floor beam shifted and unsupported

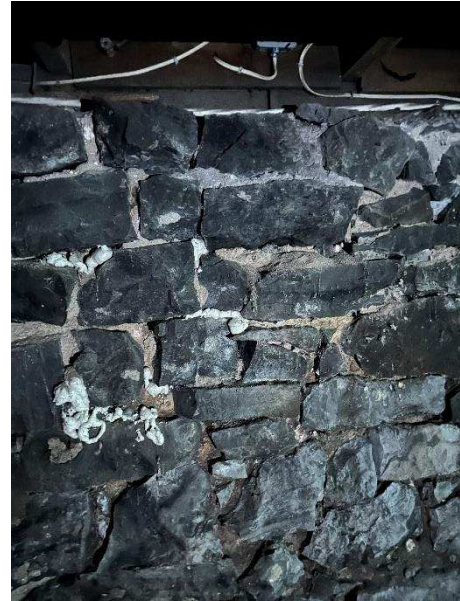
Photo 10: Deteriorated and Missing mortar in rubble stone wall

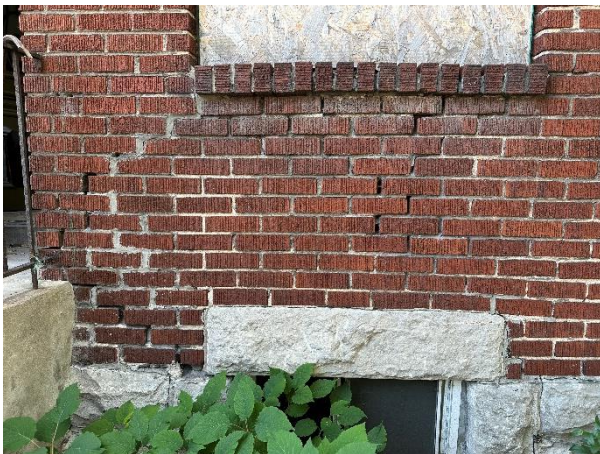
- Exterior brick cladding damage.
 - The houses containing brick cladding contained areas of significant step cracking within the mortar joints at several locations.

Photo 11: Exterior Brick damage – Step cracking

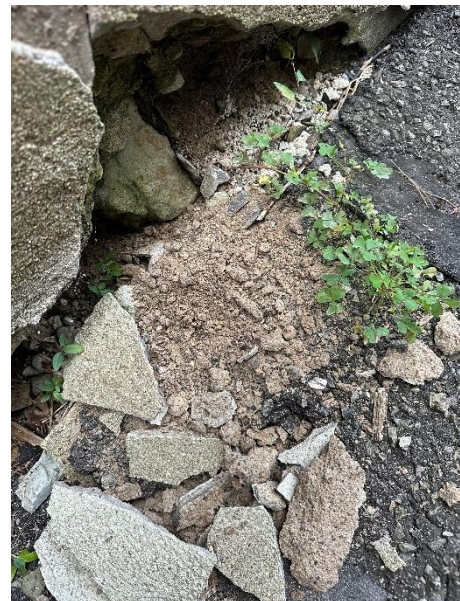
- Significant deterioration of the concrete foundation walls.
 - The deterioration of the concrete foundation walls was observed above grade on the exterior of the walls and below grade on the interior of the walls.

Photo 12: Concrete foundation deterioration at grade (exterior)

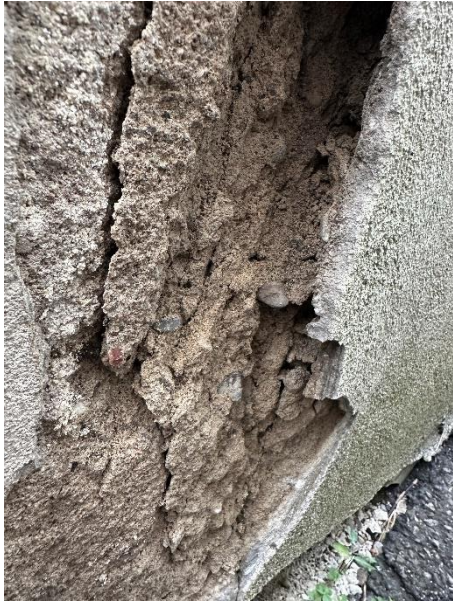
Photo 13: Concrete foundation deterioration (exterior)

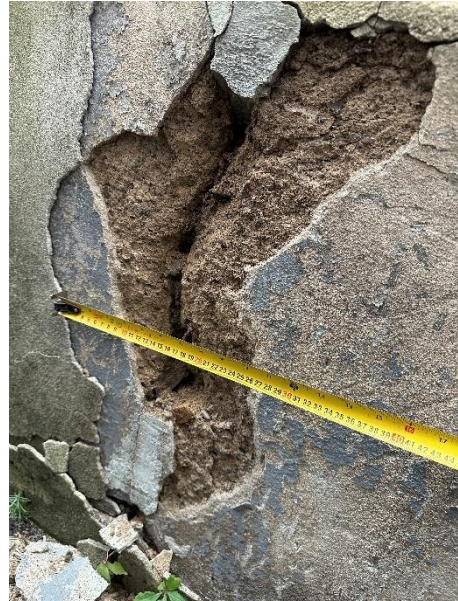
Photo 14: Concrete foundation large crack (exterior)

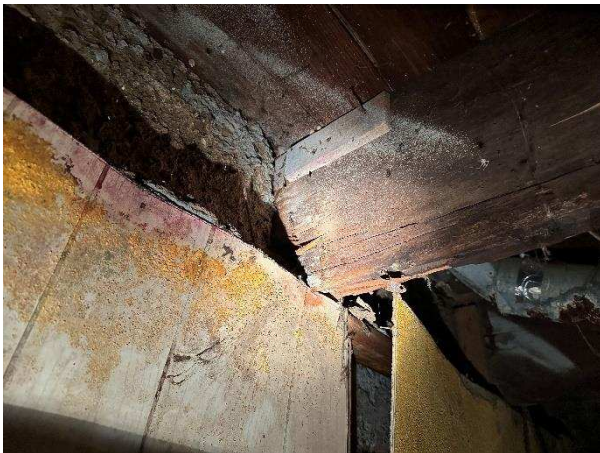
- The deterioration of the foundation walls has resulted in the loss of bearing at localized beam and joist locations.
 - Wood floor framing was observed to be inadequately supported and missing posts.

Photo 15: Unsupported wood floor beam

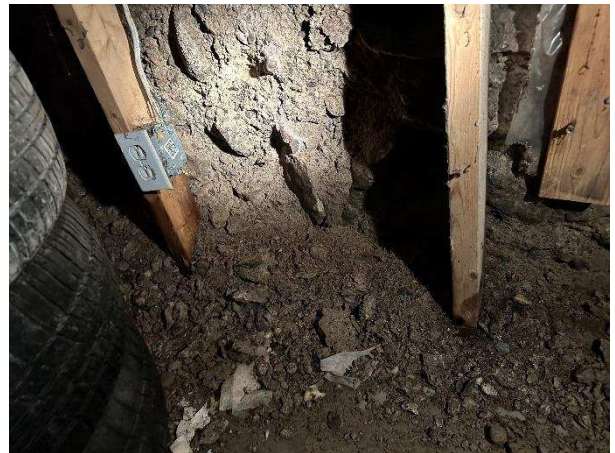
- The concrete was observed to be deteriorating to a sandy material that was able to be easily removed from the walls by hand. Piles of the sandy material and the stone aggregate from the wall was observed on floors around the interior of the foundation walls indicating that the wall deterioration is occurring without physical disturbance.

Photo 16: Concrete foundation deterioration (interior)

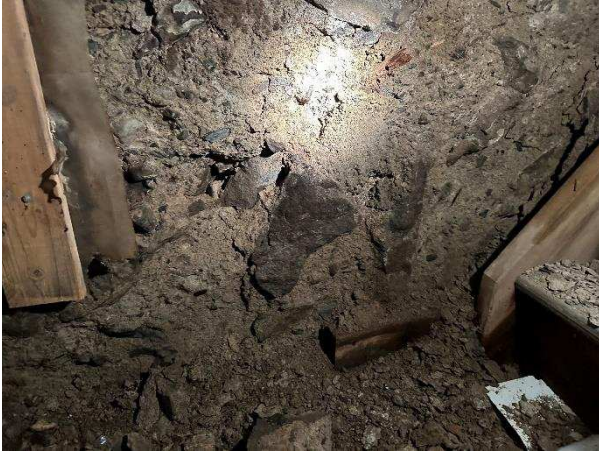
Photo 17: Concrete foundation deterioration (interior)

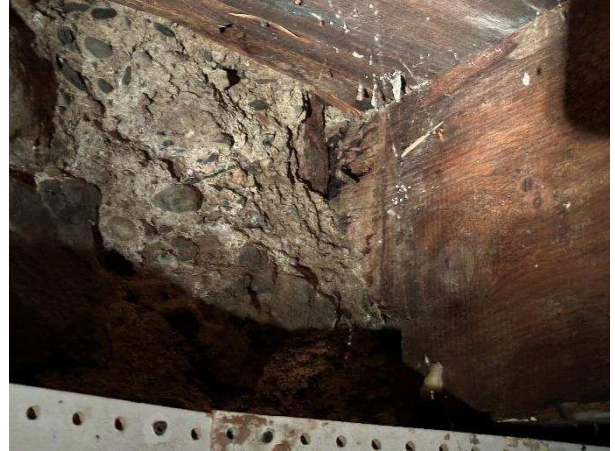
- Ground floor framing was observed to contain localized dry rot at the ends of joists and beams at the locations where they are pocketed into the foundation walls or bearing on the walls.

Photo 18: Wood beam Dry rot

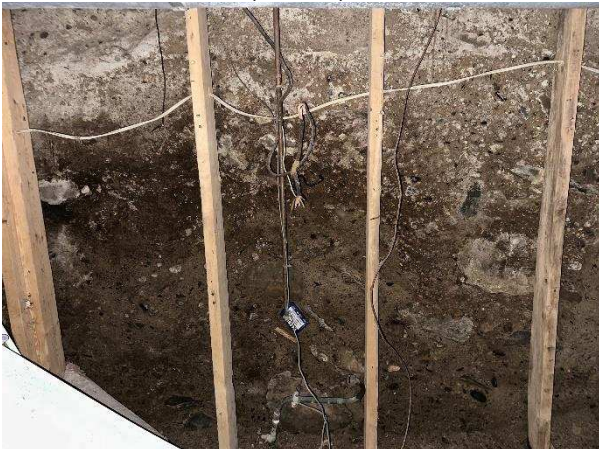
- Water ingress and efflorescence staining was observed throughout the foundation walls. The basement floors and walls were observed to be damp and wet.

Photo 19: Foundation wall Water ingress and deterioration (interior)

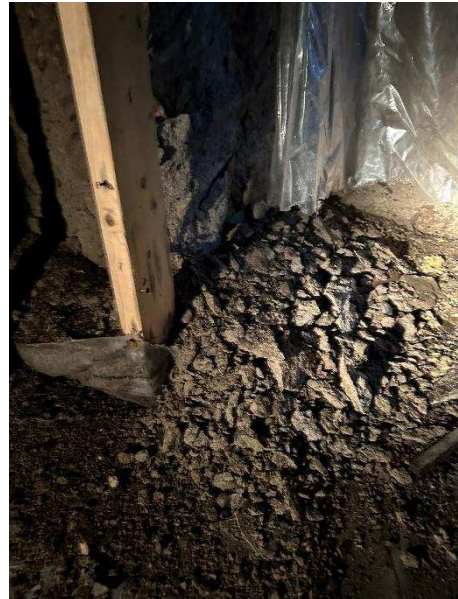
Photo 20: Foundation wall debris at base of wall (interior)

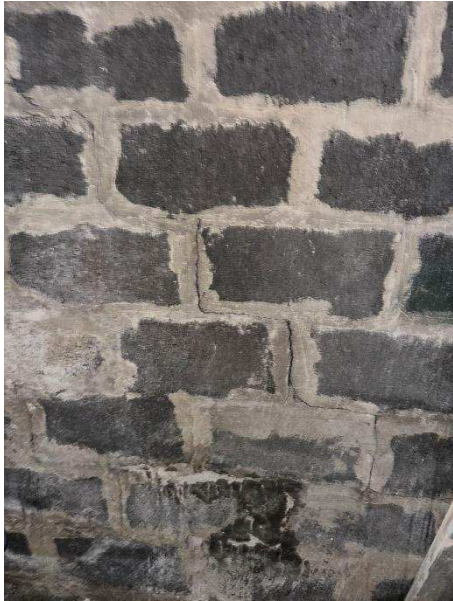
Photo 21: Step cracking in interior foundation wall
