# DESIGNATED SUBSTANCES AND HAZARDOUS BUILDING MATERIALS SURVEY

**Subject Property |** 95 Melrose Avenue, Ottawa, ON

Allstate Insurance  
Michael Chamanlall  
December 23, 2024  
SD042628  
IGENV-50314  
Matthew Magnus  
A – Photo Log  
Laboratory Results  
Sampling Plan  
Occurrences Plan

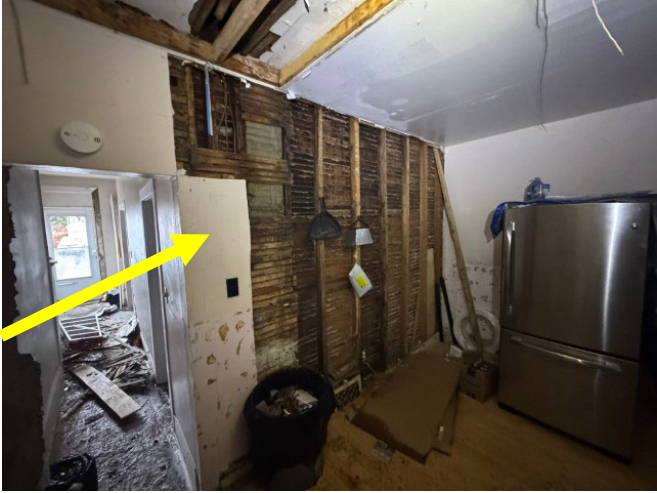
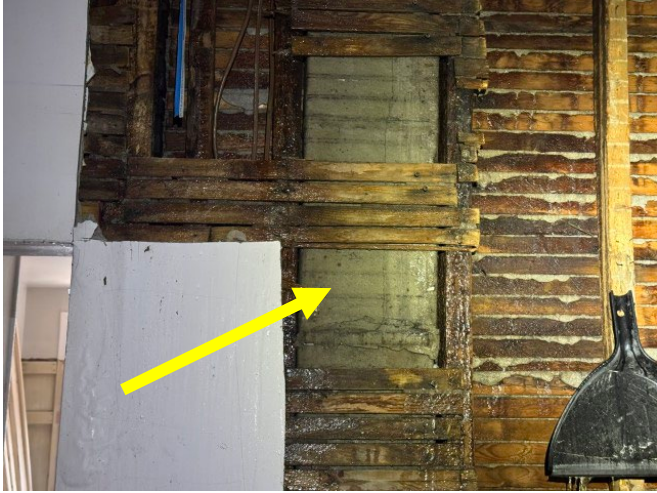
| <p><b>Photo 1: Main Floor Plaster Walls / Ceilings</b></p> <p>Plaster walls and ceilings throughout the original portion of the home are asbestos-containing. White-paint is lead-containing.</p> | <p><b>Photo 2: Thermal System Insulation</b></p> <p>Thermal system insulation associated with ductwork throughout the home is asbestos-containing.</p> |

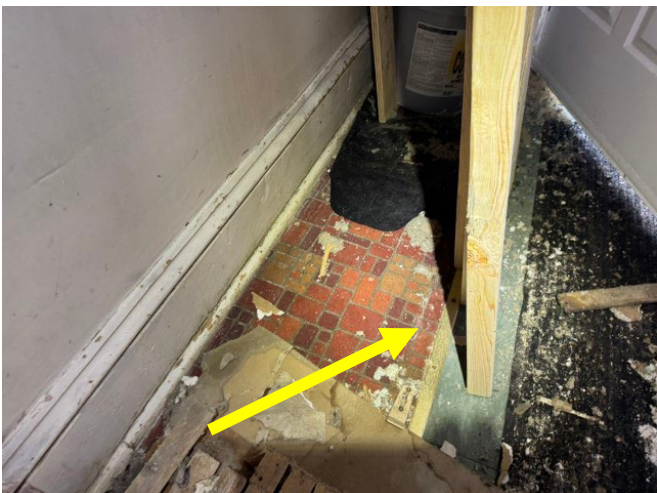
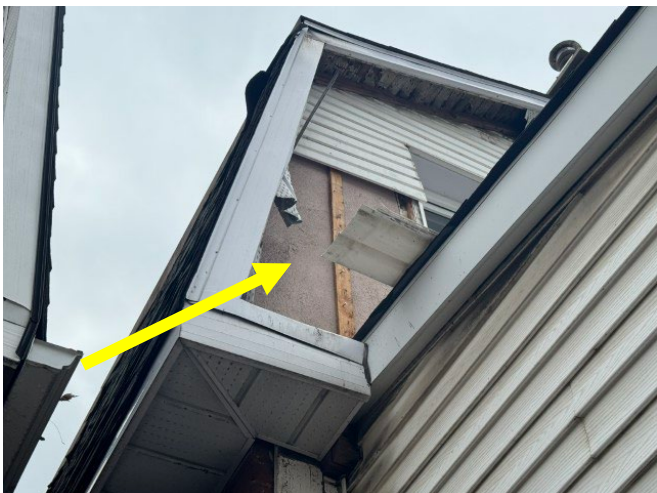
| <p><b>Photo 3: Main Floor Entranceway – Flooring</b></p> <p>Mastic associated with flooring in the main floor entranceway is asbestos-containing.</p> | <p><b>Photo 4: Exterior Plaster</b></p> <p>Exterior plaster (pink) is asbestos-containing.</p> |
