February 14, 2000

Re: Place de Ville II
Tower C and Podium Building
Sparks Street, Kent Street, Queen Street, Lyon Street
Ottawa, Ontario

**ENVIRONMENTAL DUE DILIGENCE ASSESSMENT
PLACE DE VILLE II
SPARKS STREET, KENT STREET,
QUEEN STREET, LYON STREET
OTTAWA, ONTARIO**

October 1994

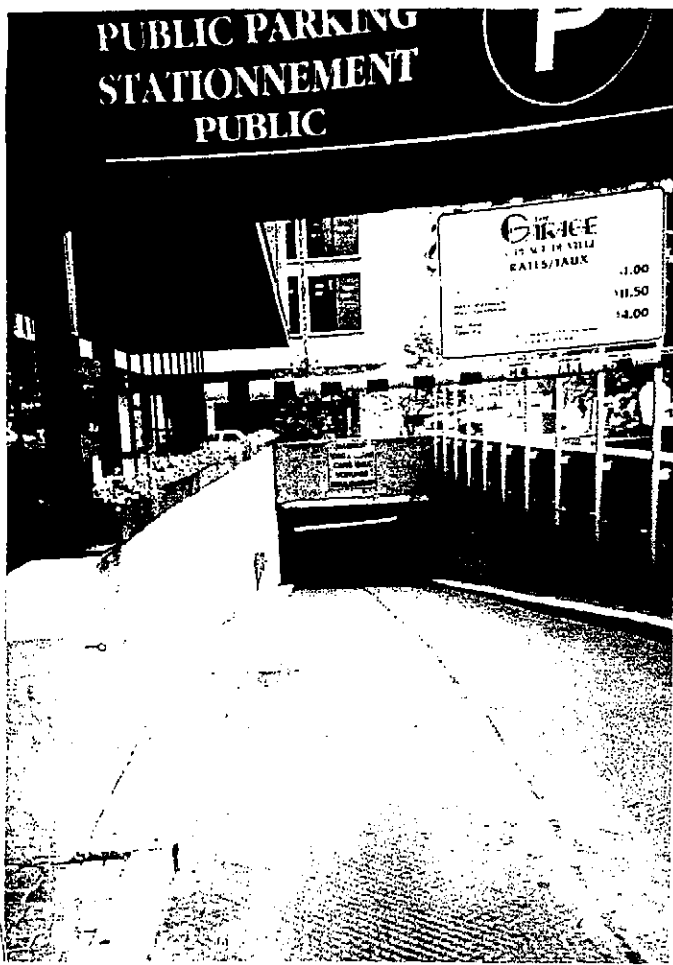
5

5. Entrance to underground parking garage of subject property, looking west from Kent Street.
6. Diesel storage tank, 1130 L capacity.
7. Diesel storage tanks, (2), 1130 L capacity each. Note tank in foreground is stained from accidental overfilling.

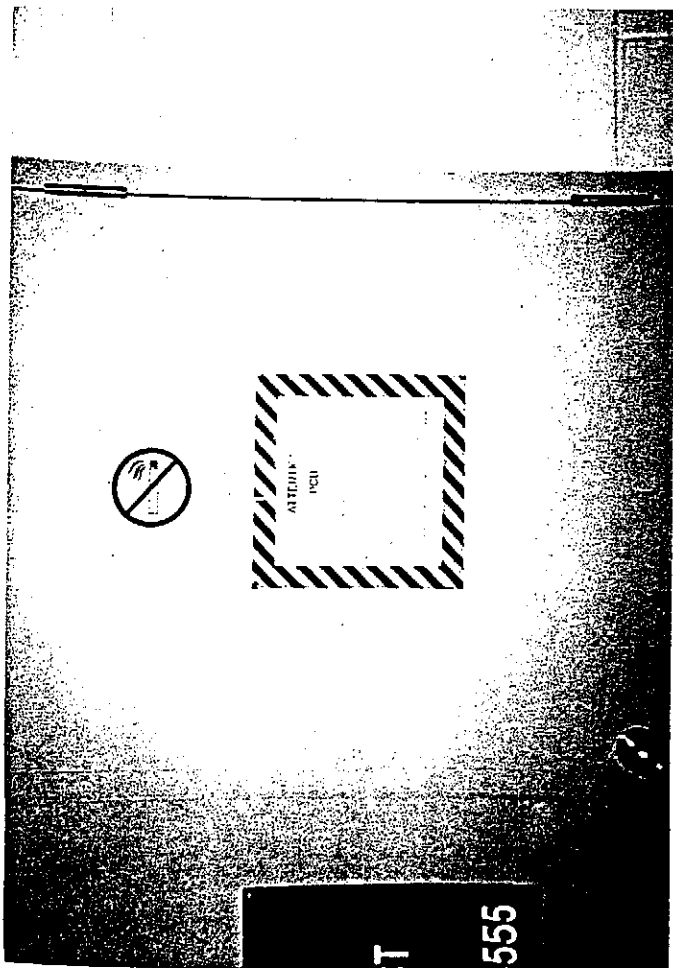
15

The presence of components at the site that contain PCB represents an environmental hazard. However, the on-site PCB storage facility was properly labelled, secured, and proper handling procedures were in place and therefore the level of risk is not significant.

According to the site manager, some fluorescent lighting ballasts that contain PCB were in use at the property. We understood that these components were being removed during on-going maintenance. A room for the storage of the components was observed in the underground parking garage. The room was locked and appropriately labelled with warning signs and emergency telephone numbers. The room was used to temporarily store equipment containing PCB prior to subsequent removal offsite by a licensed contractor. Proper PCB handling procedures and safety precautions were in place. No other on-site components containing PCBs were observed or suspected.

15. PCB storage facility, note proper identification and warning signs.
16. Ontario Hydro vault.
