July 2010

Slope Stability Assessment Proposed Development Site 101 Wurtemberg Street Ottawa, Ontario

Submitted to:
Claridge Homes Corporation
2001-210 Gladstone Avenue
Ottawa, Ontario
K2P 0Y6

Report Number: 10-1121-0003

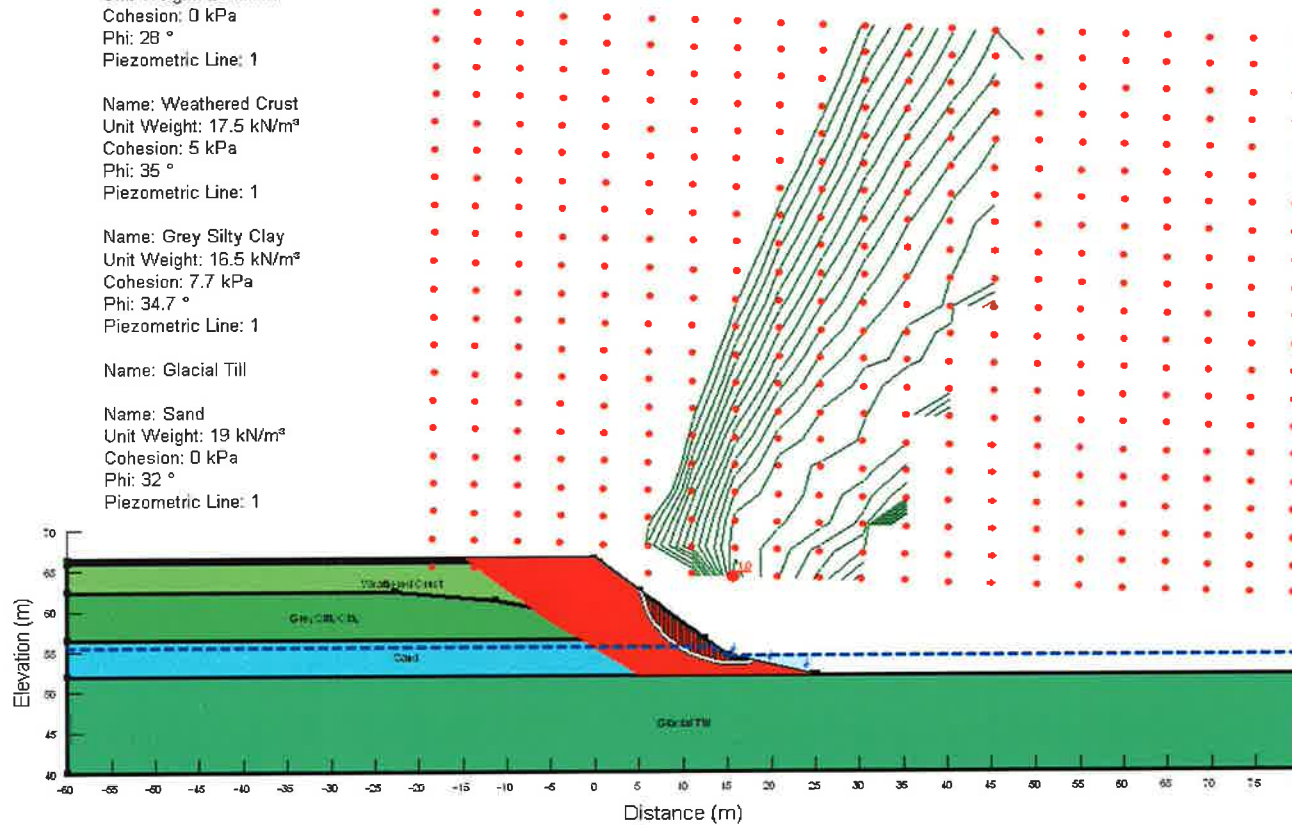
Figure 3

For static loading conditions, the results of the stability analyses indicate that the existing slope generally has a factor of safety against instability of about 1.0 and is therefore unstable. It is considered that the slope has maintained its current steep geometry as a product of the advantageous effects of the under-drainage from the sand layer and the reinforcing effects of the vegetation.

These analyses indicated a factor of safety of about 0.8, which is less than desired value of 1.1. However the potential failure surfaces with factors of safety less than 1.1 are all confined to the lower portion of the slope face and would not jeopardize the table land area.
