Subject: **Phase I - Environmental Site Assessment**
175 Richmond Road
Ottawa, Ontario

Phase I - Environmental Site Assessment

175 Richmond Road
Ottawa, Ontario

Report: PE2357-1

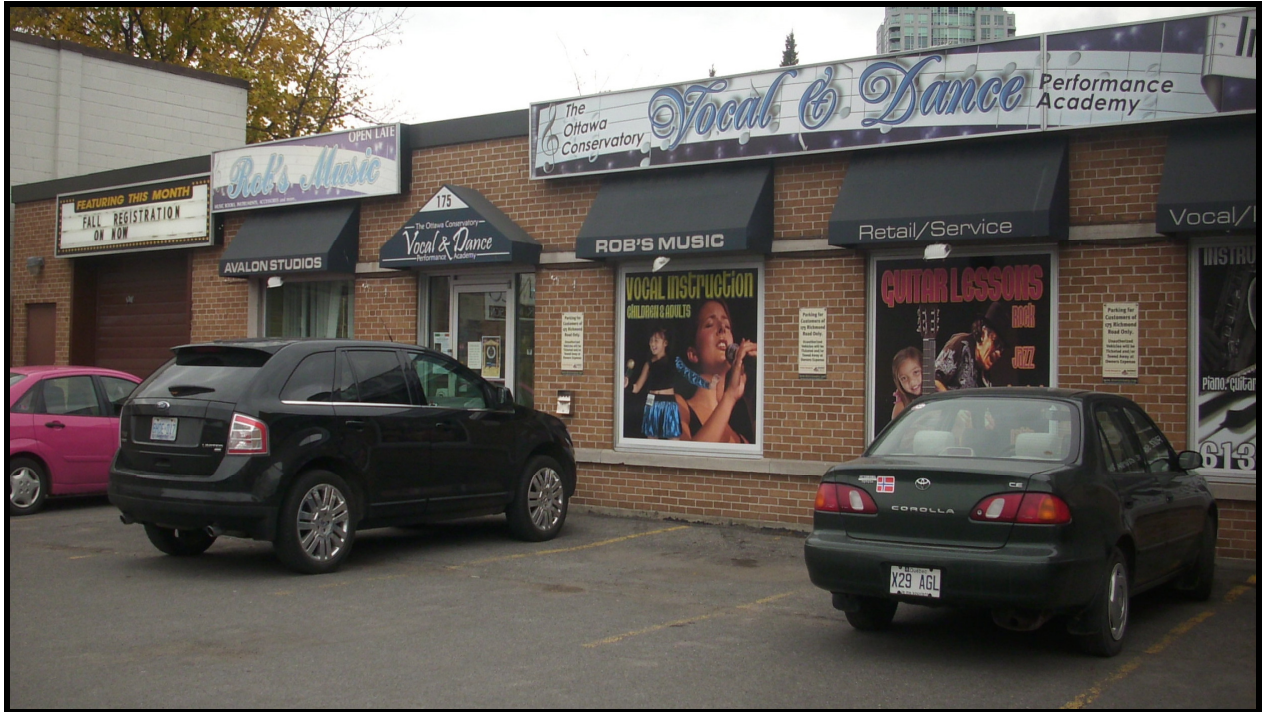
Photograph 1: South wall of western portion of the building, facing north.

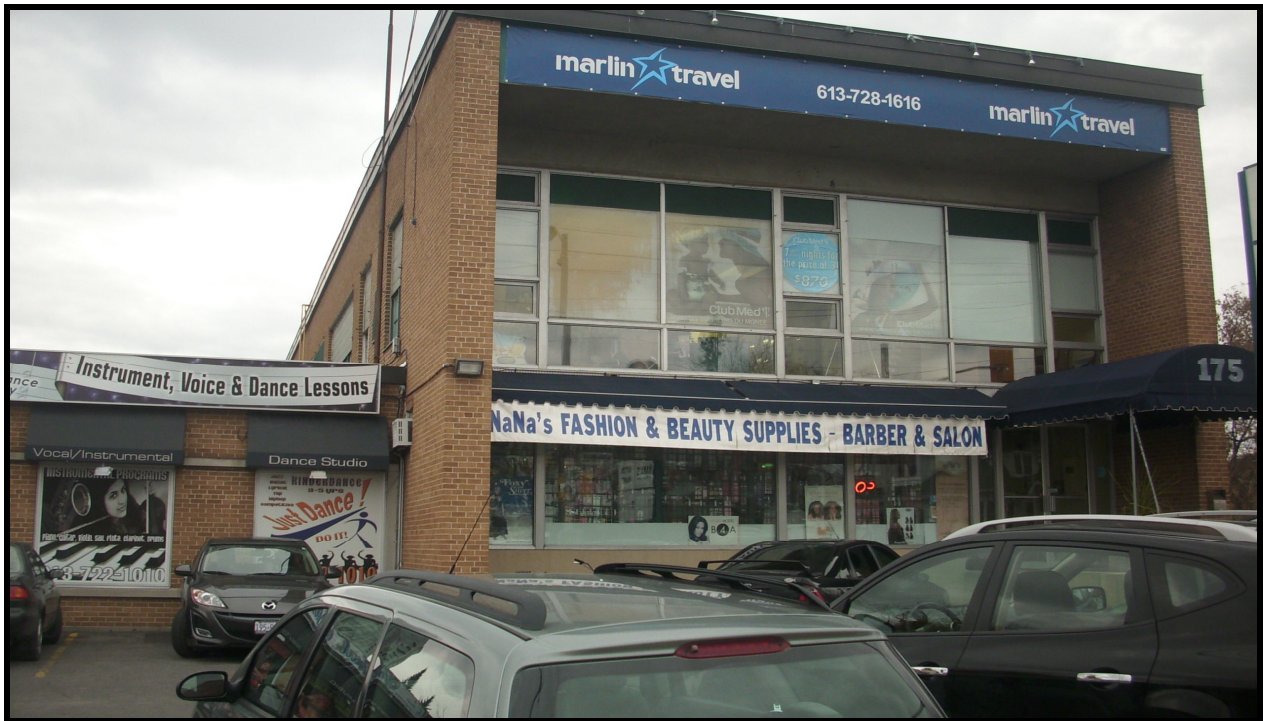
Photograph 2: South wall of eastern portion of the building, facing north.

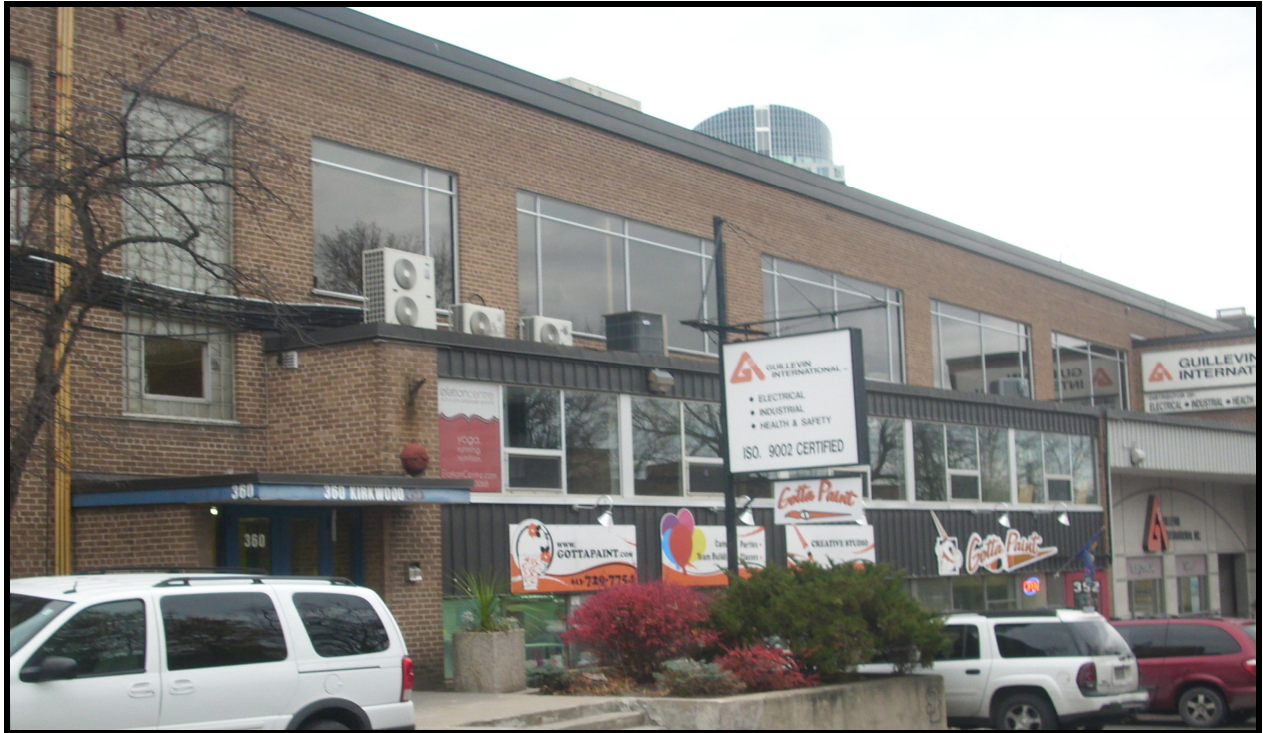
Photograph 3: East wall of southern portion of the building, facing northwest.

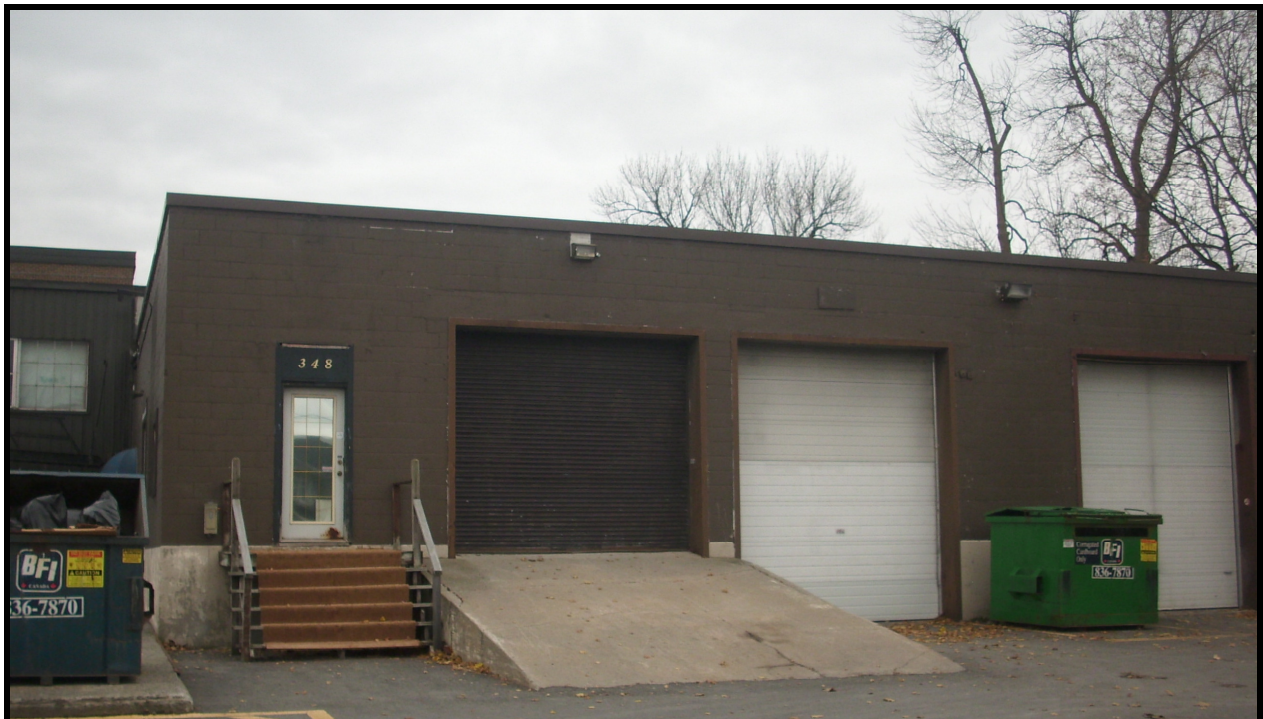
Photograph 4: South wall of the northern portion of the building, facing south.

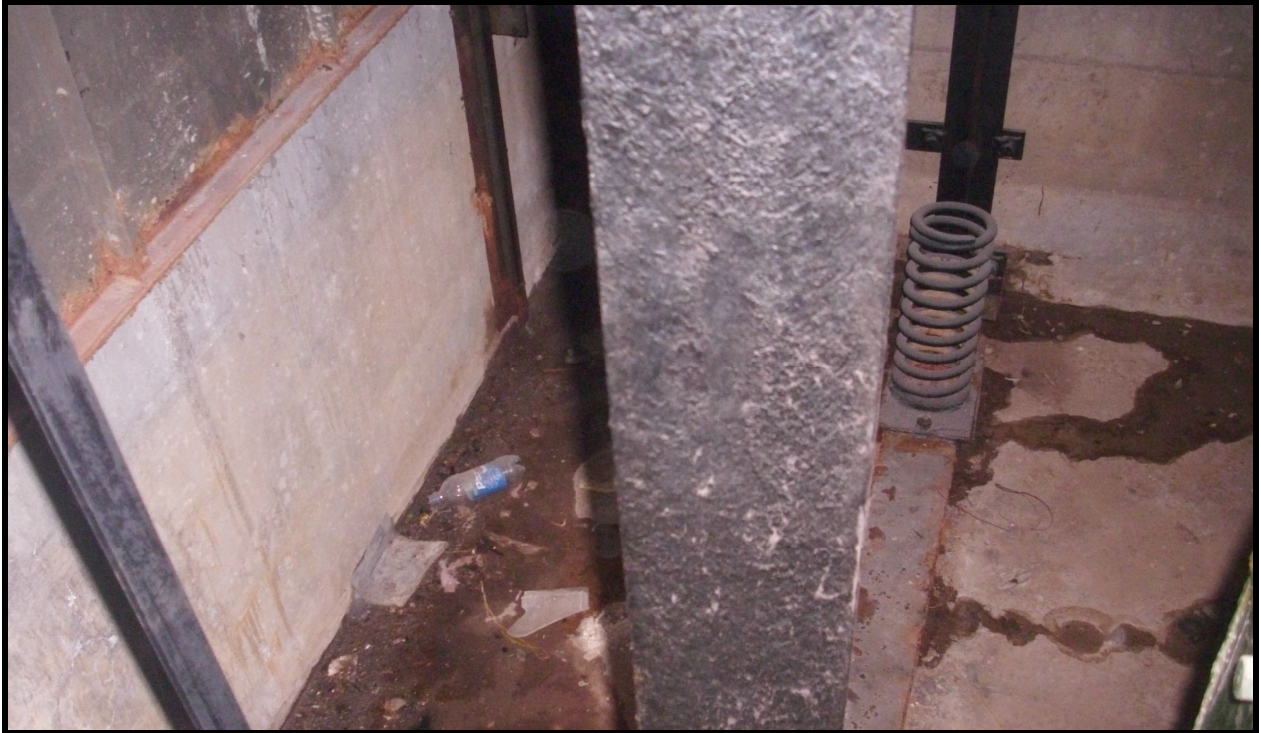
As previously discussed, a piston elevator is present in the subject building. The elevator was reportedly decommissioned three (3) years ago. The elevator room was accessible at the time of the inspection. Some staining was observed on the poured concrete floor around the elevator pump and around three (3) small containers of hydraulic fluid stored on the floor. The elevator pit was not fully accessible at the time of the site inspection, however it was possible to view a limited portion of the pit. What appeared to be water and rust stains were present on the concrete floor of the pit and are shown in Photograph 5.

Photograph 5: Floor of elevator pit.

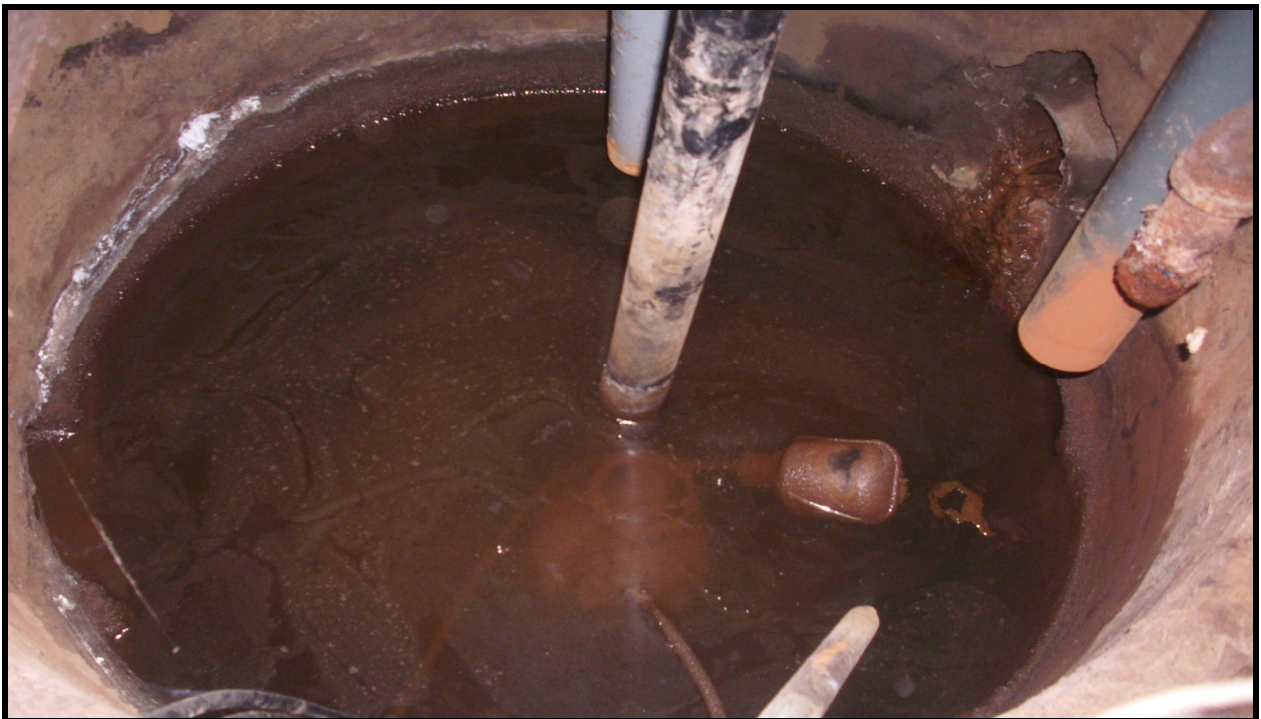
The liquid discharge from the subject property includes the washwater and sewage from the building and the water from the floor drains and sump pit. The sump pit was located in the boiler room situated along the eastern wall of the subject structure. The sump pit, approximately 1 m in depth, is suspected to be original with the construction of the building in the 1950's. Water was present in the pit at the time of the inspection. The water appeared cloudy at the time of the site assessment, however no hydrocarbon sheen or unusual odour was noted.

Several floor drains were observed at the time of the site inspection. A floor drain was observed in the mechanical room containing the air handling equipment. Water was ponded around the drain at the time of the assessment. The water was clear and no signs of contamination were observed. A floor drain was observed in the basement hallway (within the northern portion of the subject building). It was not possible to open the drain cover at the time of the inspection. A floor drain was also observed in the ground floor level CBNC storage area. The drain appeared to be dry upon inspection. A floor grate, extending the length of the basement-level CBNC storage area was noted at the time of the inspection. It was not possible to inspect the length of the floor grate as the majority of it was covered with stored items. However, the drain led to a catch basin at the base of the entrance ramp, which was inspected. The basin was approximately 1 m deep and the water inside was observed to be clean with no hydrocarbon sheen or odour and is shown in Photograph 6.

Photograph 6: Sump pit in boiler room.
