Urban Forestry & Forest Management Consulting

September 10, 2019

RE: TREE CONSERVATION REPORT – PHASE 2, QWEST (114 RICHMOND ROAD, OTTAWA)

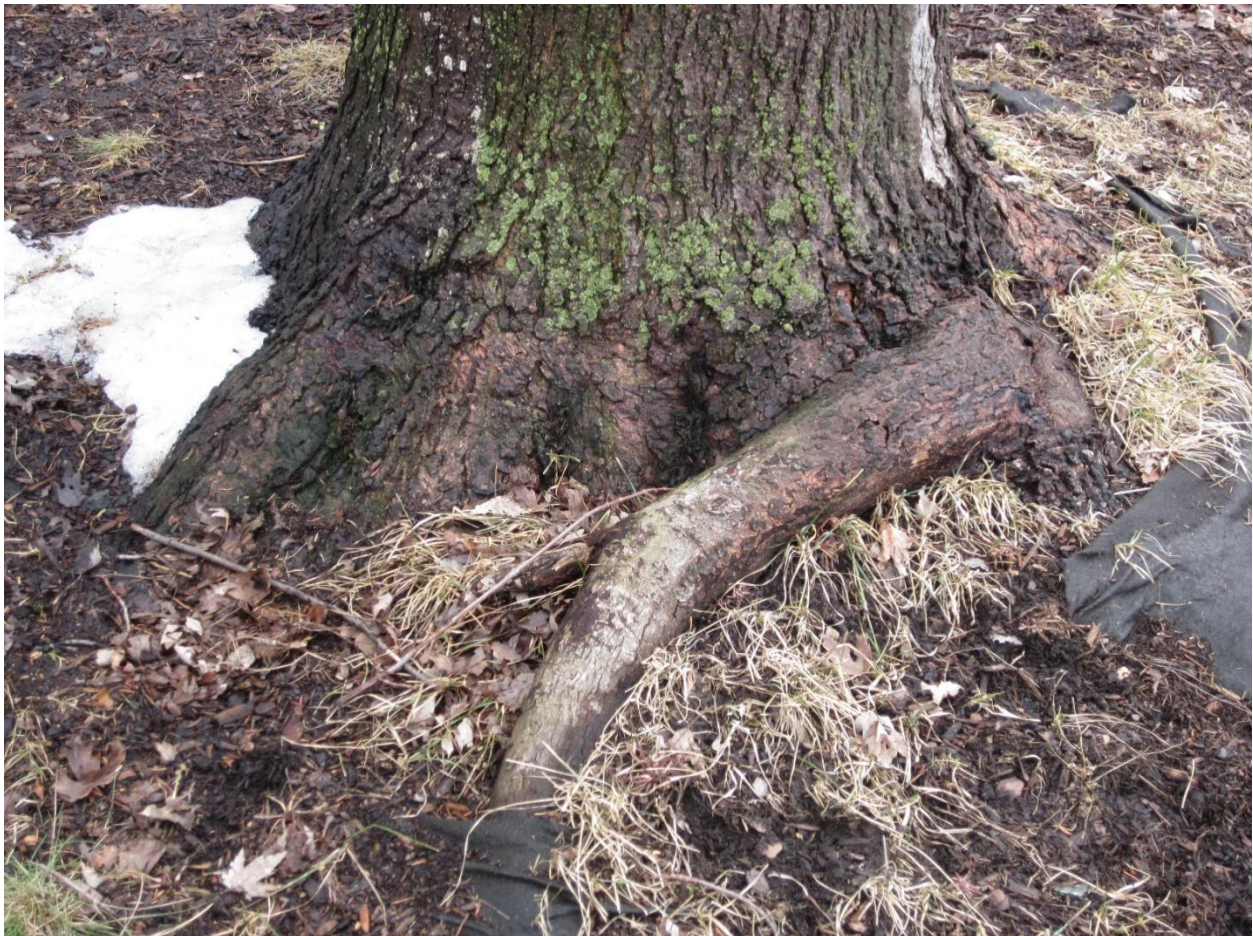
is held at approximately 5m above grade due to the need to provide clearance over Nun’s Walk and the development site to the west. Their root collars appear to be well formed with only occasional girdling or binding roots present (with the exception of tree #46 – see picture 1 on page 4).

Picture 1. Binding root on root collar of tree in Phase 2 of Qwest development. Picture taken March 2018.

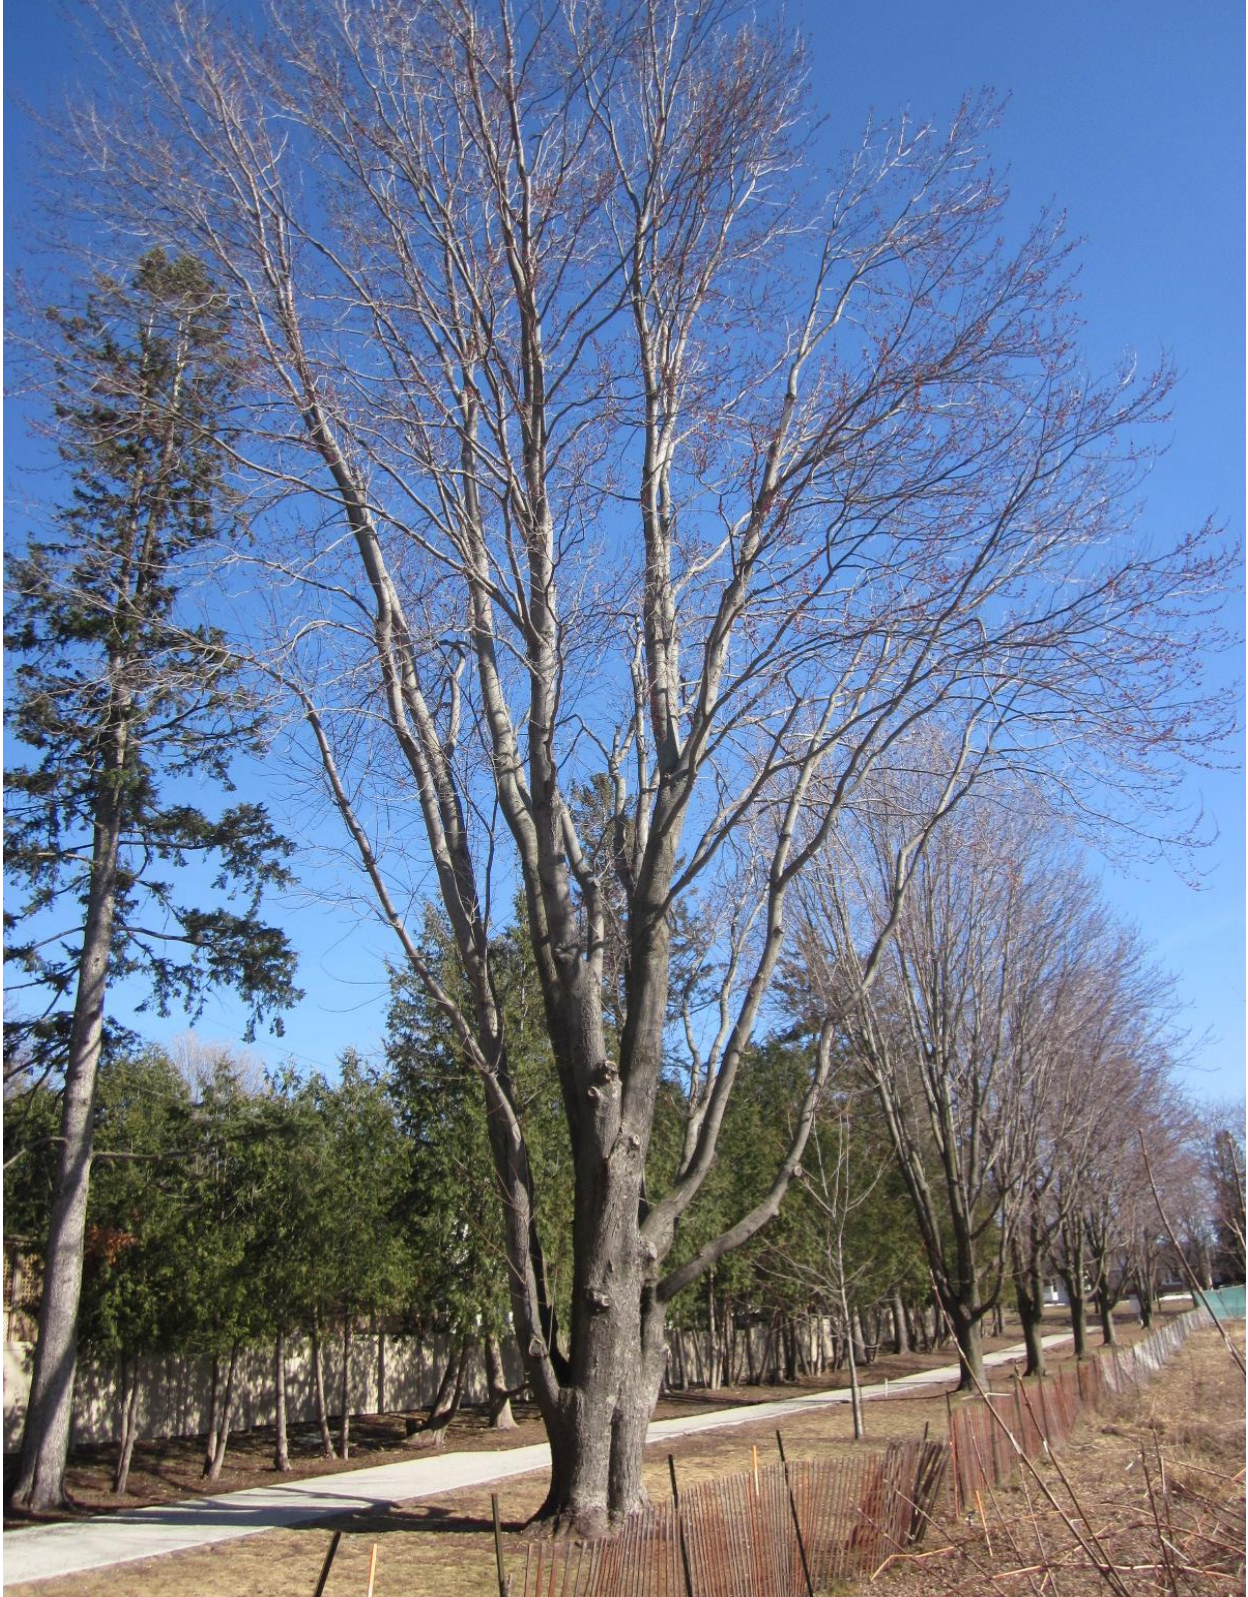
Picture 2. Line of silver maple trees in Phase 2 of Qwest development (looking eastward). Note Nun's Walk on far side of trees. Picture taken April 2019.

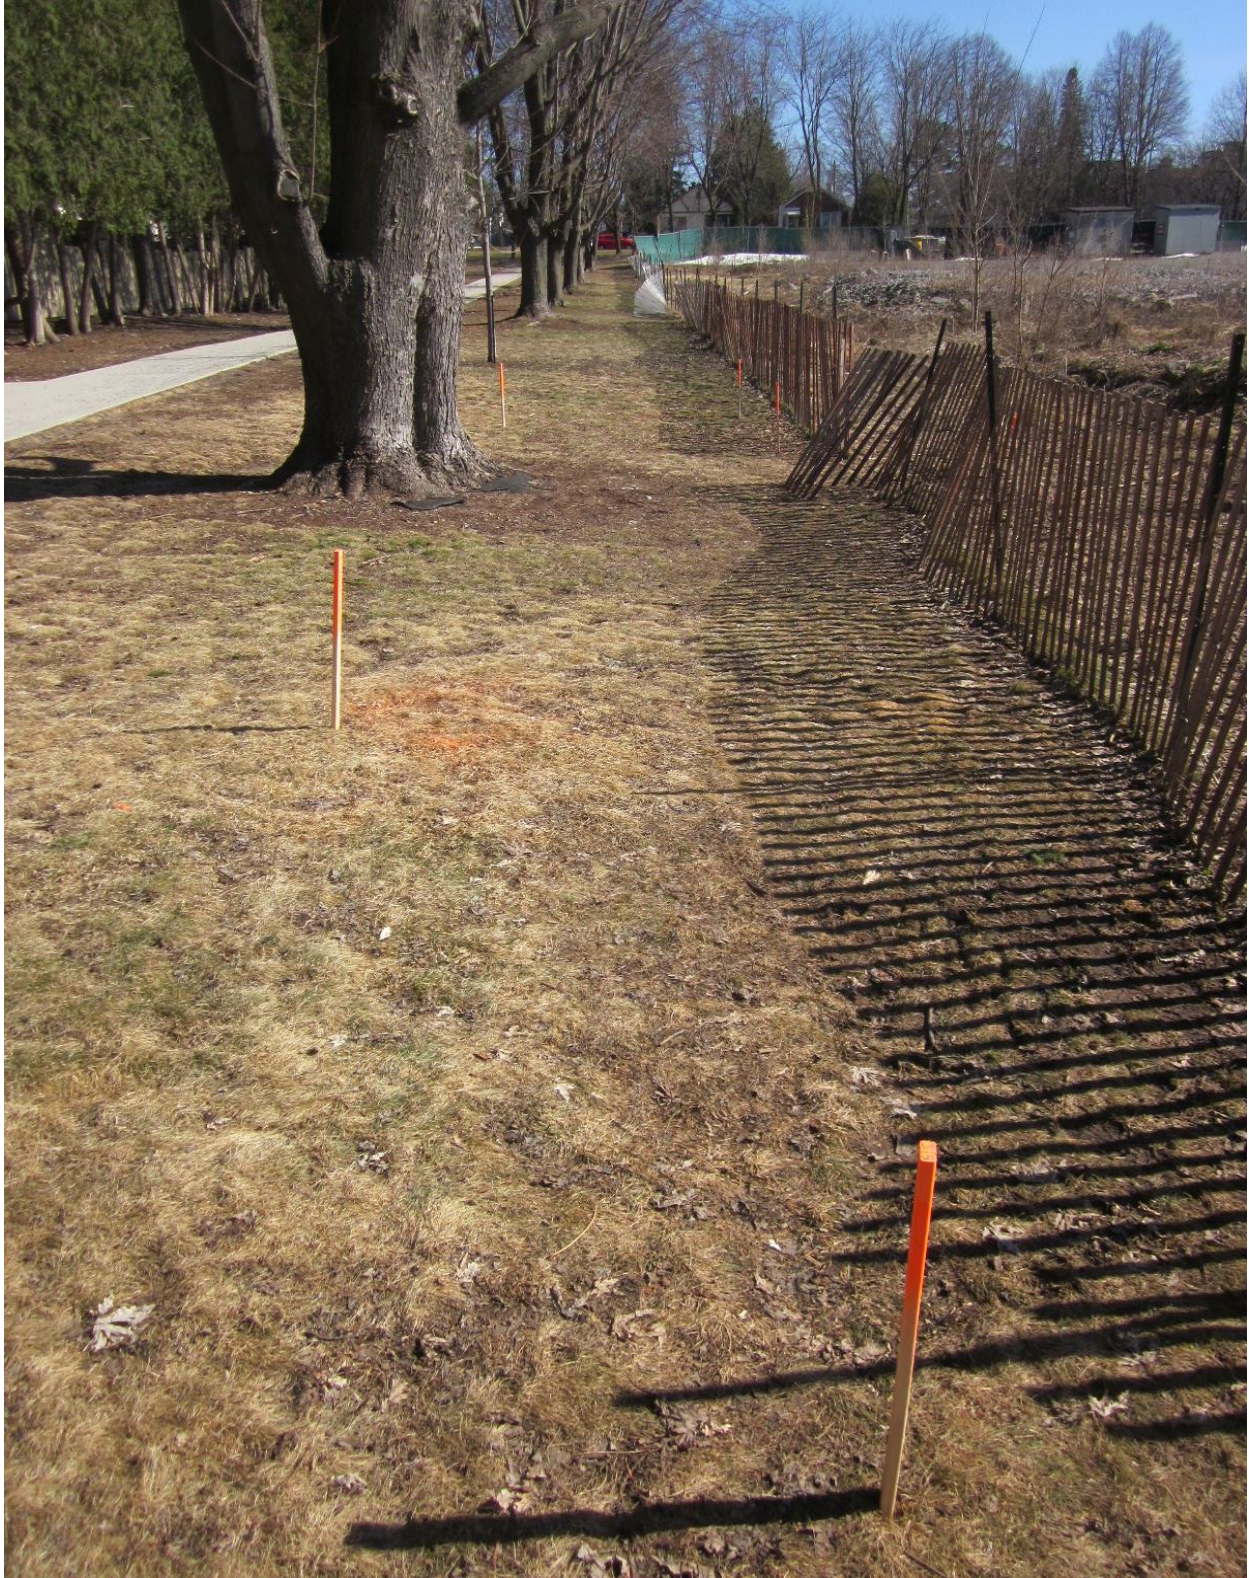
Picture 3. Line of silver maple trees in Phase 2 of Qwest development (looking southeastward). Snow fence is approximate distance of excavation in relation to trees in background (tree #41 is in foreground). Picture taken April 2019.

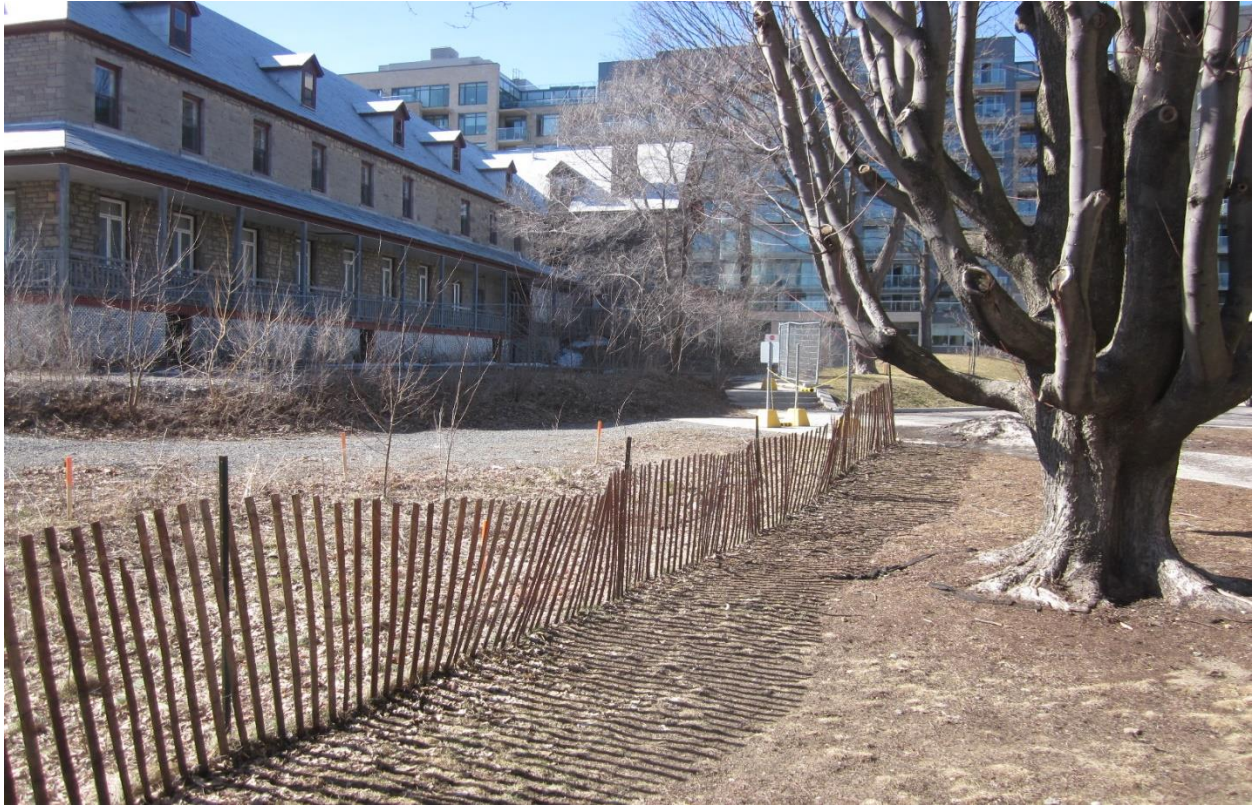
Tree No.	DBH ¹ (cm)	CRZ ² (m)	Distance to excavation ³ (m)	Tree condition
38	77.8	7.8	+/-6	Very mature; multiple co-dominant stems arising at 1.0m from grade – broad crown; good crown density, growth increment and leaf colour; multiple exposed surface roots
41	102.5 (at 0.5m)	+/-10	+/-4.5	Very mature; central stem with co-dominant leaders at 3.5m and competing laterals at 1.2m on north and east sides; crown raised to 7m on west; good crown density, growth increment and leaf colour; multiple exposed surface roots
44	57.4	5.7	+/-3.5	Mature; central stem with competing lateral at 2.5m on east; tri-dominant leaders at 3.5-4m - central stem with competing laterals on north and south sides; major surface root damaged by mowers
46	54.9	5.5	+/-3.5	Mature; central stem with competing lateral at 2m on west and suppressed laterals at 2.5m on north and 3.25m on west side; co-dominant leaders at 4m; two binding roots present

Picture 2. Silver maple tree #38 in Phase 2 of Qwest development (looking northward). Stakes on left indicated set back of future fire route. Picture taken April 2019.

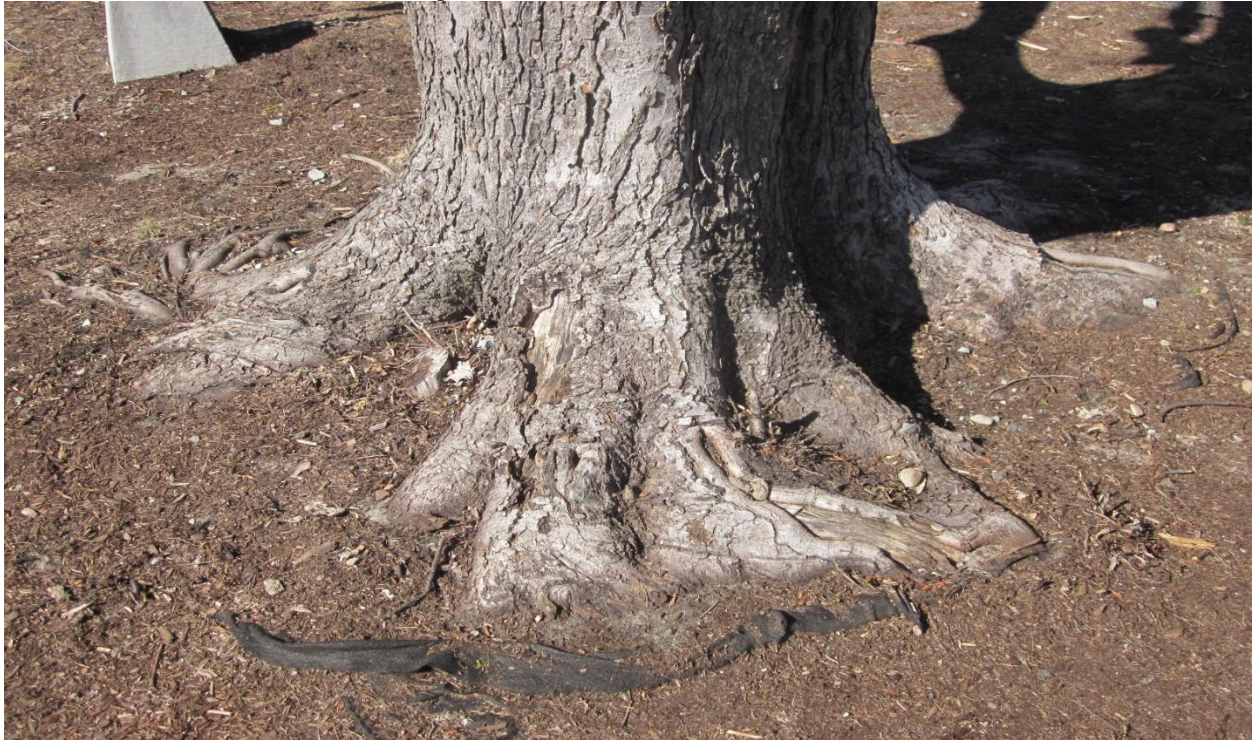
Picture 4. Root collar of tree #38 in Phase 2 of Qwest development (note damaged root flares and landscape fabric). Picture taken April 2019.

The landscape fabric presently around the trees should be removed and replaced with a layer of topsoil in direct contact with the native soil. This soil should then be covered by woodchip mulch. The combined depth of soil and mulch should not exceed 10cm and should not be spread to the point that any tree's root collar is obscured. This treatment should extend for the length of the tree line so to encompass all seven trees and cover all exposed surface roots. If desired this area can be made into a garden bed containing low-growing herbaceous vegetation.
