3. SCOPE OF WORK

DST visited AIM recycling facility on October 16, 2019, to inspect slope between the AIM property and Ramsay Creek. Following that, DST conducted a topographic survey to establish ground elevations at the boundaries of the mentioned property, to come up with two cross-sections (Refer to Figure 2, Appendix A for cross-section locations), which demonstrate the shape of the slope and land between the mentioned property and Ramsay Creek.

Summary Letter of Screening Assessment 2555 Sheffield Road, Ottawa, Ontario DST File No: TS-SO-37029

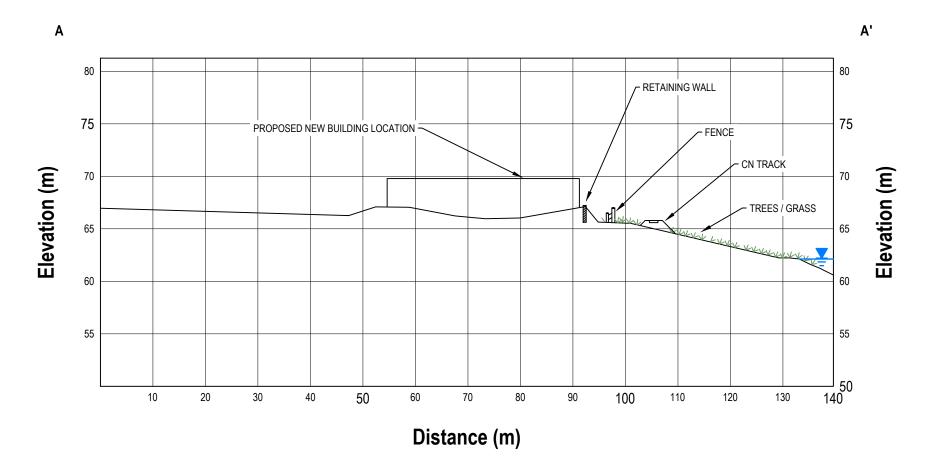
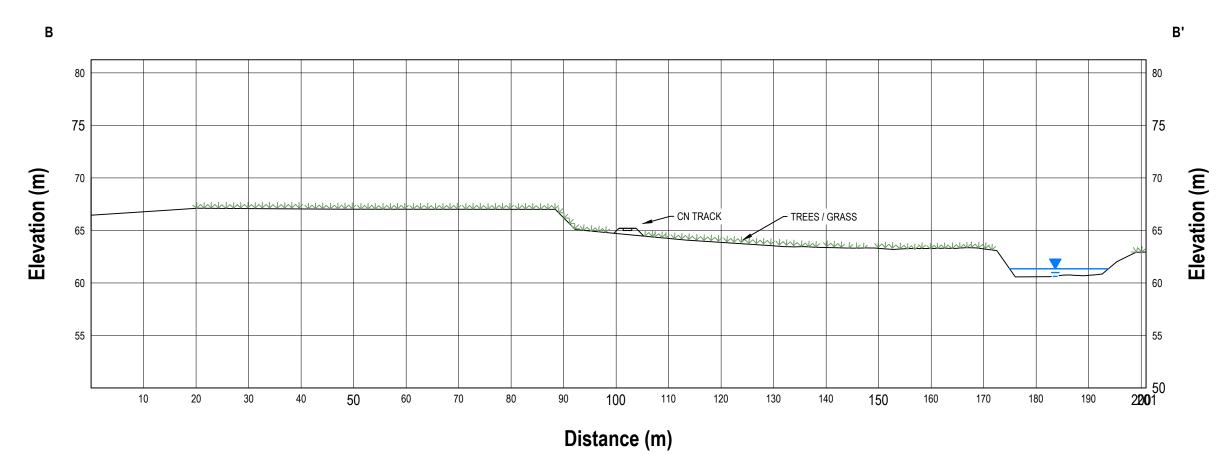
Cross-Section Views

- The Stable Slope Allowance used by JTB is based on a 5:1 slope. Based on DST's site visit and topographic survey, the toe of the valley slope is located more than 15 m away from the stream bank. Therefore, DST believes that a stable slope allowance based on a 3:1 slope should be used.

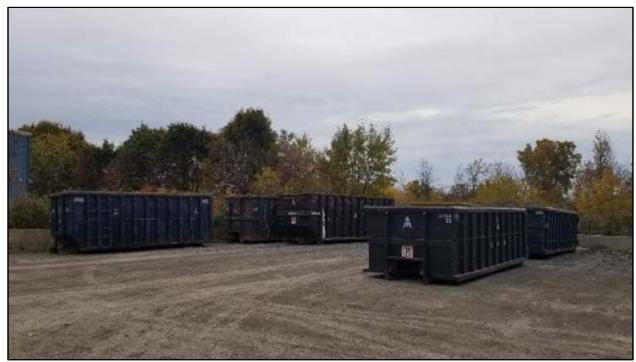
Figure 1: Proposed Location of New Building at 2555 Sheffield Road

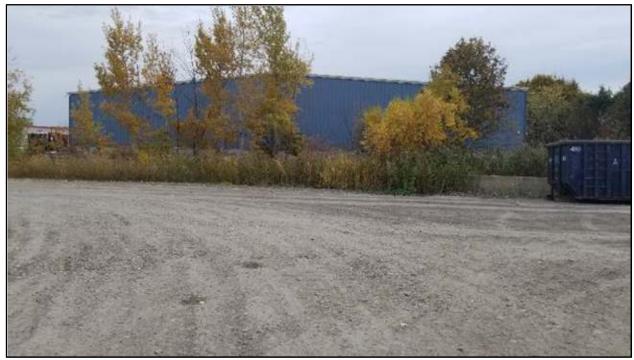
Figure 2: Proposed Location of New Building at 2555 Sheffield Road

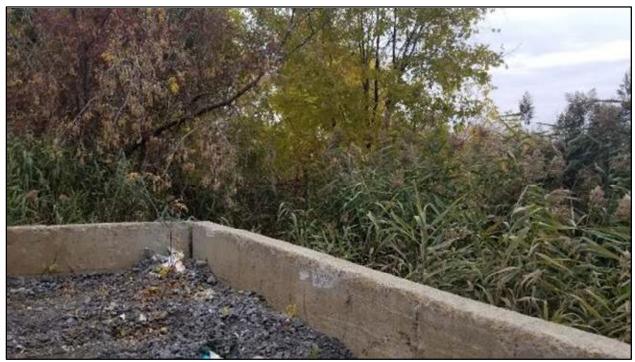
Figure 3: Retaining Wall at North East Side of Property

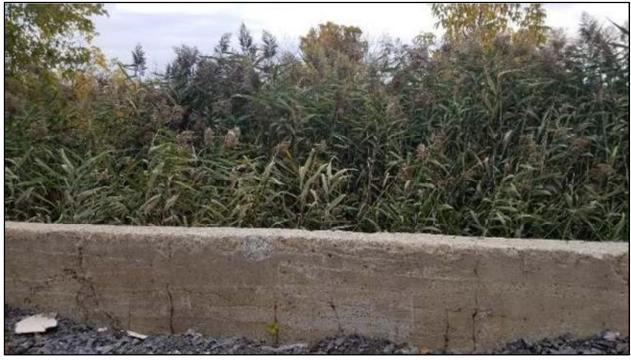
Figure 4: Retaining Wall at North East Side of Property

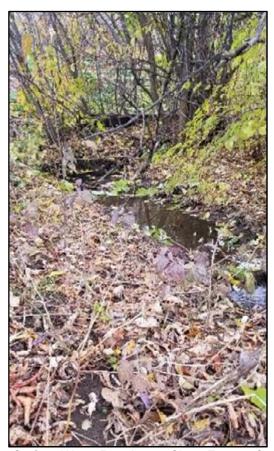
FACE Negligible - Surface water table running towards stream - No Erosion

Figure 5: Surface Water Running on Slope Face at Cross-Section 1

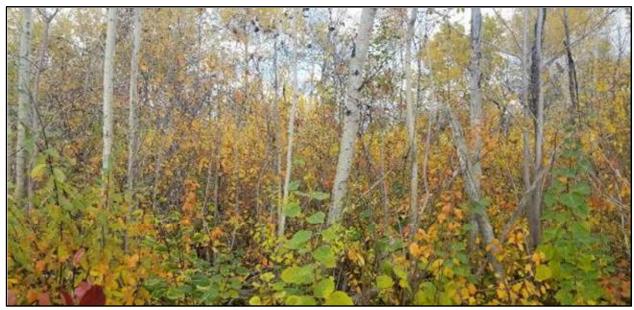
Figure 6: Vegetation at Cross-Section 1

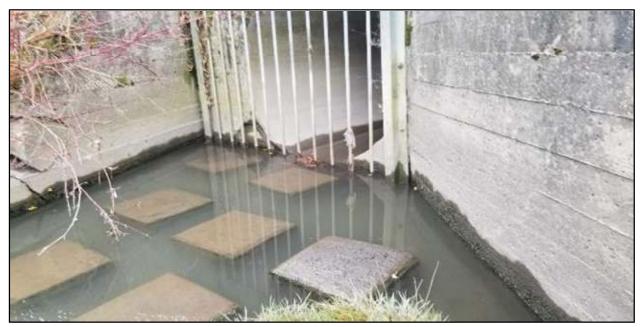
Figure 8: Concrete Box at Cross-Section 1

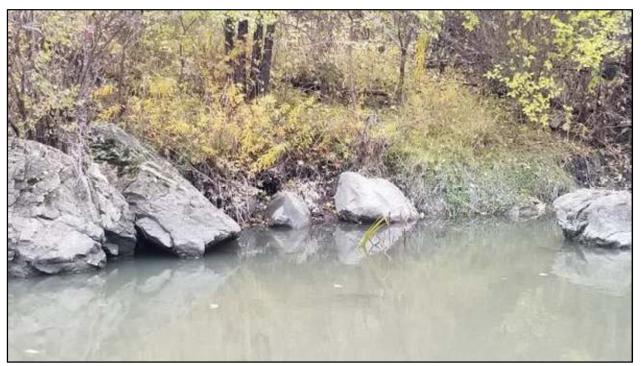
Figure 9: Creek Bank at Cross-Section 1

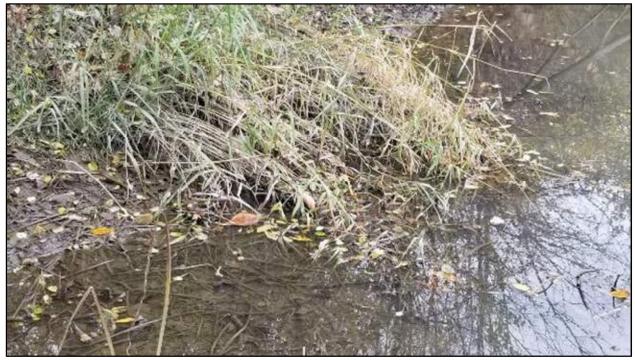
Figure 10: Water Covering Vegetation at Cross-Section 2 Near Creek Bank

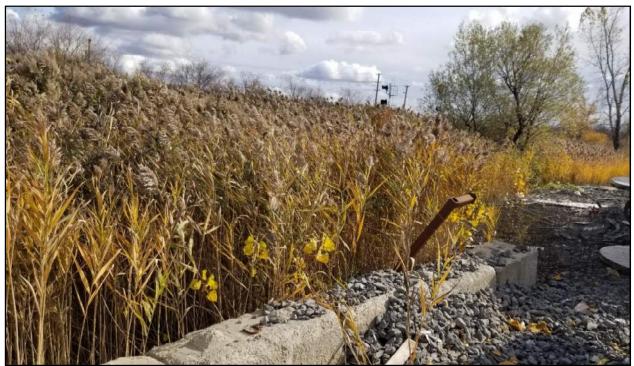
Figure 11:Aquatic Plants at North East Side of Property

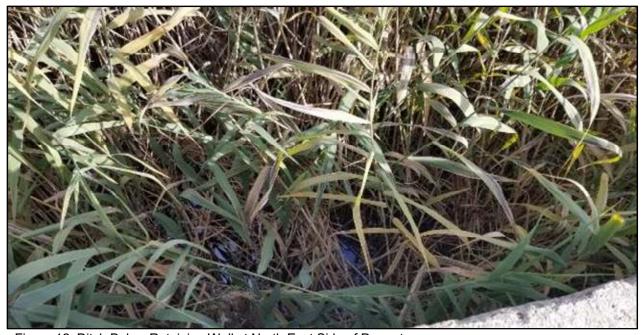
Figure 12: Ditch Below Retaining Wall at North East Side of Property
