URBAN FORESTRY & FOREST MANAGEMENT CONSULTING

August 7, 2020

RE: TREE PRESERVATION REPORT FOR SILVER MAPLE AT 28 PRETORIA AVENUE, OTTAWA

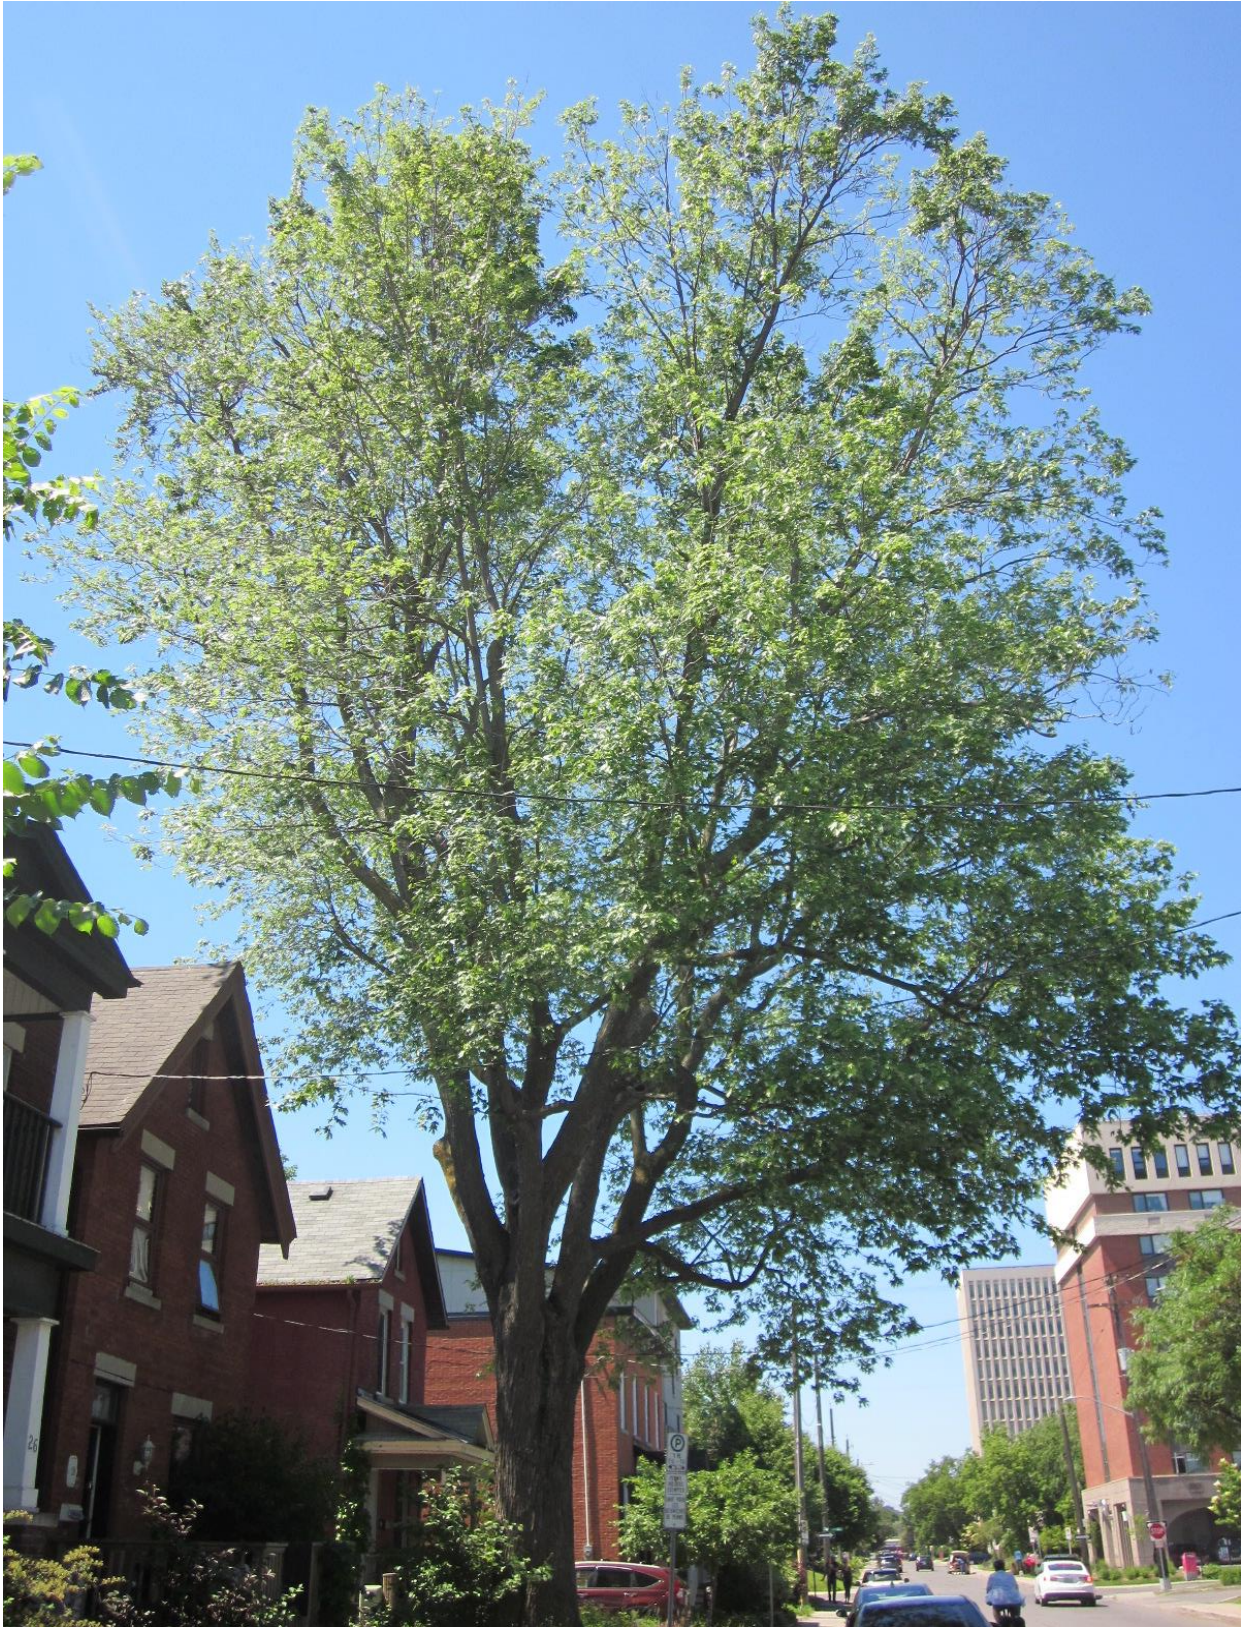
Visual inspections of the tree were completed in June 2019 and July 2020. Details of the 2019 inspection can be found in the Tree Conservation Report prepared by *IFS Associates Inc.* on June 28, 2019. In terms of the tree's growing environment, it is located nearby to the city sidewalk and between private driveways (asphalt and interlock brick). The tree's effective rooting zone is approximately 7.5m x 22m in size and is presently covered by both hard surfaces (drive- and walkways) and soft ones (turf and garden areas). As of June 2020 the tree's crown had been pruned in anticipation of the planned construction.

Picture 1. Silver maple on City of Ottawa property in front of 30 Pretoria Avenue (taken July 2019)

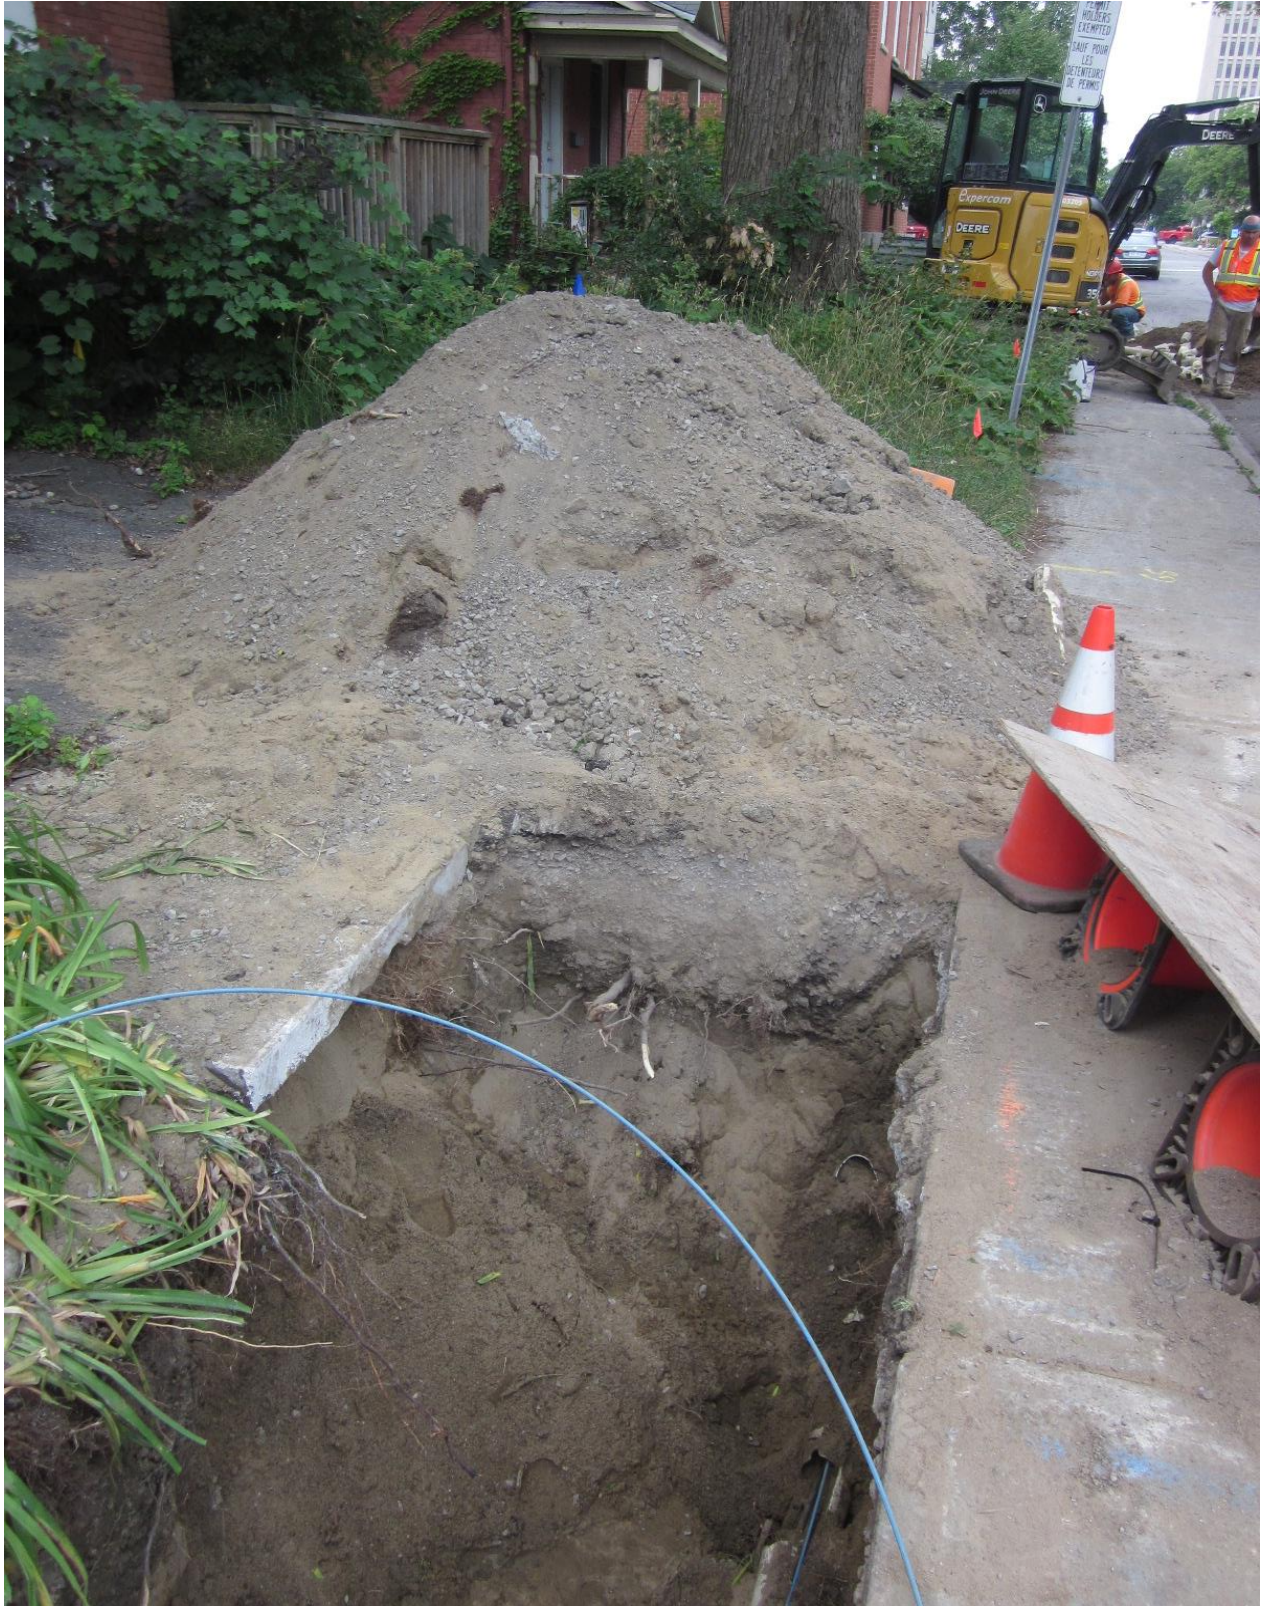
Picture 2. Recent root damage within maple's critical rooting zone due to work on Bell lines (taken July 2020)

- 3) Excavation & Exposed Roots: The use of hydro vacuuming to excavate around the tree will be required in order to carefully expose roots. Roots greater than 1cm in diameter should be cleanly cut at the furthest limits of the driveway. Bypass shears or a hand saw should be used for this work. Each cut root end should be sealed immediately with a beeswax compound. Once the exposed roots are properly treated excavation using traditional equipment can be used to complete the work.
- 4) Watering: Roots exposed during excavation should be immediately reburied with soil or temporarily covered with burlap, filter cloth or woodchips and kept moist (*i.e.* watering with a soft-spray nozzle at least three times a week). A covering of plastic should be used in order to retain moisture during an extended period when watering may not be possible (*i.e.* over long weekends).
