June 28, 2019

JB Holdings Inc.  
107 Pretoria Avenue  
Ottawa, ON  
K1S 1W8  
Attn. John Bassi – President

**RE: TREE CONSERVATION REPORT FOR 24-30 PRETORIA AVENUE, OTTAWA**

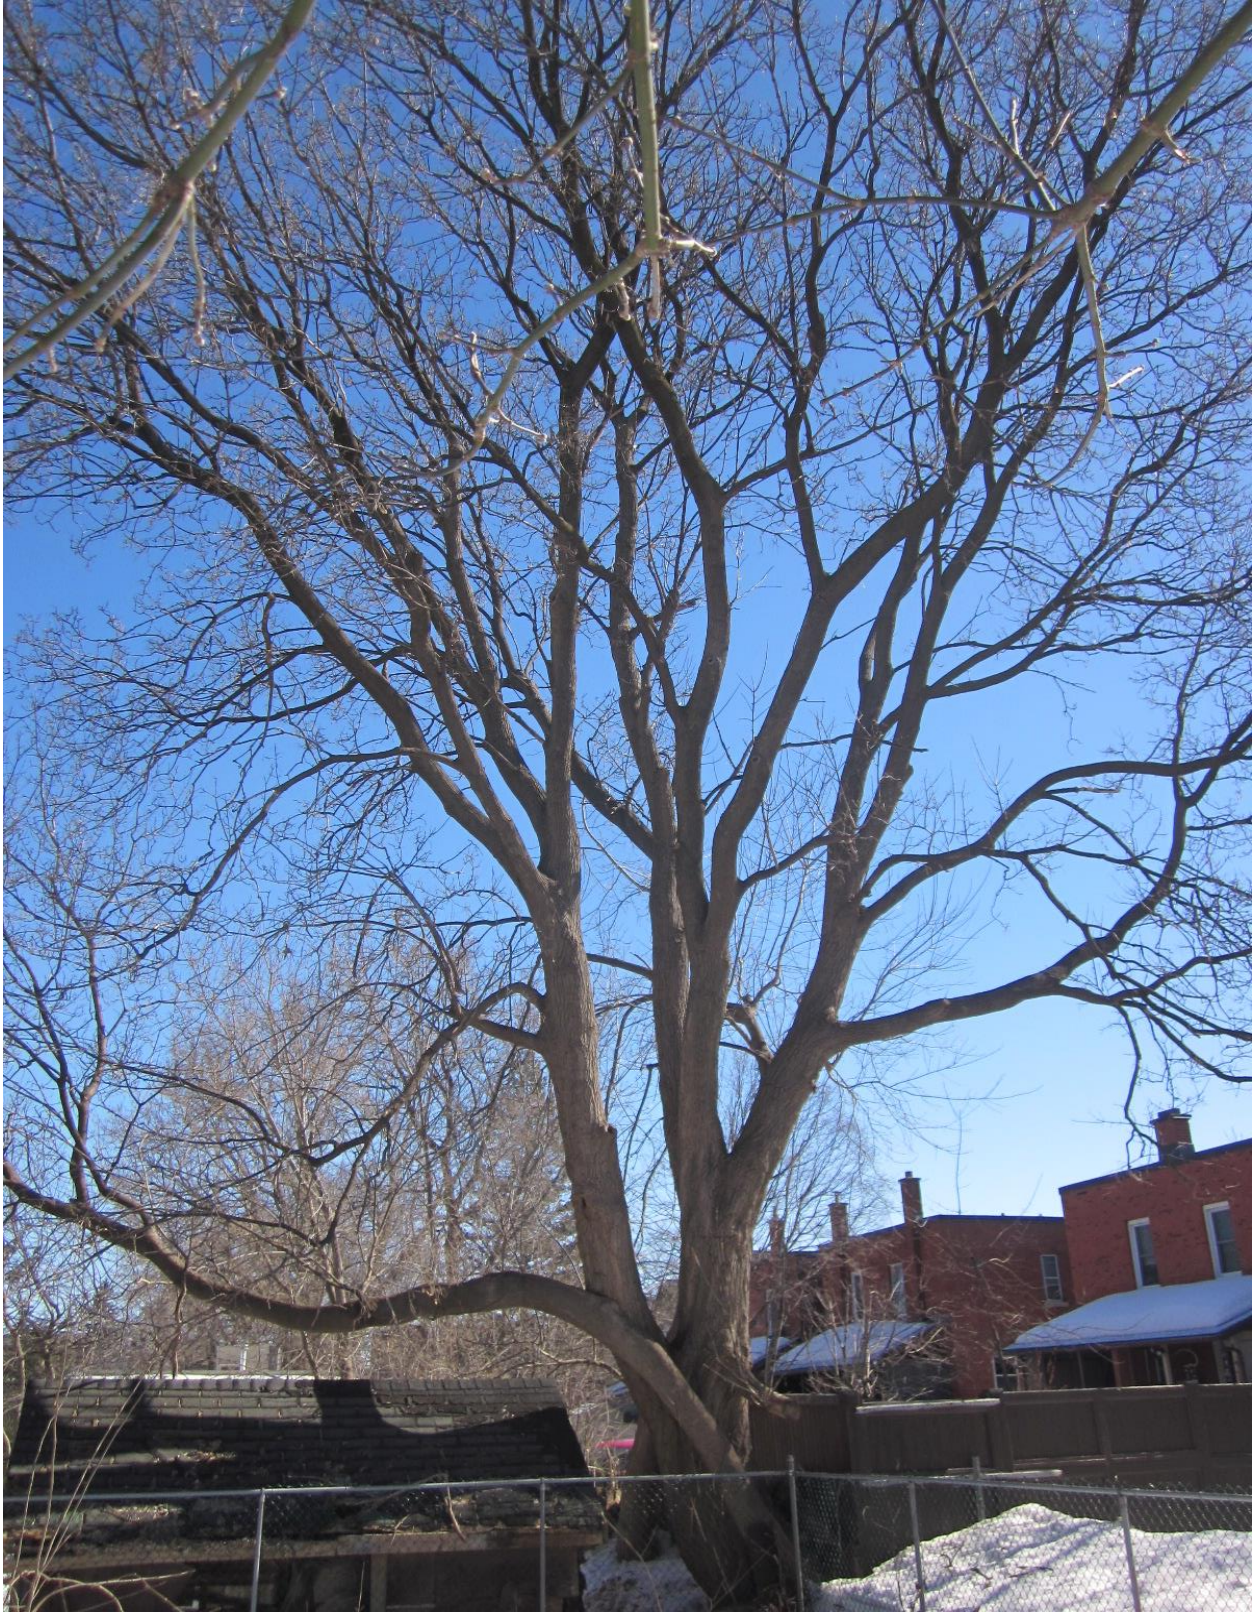
Picture 2. Manitoba maple (tree #11) to be removed from 24-30 Pretoria Avenue.

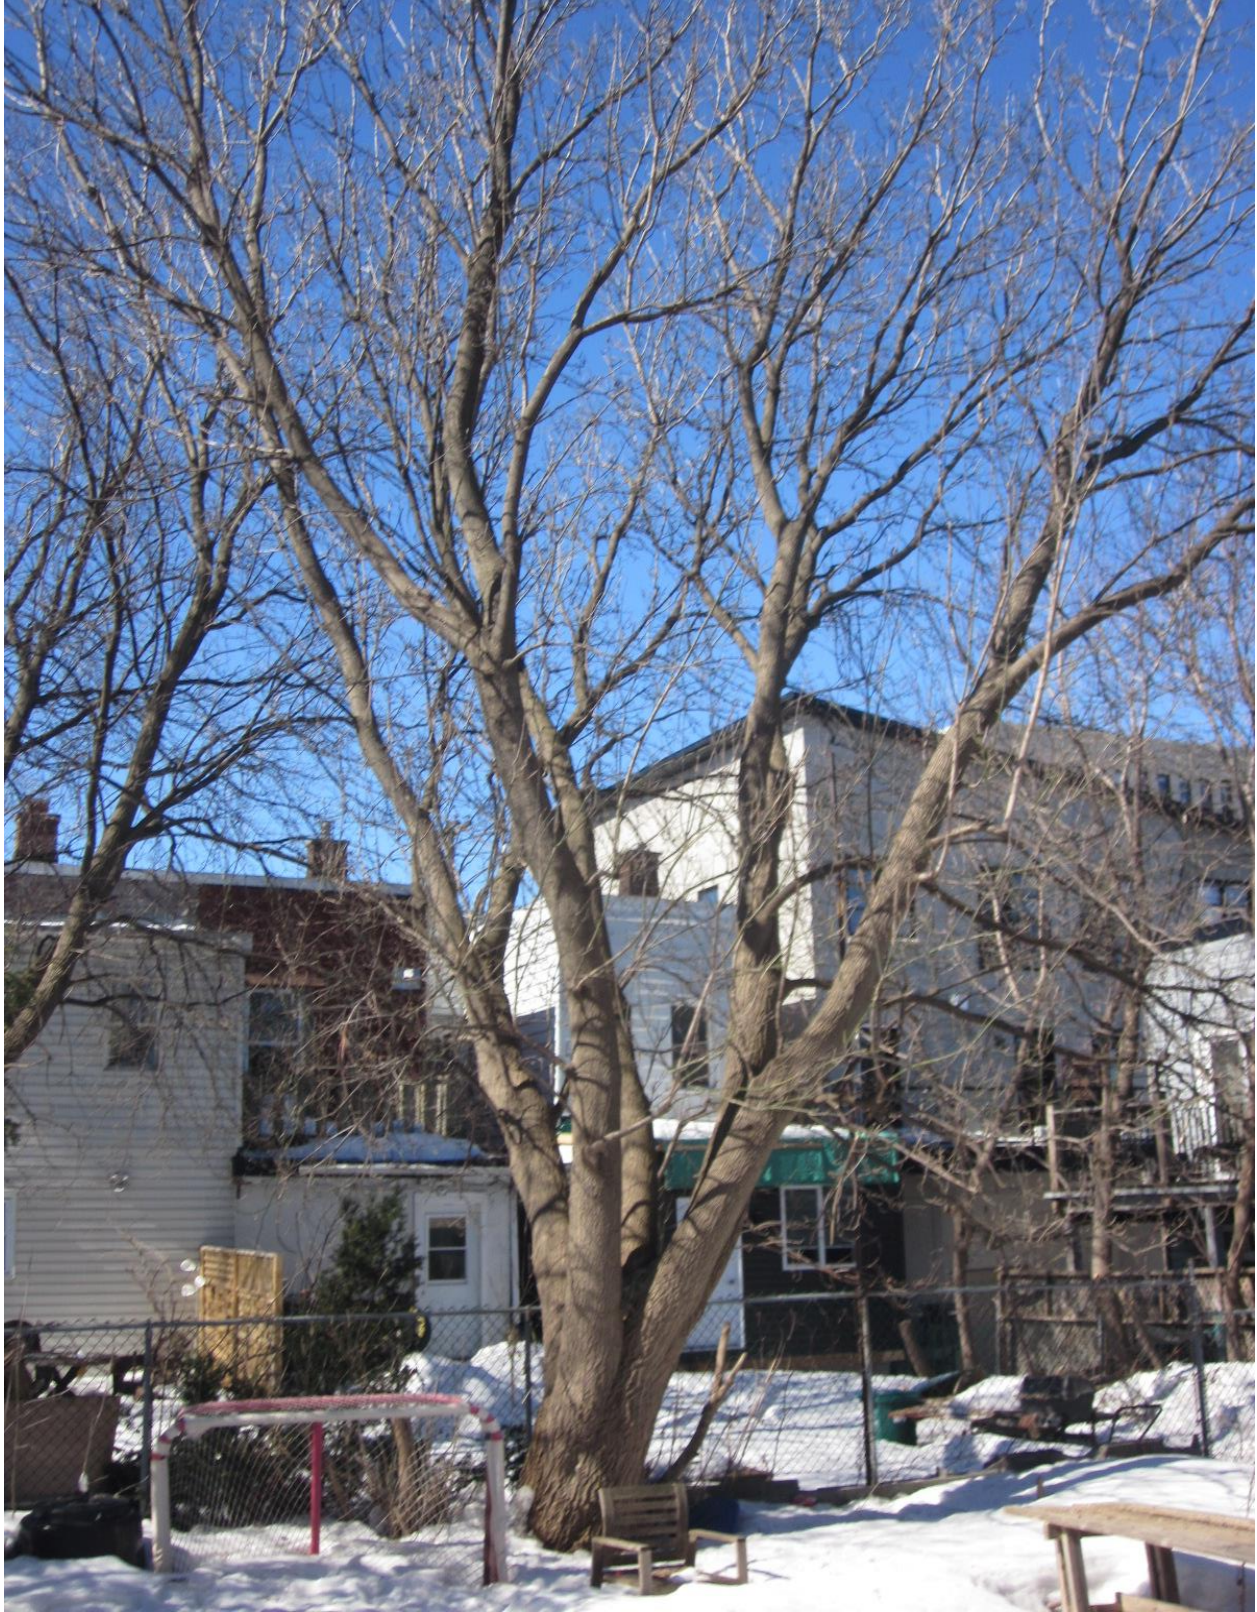
Picture 3. Manitoba maple (tree #14) to be removed from 24-30 Pretoria Avenue.

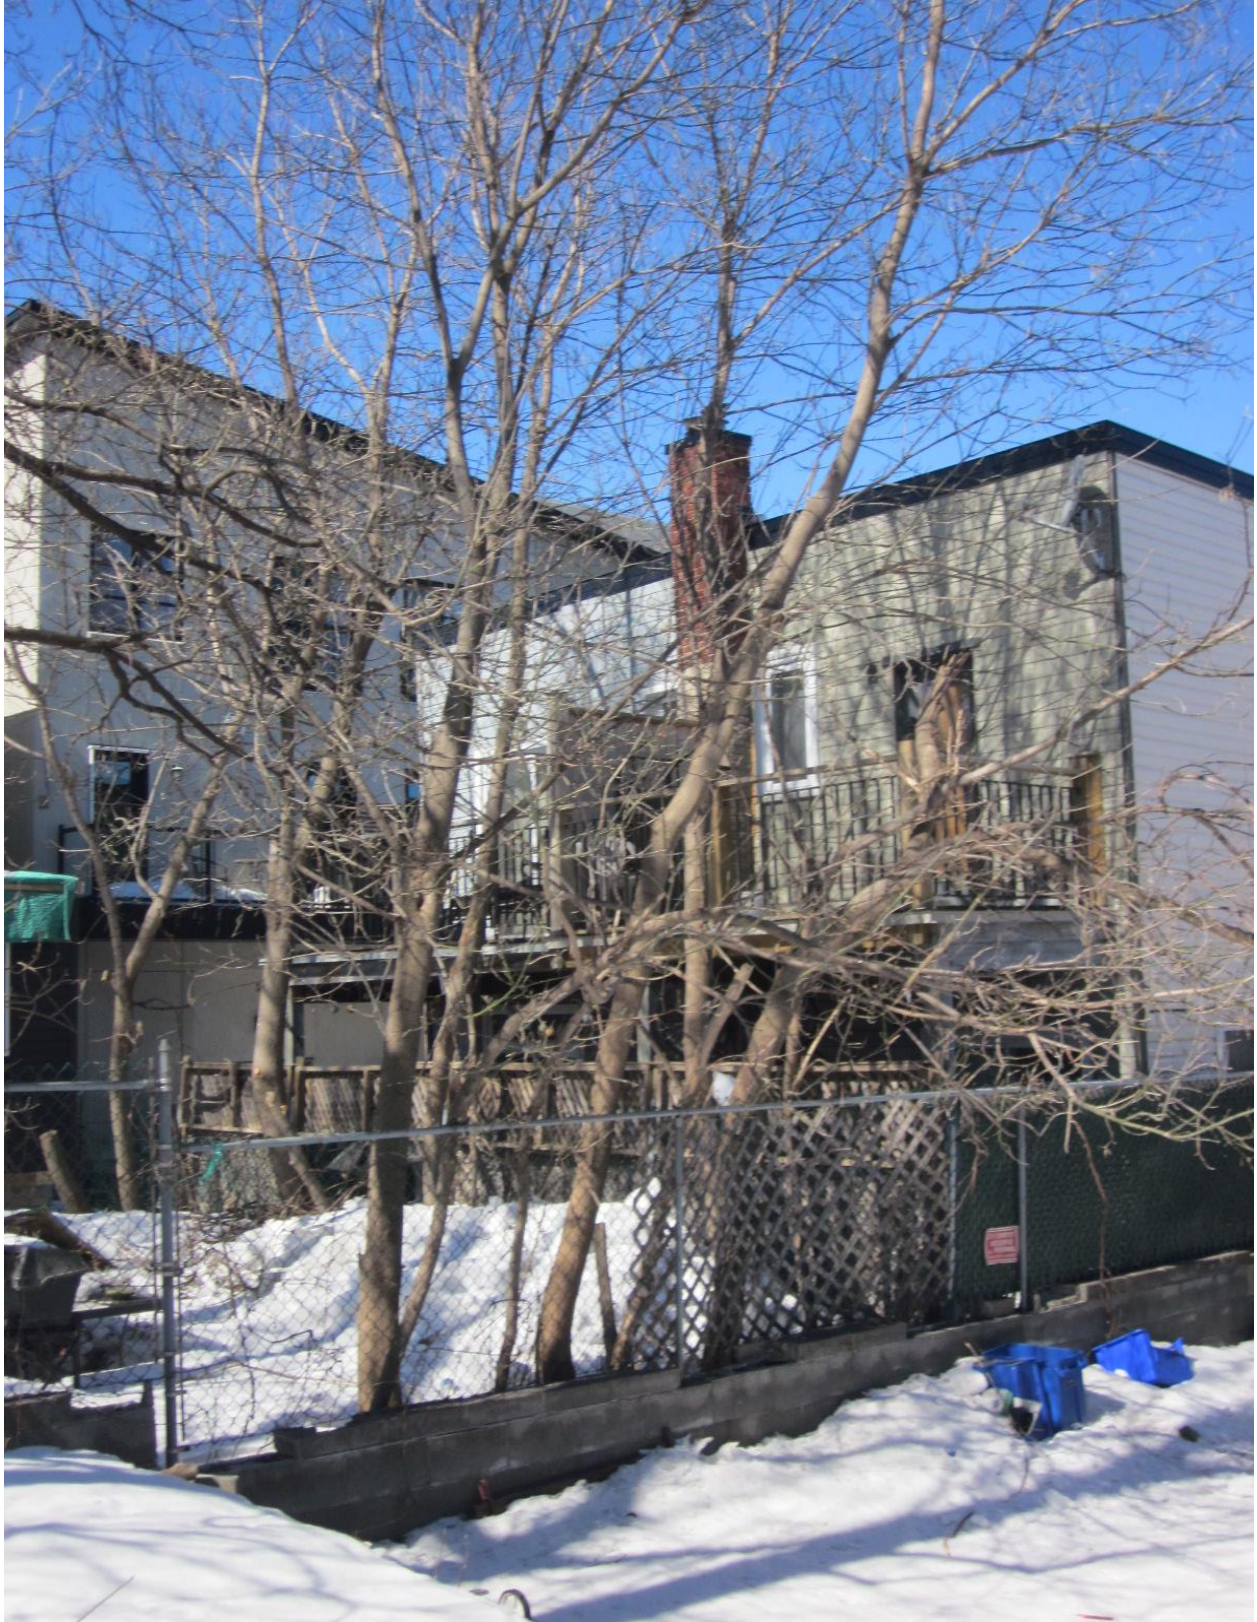
Picture 4. Manitoba maple grouping (#15) to be preserved and protected adjacent to 24-30 Pretoria Avenue.
