January 16, 2020
File: PE4809-LET.02

Subject: **Phase II - Environmental Site Assessment Update**
289 Carling Avenue
Ottawa, Ontario

JOHN HOWARD SOCIETY OF OTTAWA
PHASE II ENVIRONMENTAL SITE ASSESSMENT UPDATE
 289 CARLING AVENUE
 OTTAWA, ONTARIO

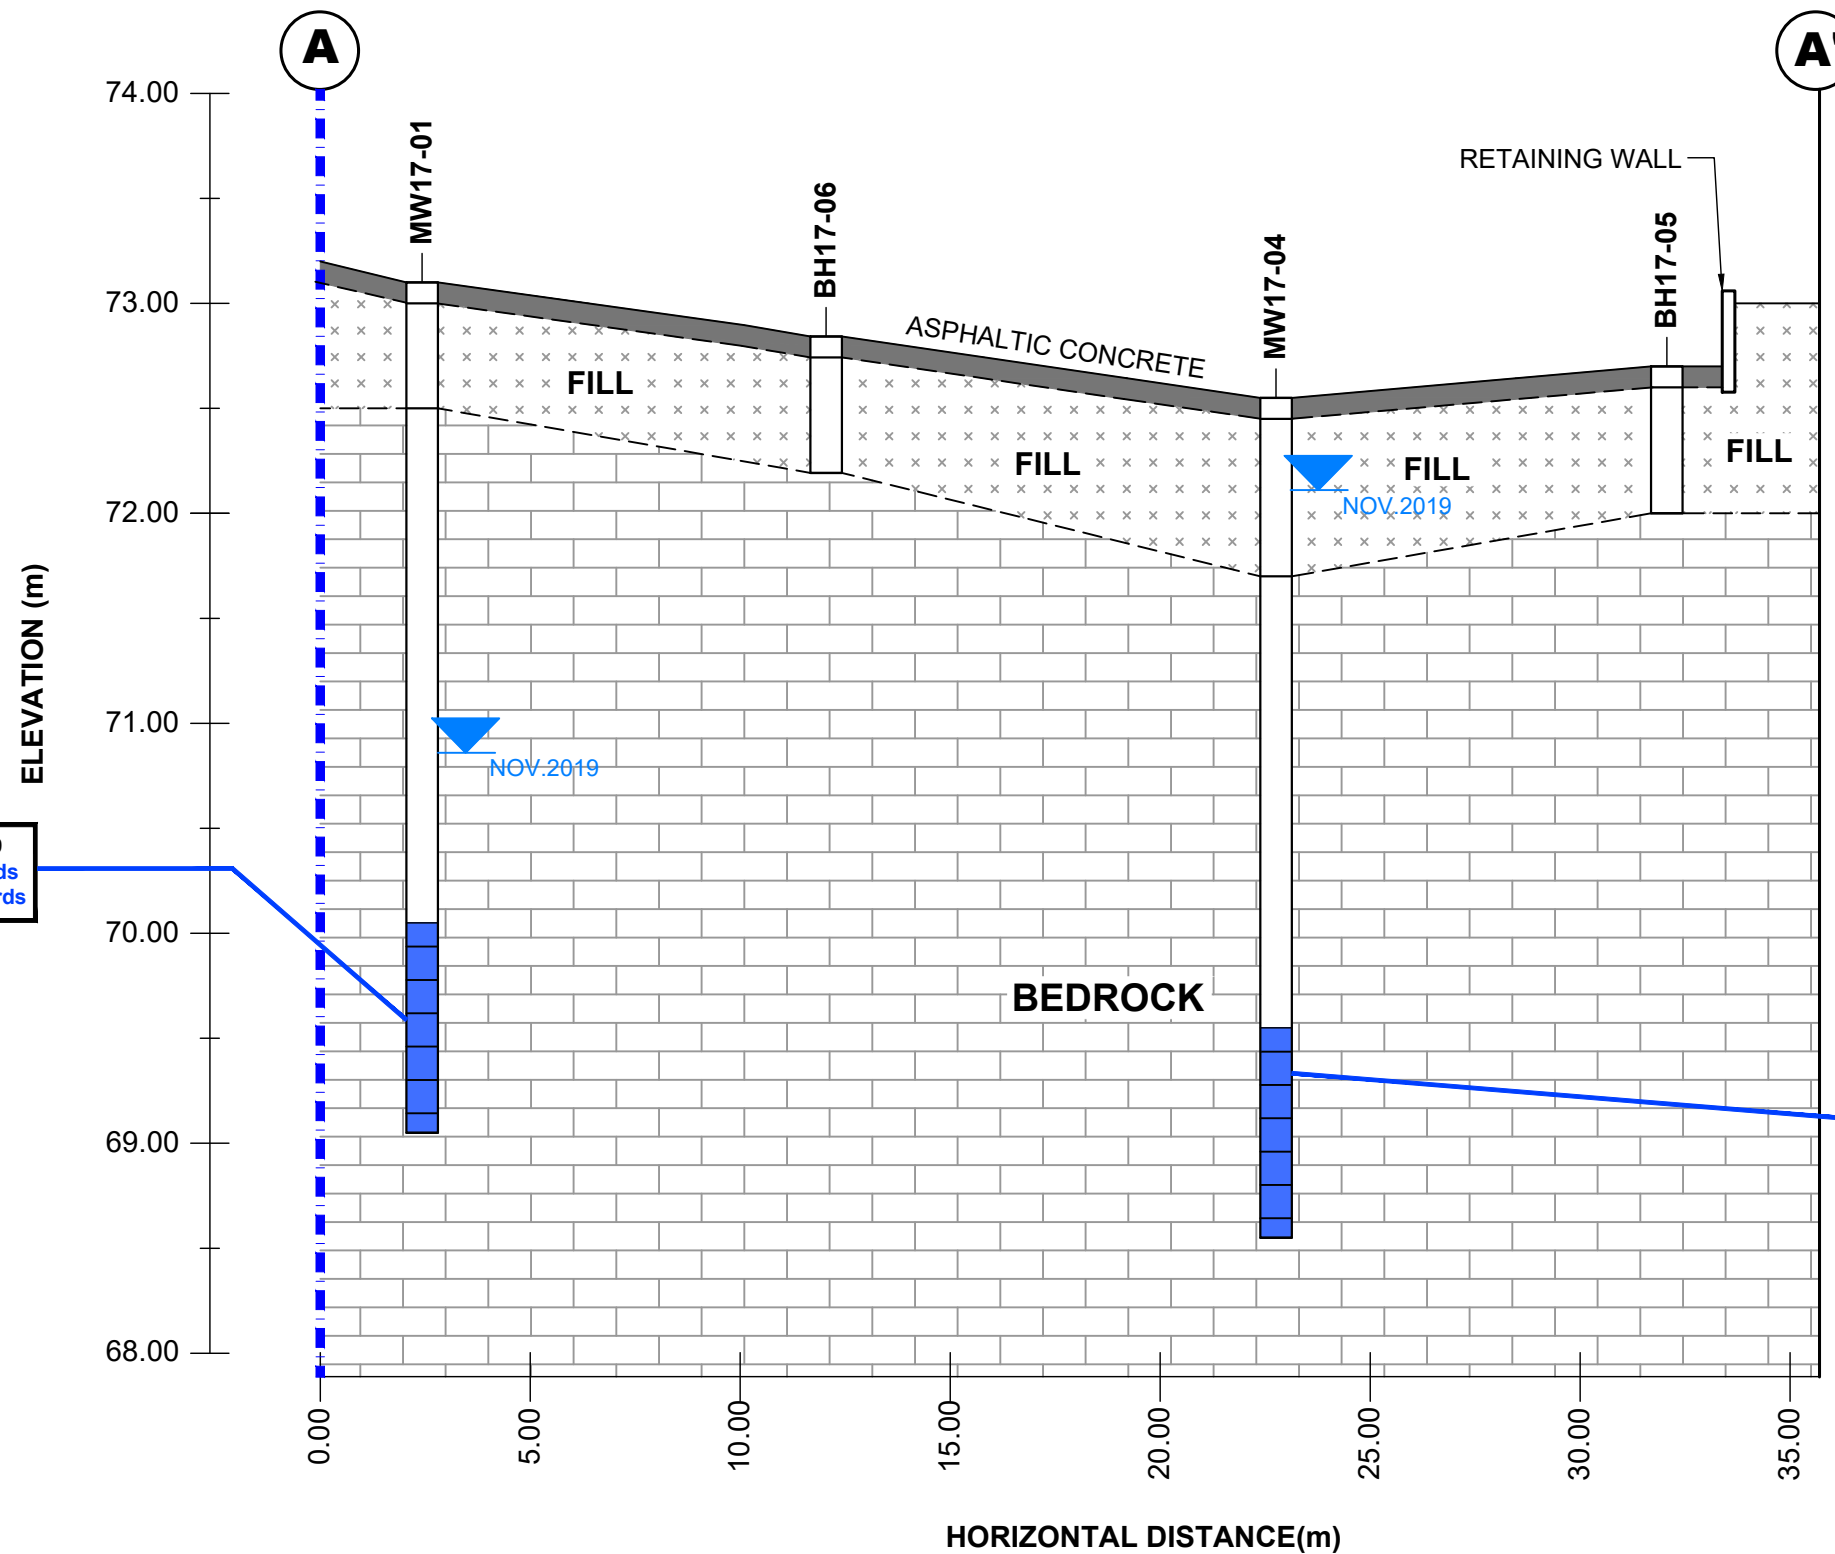
CROSS SECTION A-A'

MW17-01-GW2 3.05-4.05m 28-Nov-19
 Sodium complies with MECP Table 7 Standards
 Chloride complies with MECP Table 7 Standards

MW17-04-GW2 3.00-4.00m 28-Nov-19
 Sodium complies with MECP Table 7 Standards
 Chloride complies with MECP Table 7 Standards
 MW17-04-GW2 3.00-4.00m 12-Dec-19
 Cyanide complies with MECP Table 7 Standards

GROUNDWATER RESULTS COMPLY WITH MECP
 TABLE 7 STANDARDS
