January 16, 2020
File: PE4809-LET.02

Subject: **Phase II - Environmental Site Assessment Update**
289 Carling Avenue
Ottawa, Ontario

JOHN HOWARD SOCIETY OF OTTAWA
PHASE II ENVIRONMENTAL SITE ASSESSMENT UPDATE
 289 CARLING AVENUE
 OTTAWA, ONTARIO

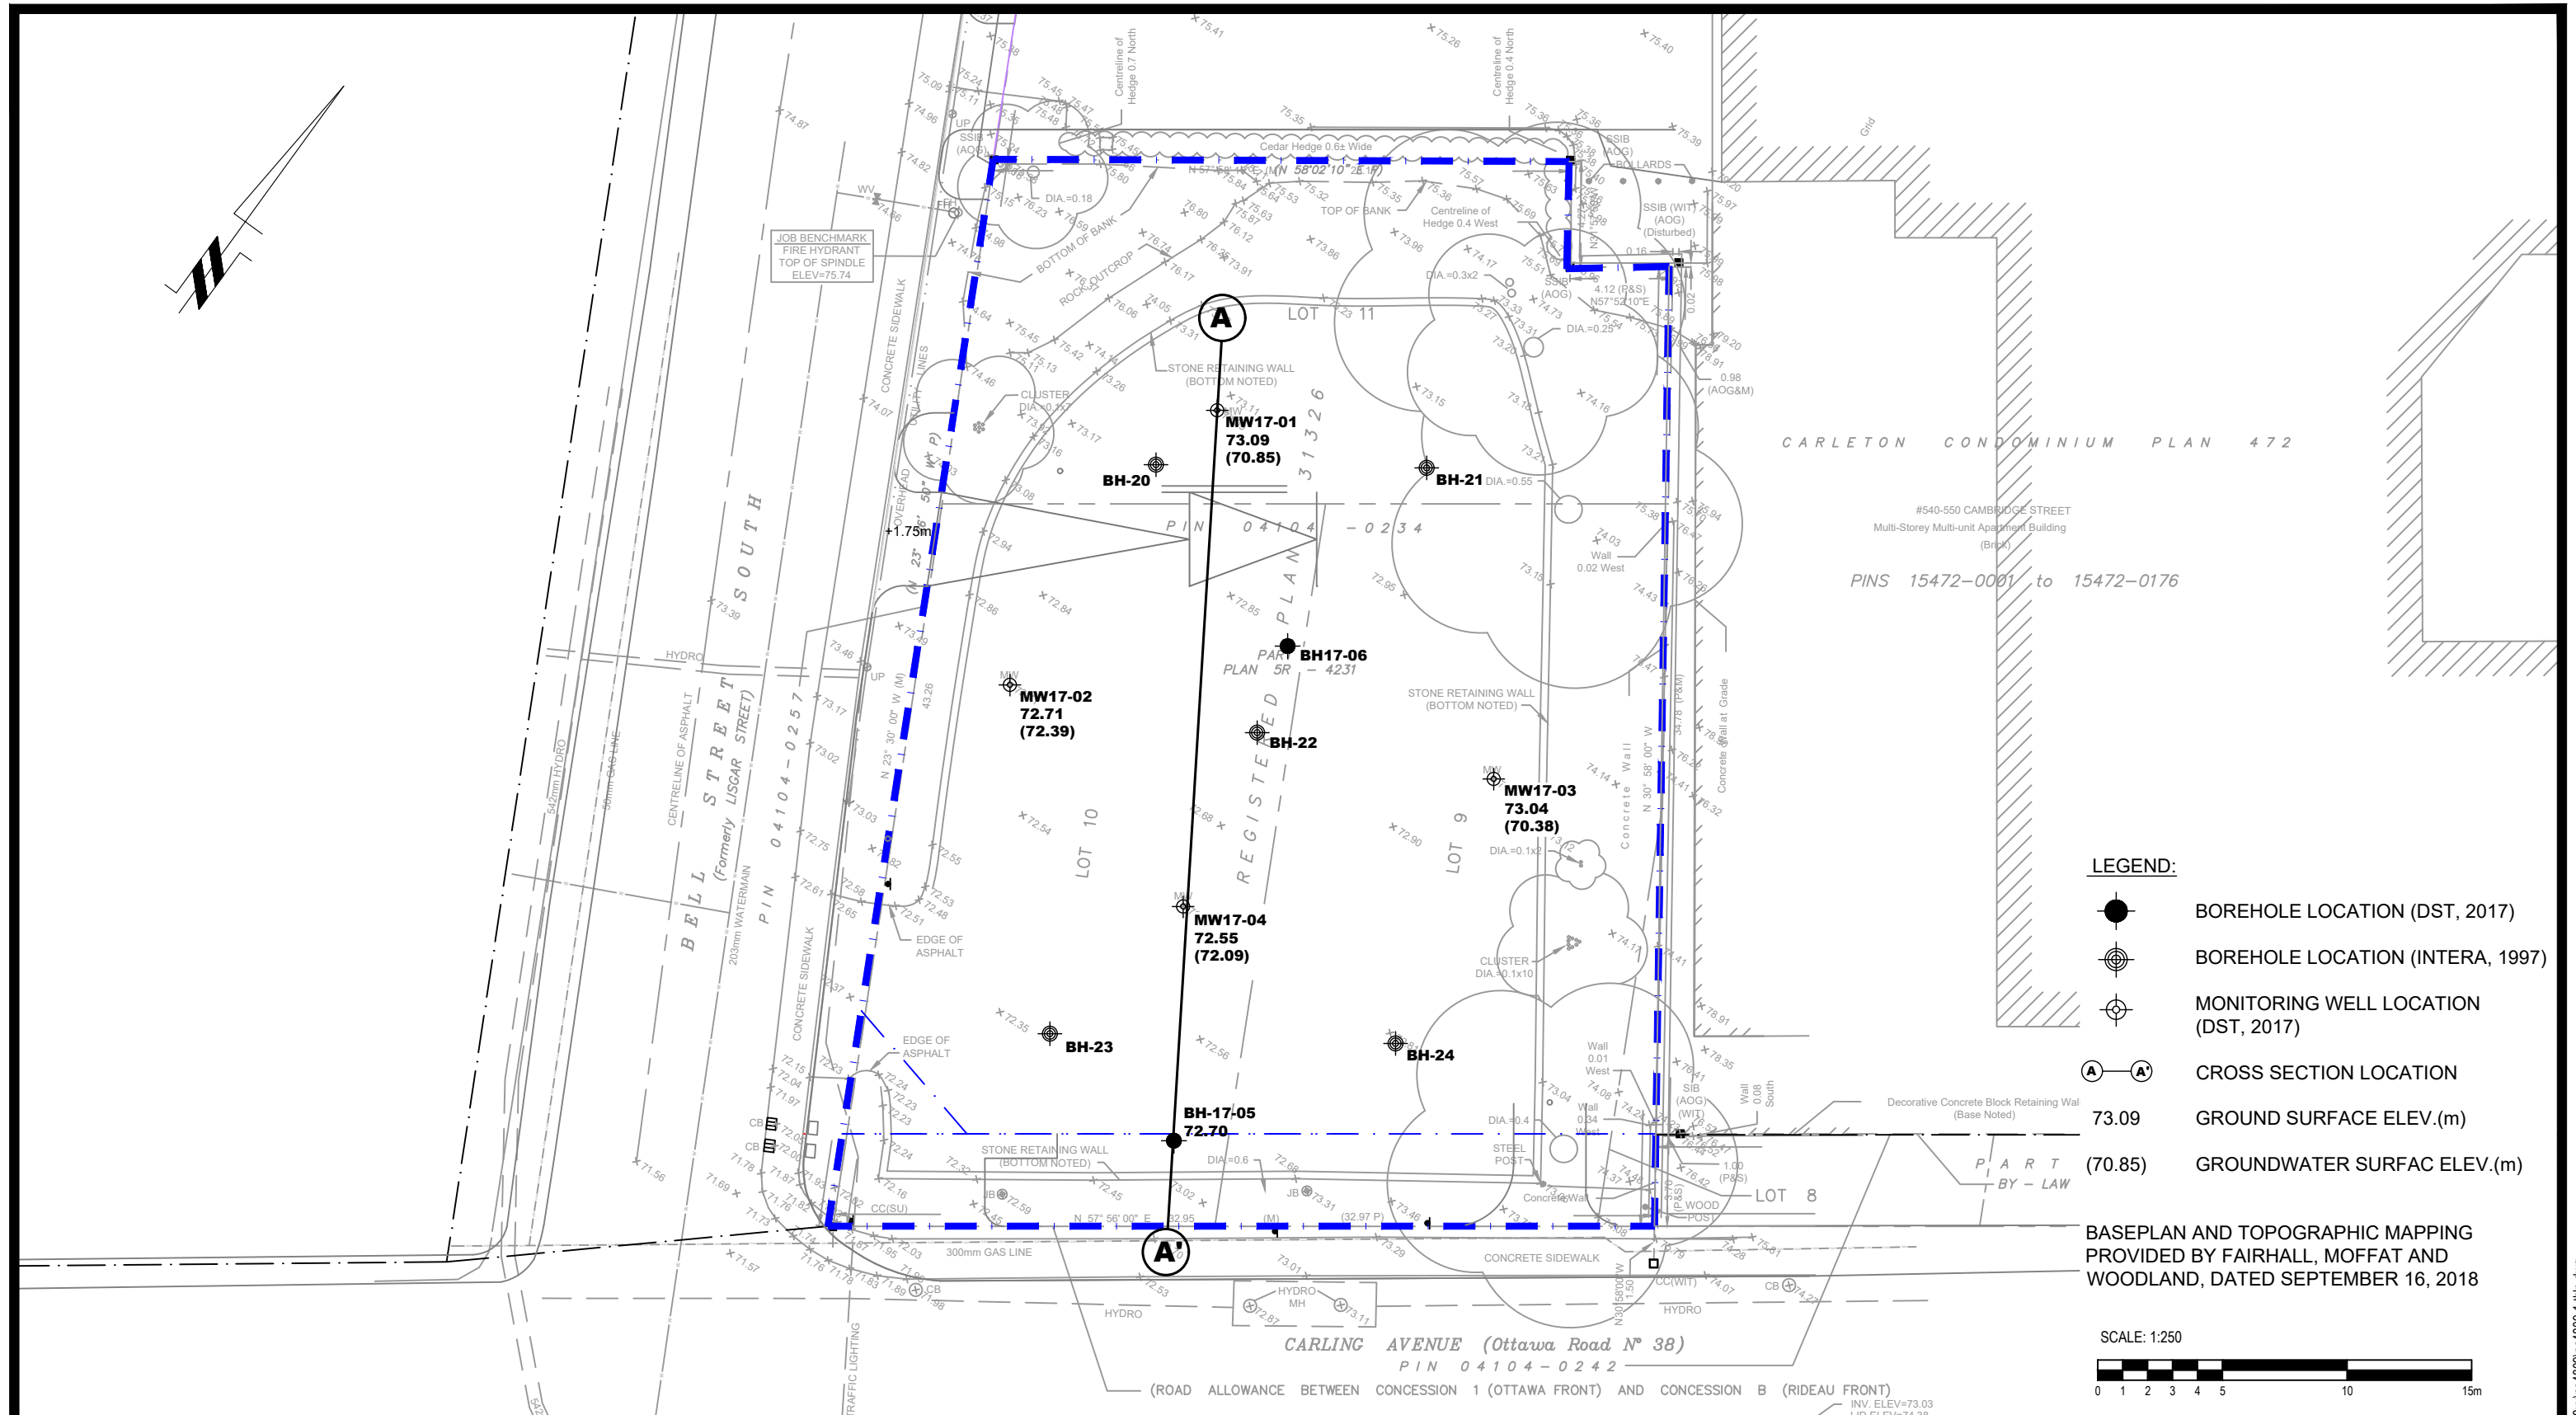
TEST HOLE LOCATION PLAN

Four (4) groundwater monitoring wells were installed in 2017, as part of the original Phase II ESA. As part of this update, all monitoring wells were viable for sampling. There were no impediments with regard to the work carried out for this update. All drilled boreholes and monitoring wells on the Phase II Property are shown on Drawing PE4809-3 – Test Hole Location Plan, appended to this report.

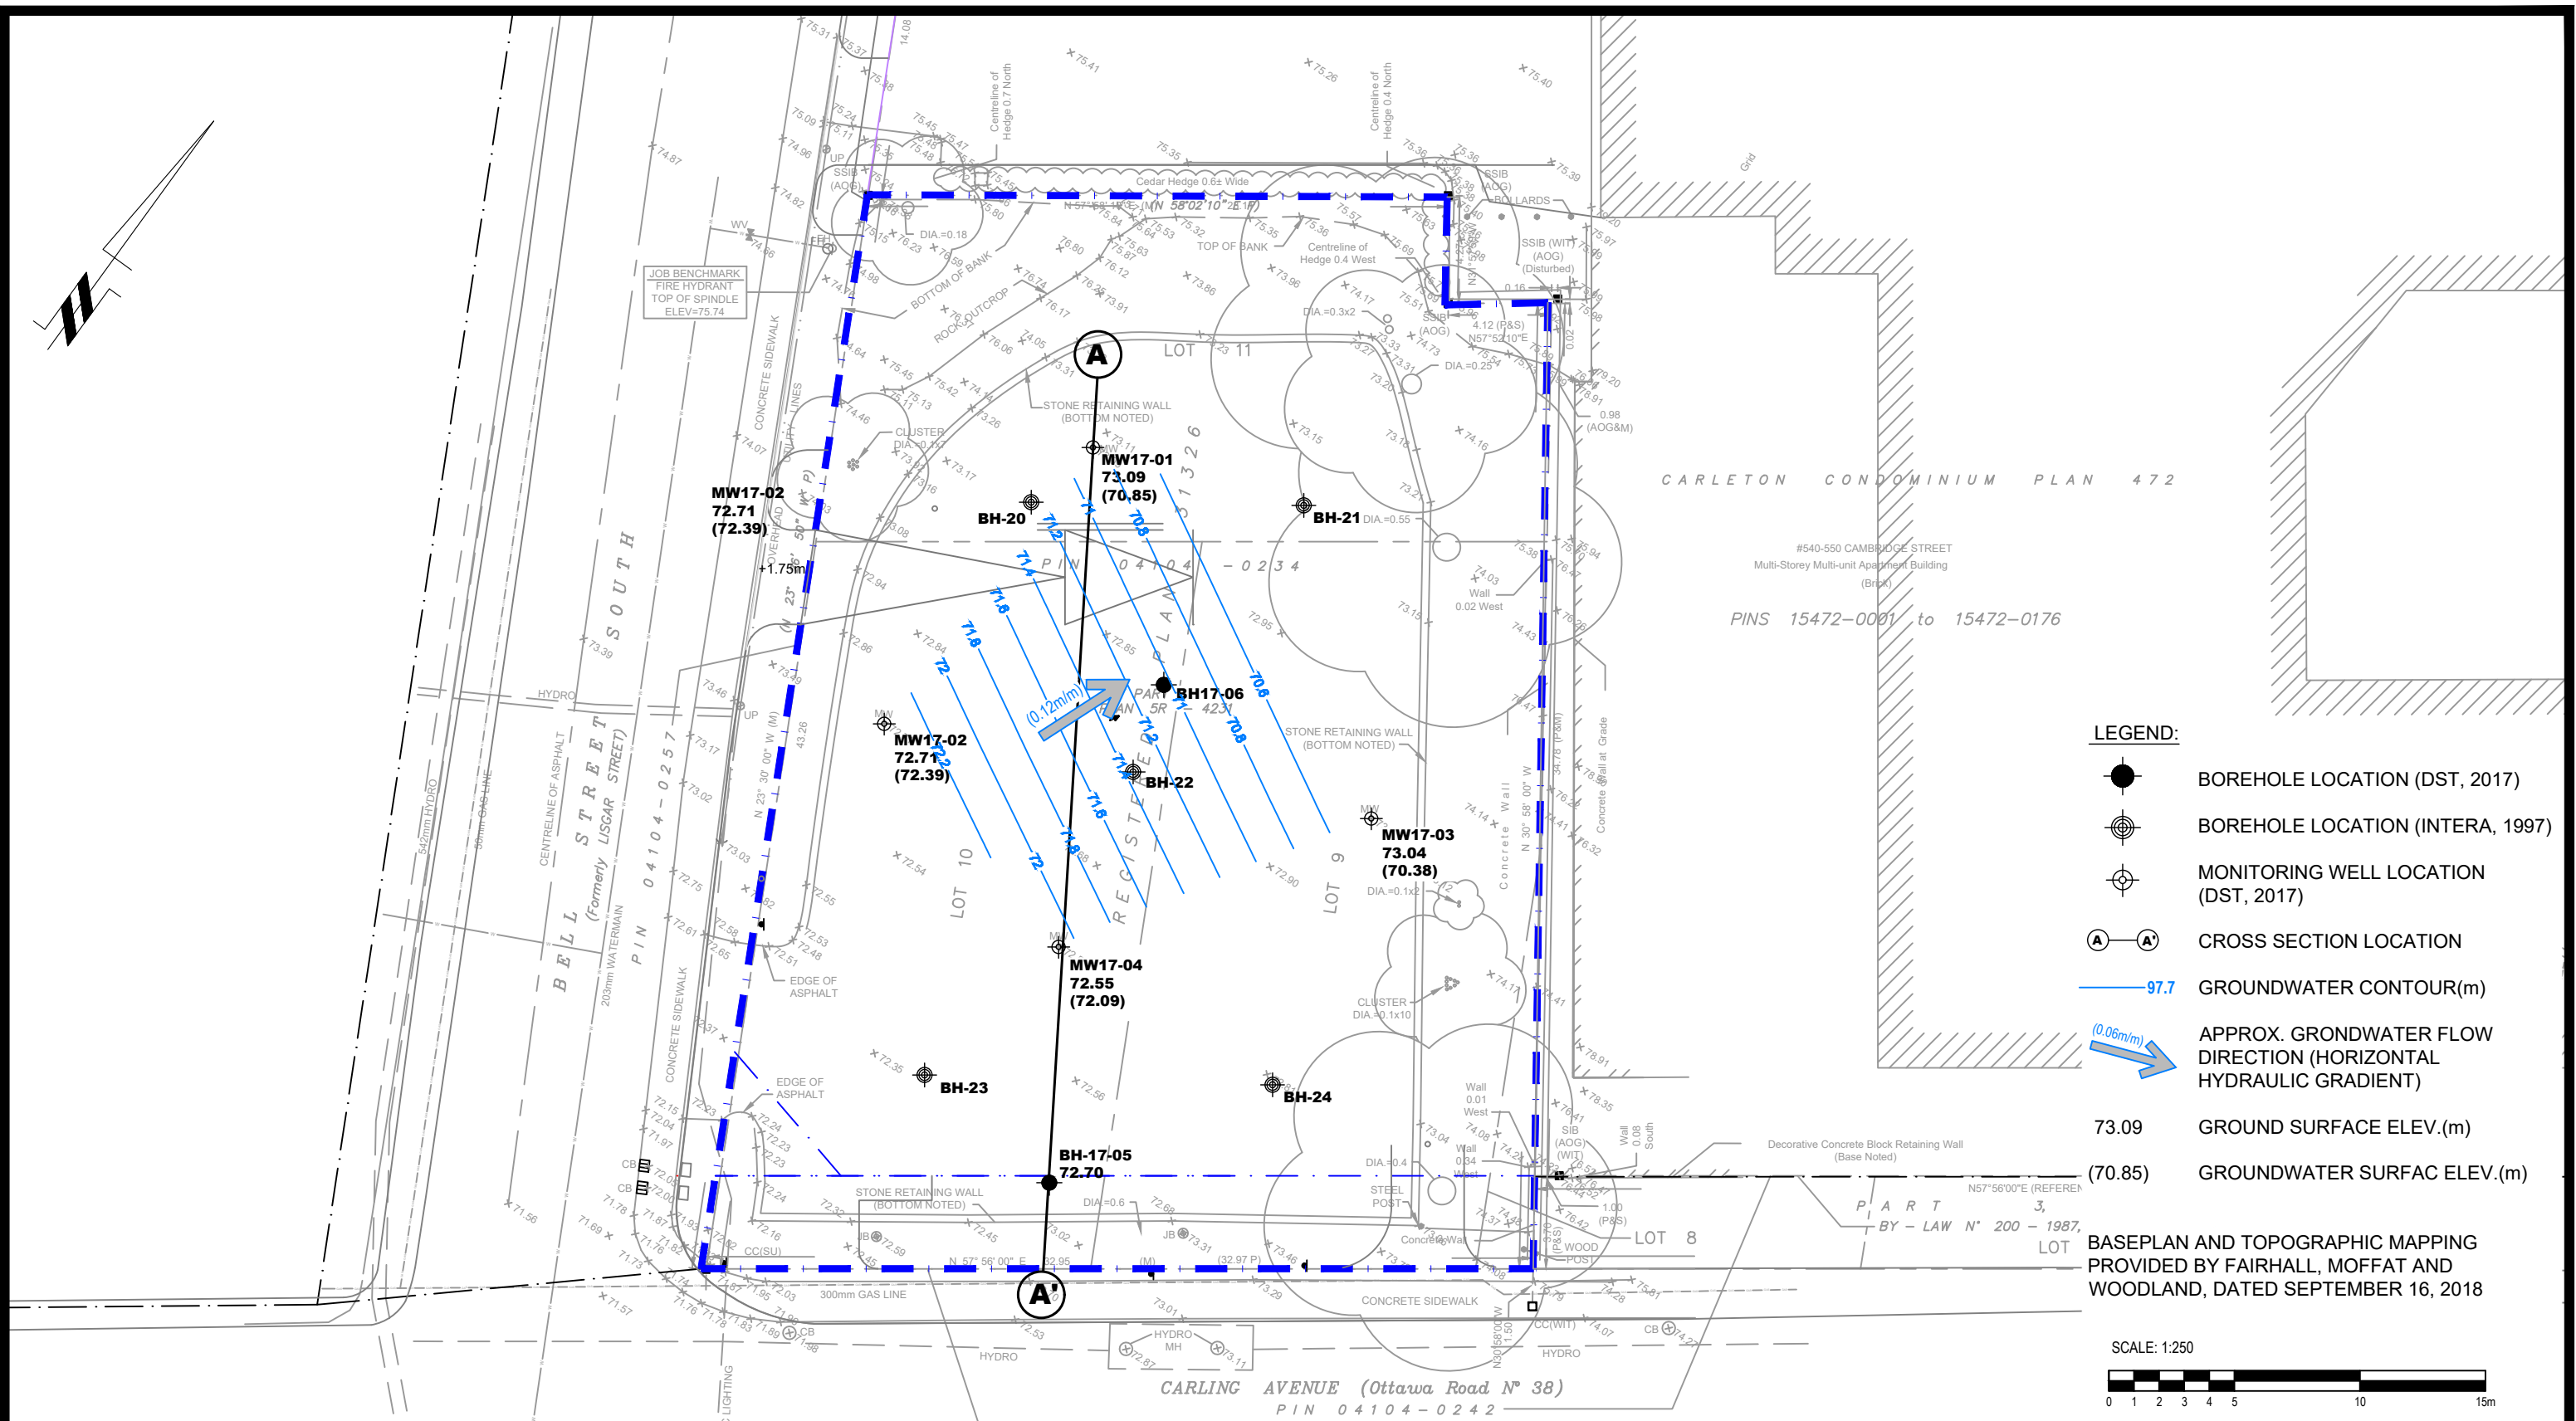
GROUNDWATER CONTOUR PLAN

The groundwater contour mapping is shown on Drawing PE4809-4 –Groundwater Contour Plan. Based on the contour mapping, groundwater flow beneath the Phase II Property is in a northerly direction. A horizontal hydraulic gradient of approximately 0.12 m/m was calculated.

Based on the recent groundwater levels, groundwater beneath the Phase II Property flows in a northerly direction. It is considered possible that the groundwater flow beneath the site is being affected by the adjacent development to the north.

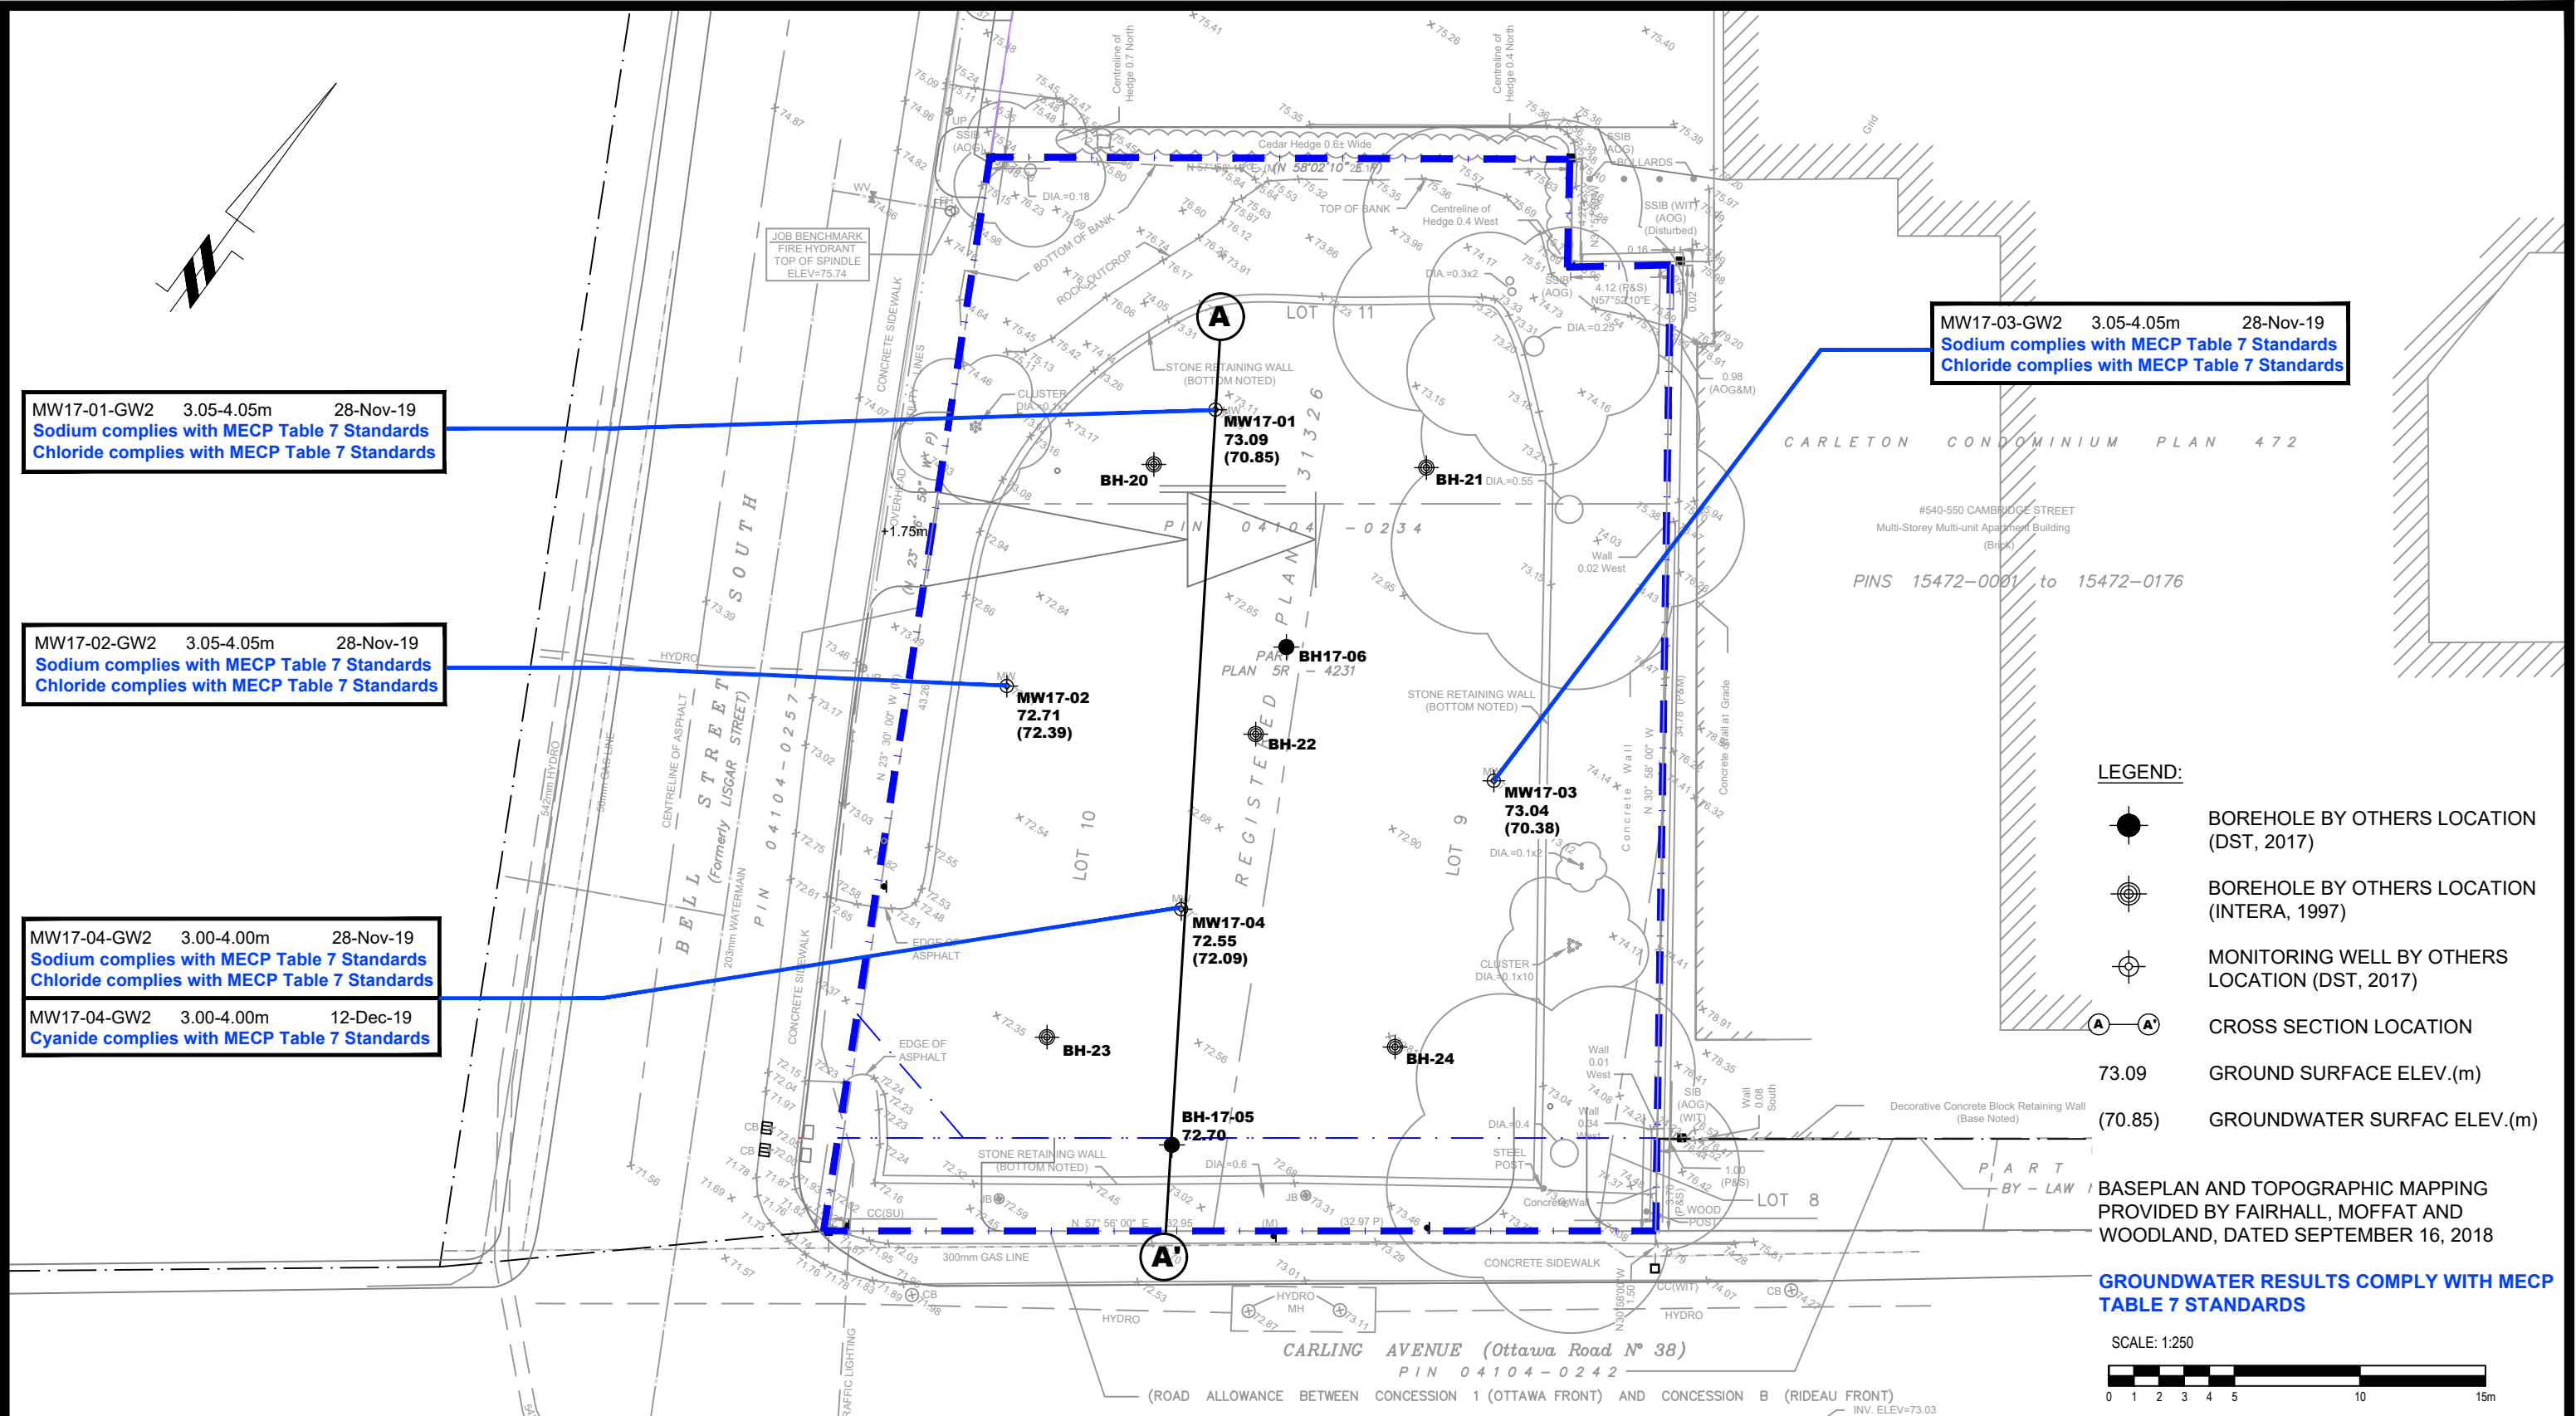
JOHN HOWARD SOCIETY OF OTTAWA
PHASE II ENVIRONMENTAL SITE ASSESSMENT UPDATE
289 CARLING AVENUE
OTTAWA, ONTARIO
Title: ANALYTICAL TESTING PLAN - GROUNDWATER

A duplicate sample was collected from MW17-02 was submitted for dissolved sodium and chloride concentrations. All analyzed parameters in groundwater comply with the selected MECP Table 7 Standards.

All contaminant concentrations in groundwater comply with the MECP Table 7 Standards.

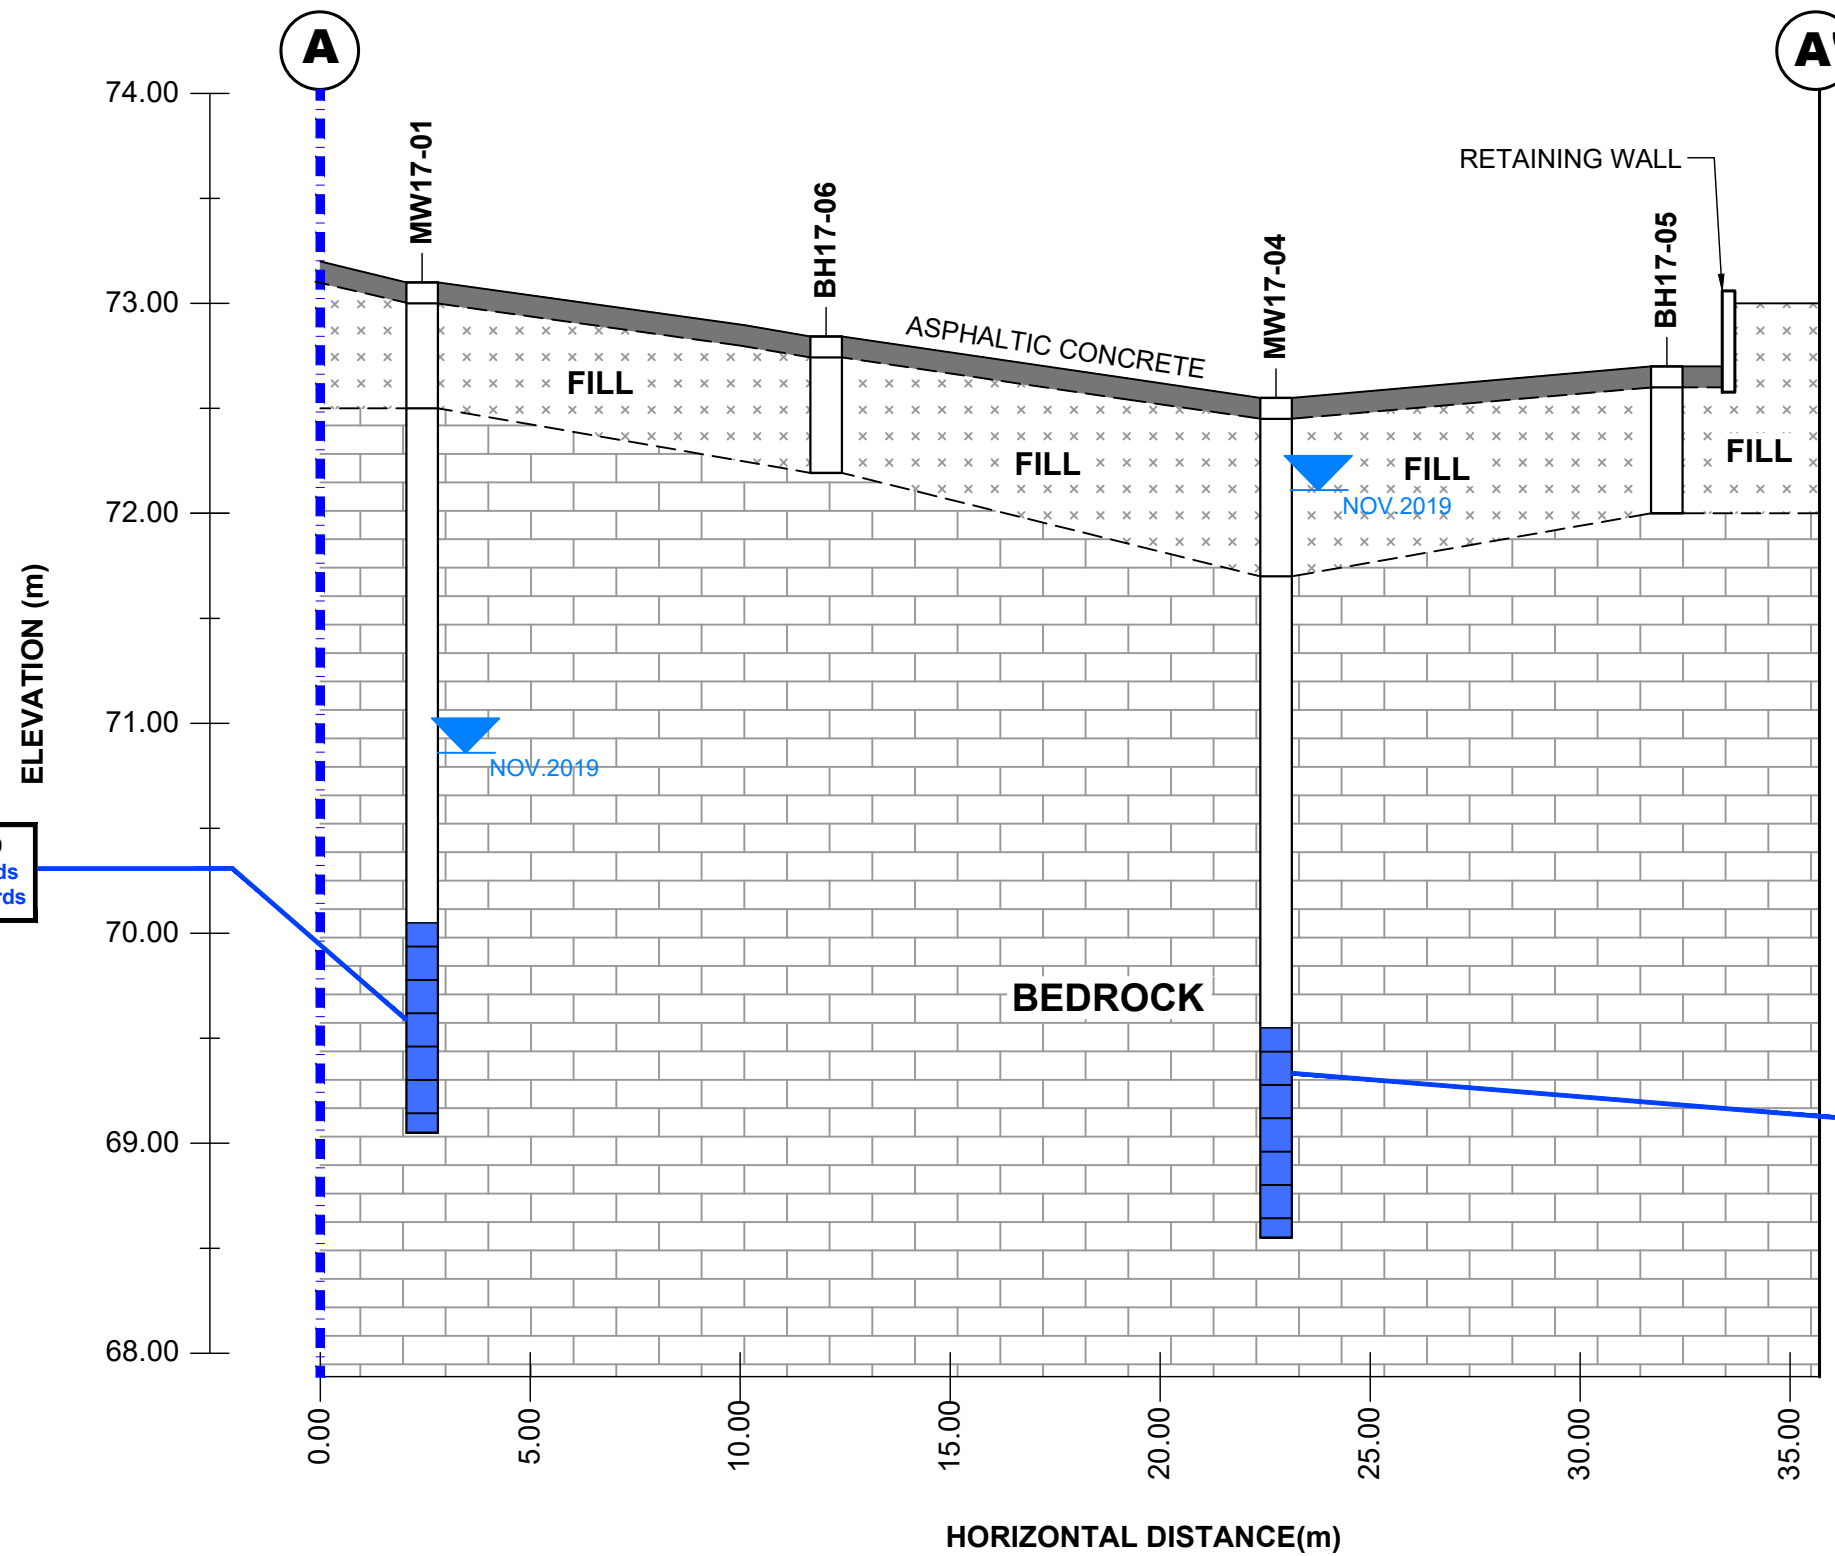
Title: **CROSS SECTION A-A'**

MW17-01-GW2 3.05-4.05m 28-Nov-19
 Sodium complies with MECP Table 7 Standards
 Chloride complies with MECP Table 7 Standards

MW17-04-GW2 3.00-4.00m 28-Nov-19
 Sodium complies with MECP Table 7 Standards
 Chloride complies with MECP Table 7 Standards

MW17-04-GW2 3.00-4.00m 12-Dec-19
 Cyanide complies with MECP Table 7 Standards

GROUNDWATER RESULTS COMPLY WITH MECP TABLE 7 STANDARDS
