re: Geotechnical Assessment - Slope Review - Block 8
Proposed Multi-Storey Building
8466 Jeanne-d'Arc Boulevard - Ottawa

to: Brigil Construction - **Mr. Jean-Luc Rivard** - jlrivard@brigil.com
to: Brigil Construction - **Mr. Philip Thibert** - pthibert@brigil.com
date: June 23, 2021
file: PG4112-MEMO.02

Photographs from Site Visits – June 22, 2021

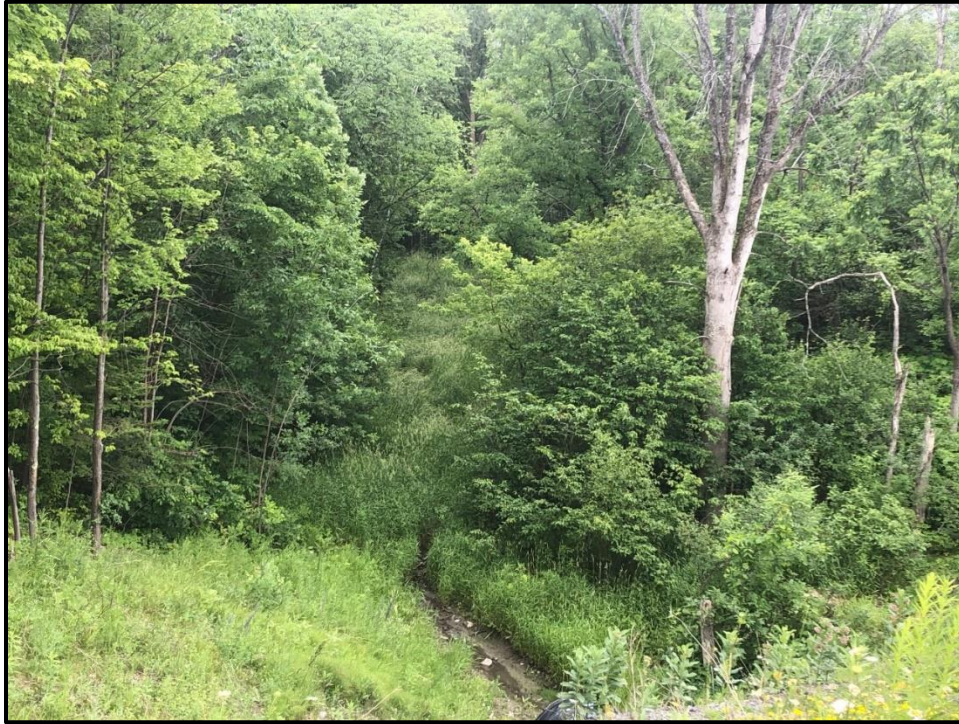
The valley area of the ravine consisted of tall grass and varied in width from approximately 4 to 6 m. The main watercourse channel was noted to be approximately 1 to 1.2 m wide. At the time of our site visit, the channel was observed to be generally dry, with some moist soil and very minor water ponding near the north portion of the site at the culvert crossing beneath Jeanne-d'Arc Boulevard. No active running water was observed and no sign of erosions were noted..

Photo 1: Photograph taken looking south from the road showing the location of the culvert where very minor water ponding was observed, the grass covered channel and the heavily vegetated slope adjacent to Block 8.

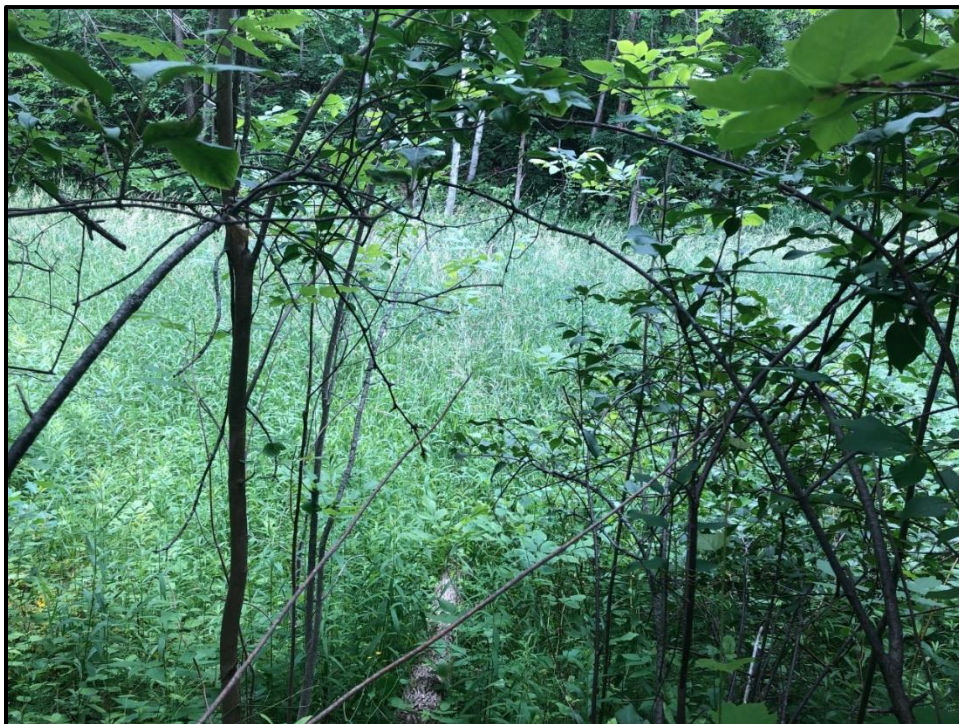
Based on our cursory review, no sign of sloughing or cracking were observed along the slope. The shape of the slope has remained unchanged and well vegetated since our previous review. The ravines side-slopes are considered to be stable from a geotechnical perspective

Photo 2: Photograph taken looking east from the bottom of the slope adjacent to Block 8 at the grass covered channel.

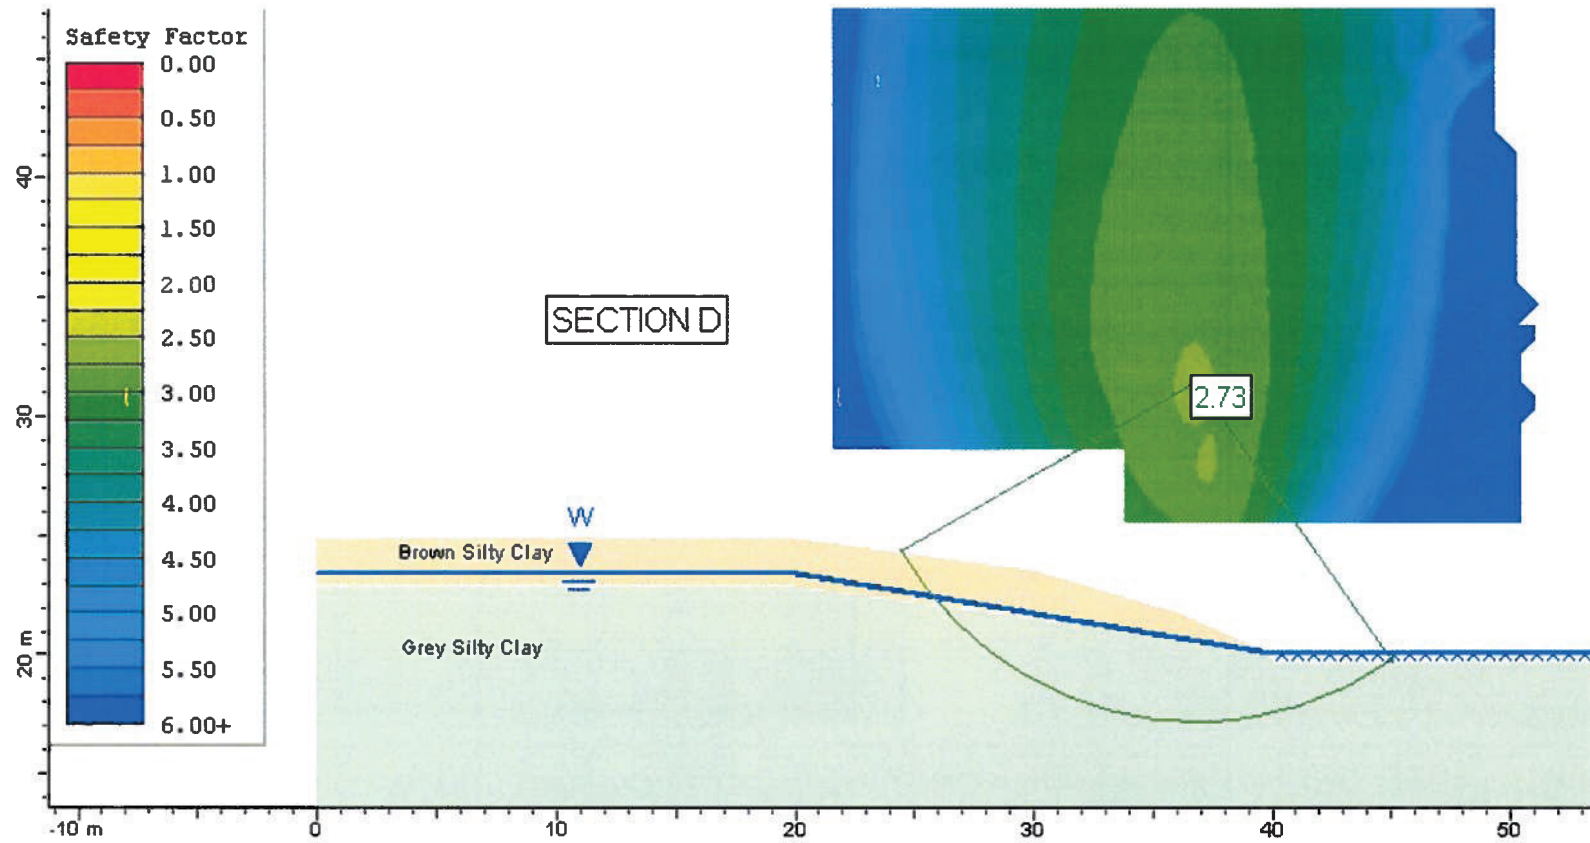
Figure 8, Section D, Effective Stress Analysis

The results of the previous slope stability analysis yielded factors of safety for static and seismic conditions of 2.73 and 2.36, respectively, which are considered to be well within acceptable limits from a geotechnical perspective. The study recommended an toe erosion allowance of 2 m and an erosion access allowance of 6 m, for a total required setback of 8 m from the top of slope.
