SUPPLEMENTARY TREE CONSERVATION REPORT

1050&1060 Bank Street

**Supplemental Report to Tree Conservation
Report submitted as Partial Requirements
for a Site Plan Control Application**

Date: November 20, 2020

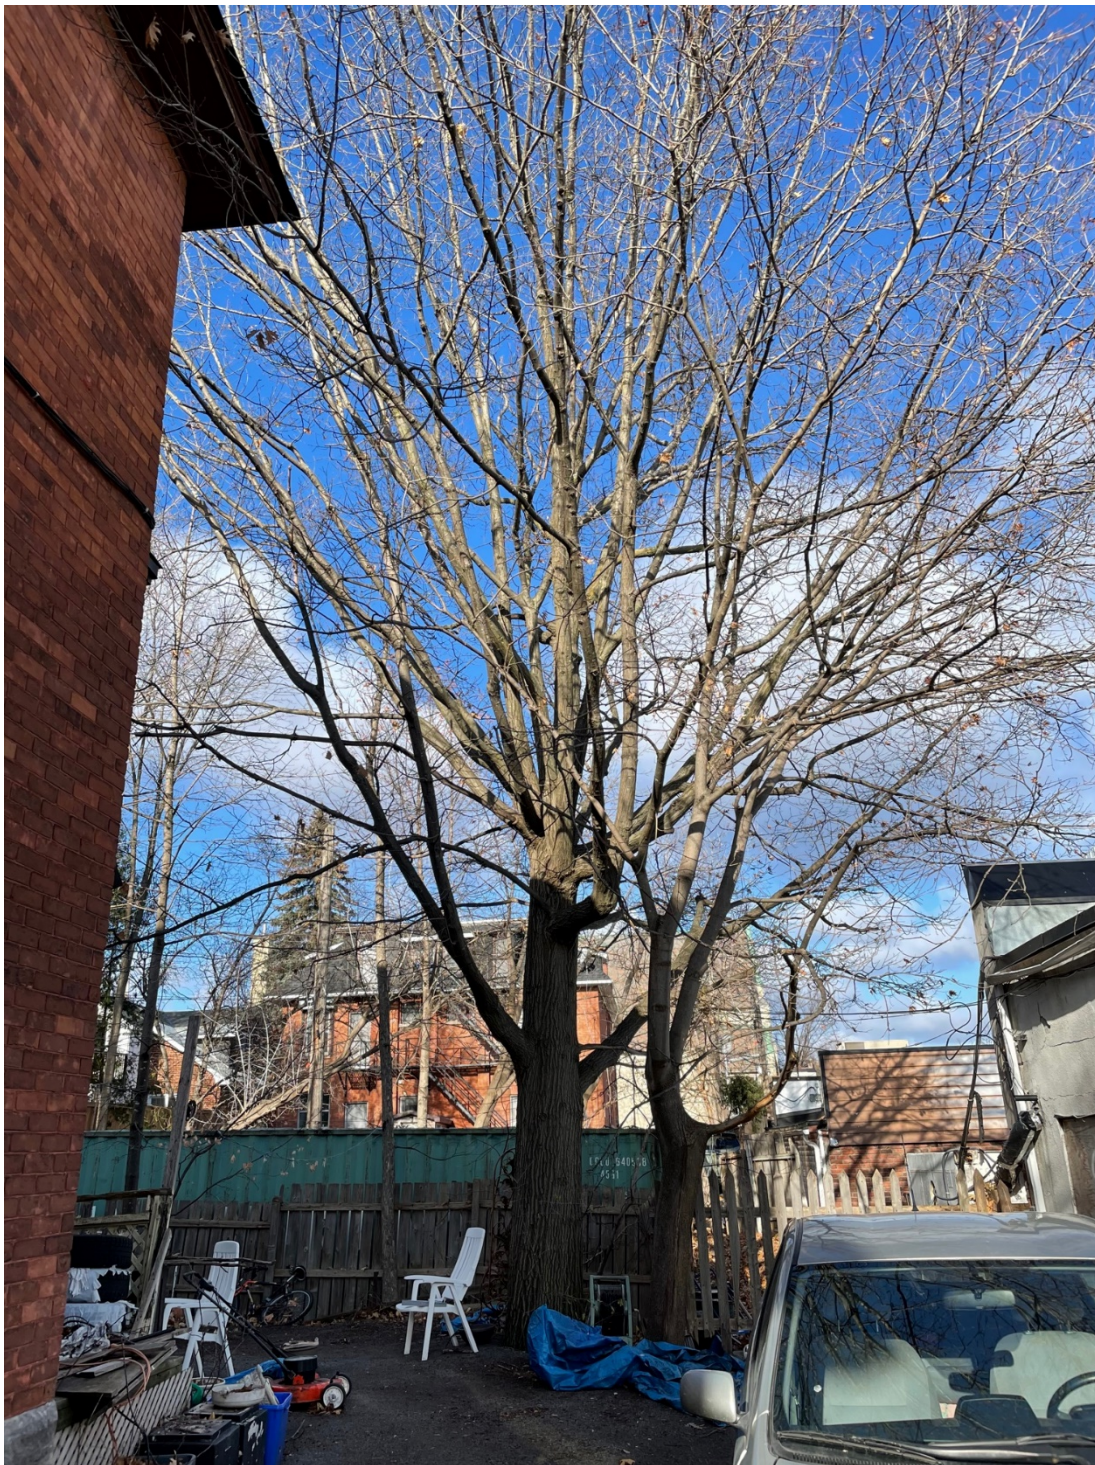
The red oak lies entirely on the 9-11 Euclid property; however, the roots most likely extend onto the adjacent city lane. The tree is currently in good health and has a diameter of 65 cm. The surrounding rooting area is made of hard surface asphalt. The trunk of the tree has outgrown its space and is currently being girdled by the asphalt at the base (see photo). This restriction in growth should be addressed to prevent further girdling of the trunk and roots that could lead to tree decline in the near future.

Figure 1: Photo of tree taken from the Euclid side

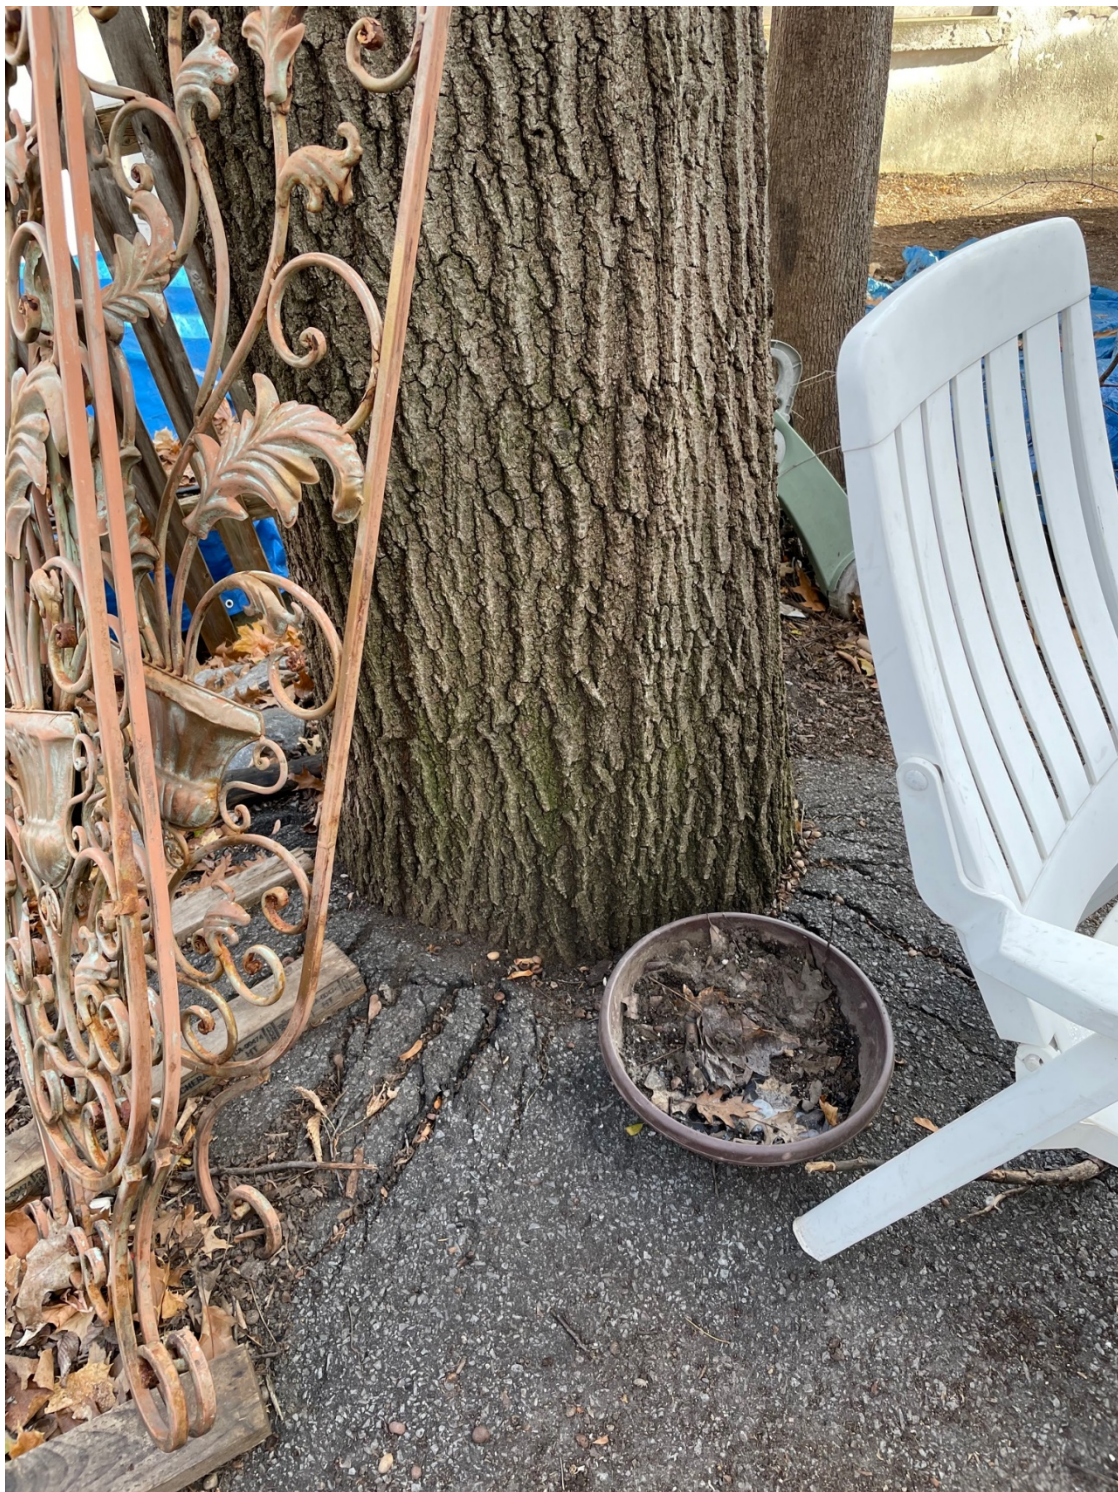
Figure 2: Photo showing how the asphalt is girdling the base of the tree

- 1) Removing the asphalt by peeling it off with as little disruption to the roots as possible
- 2) Replacing the current soil within the tree roots with a structural soil as recommended in the Tree Conservation Report prepared by James B Lennox & Associates. Hydrovacating may not be required if the soil can be replaced manually. If a very low pressure is not used, hydrovacating can

damage the roots by stripping off the bark. Furthermore, it can be costly. If the work can be completed manually, this would be the preferred method to maximize tree protection.

- 3) The remaining lane will be graded to match the existing grade. Care should be taken when removing the rocks not to damage any of the roots that may be growing underneath.

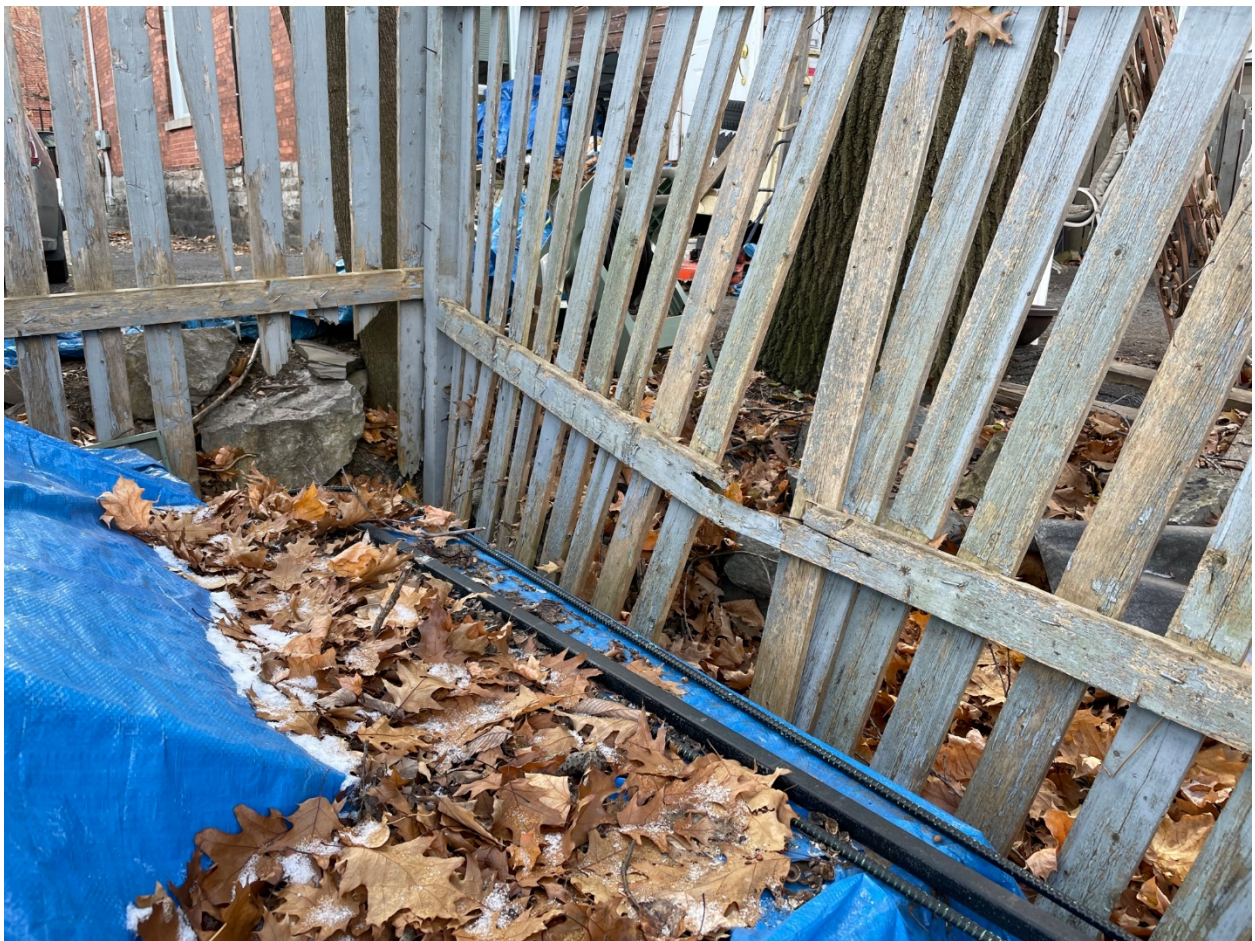
Right beside the tree to the northeast side, there is a sharp drop of approximately 80 cm in elevation and the retaining wall is made up of large rocks. Due to this significant elevation change, it is unlikely that there are roots growing under asphalt in the lower portion of the city lane. It is most likely that those roots that lie under the asphalt on the city lane are entirely in the upper portion that is at the same grade as the tree. Based on this assumption, the estimated rooting area has been drawn on the Tree Conservation Report map. The majority of the roots most likely exist on the property at 9-11 Euclid.

Figure 3: Photo taken from the Bank side demonstrating the 80 cm grade change right beside the tree

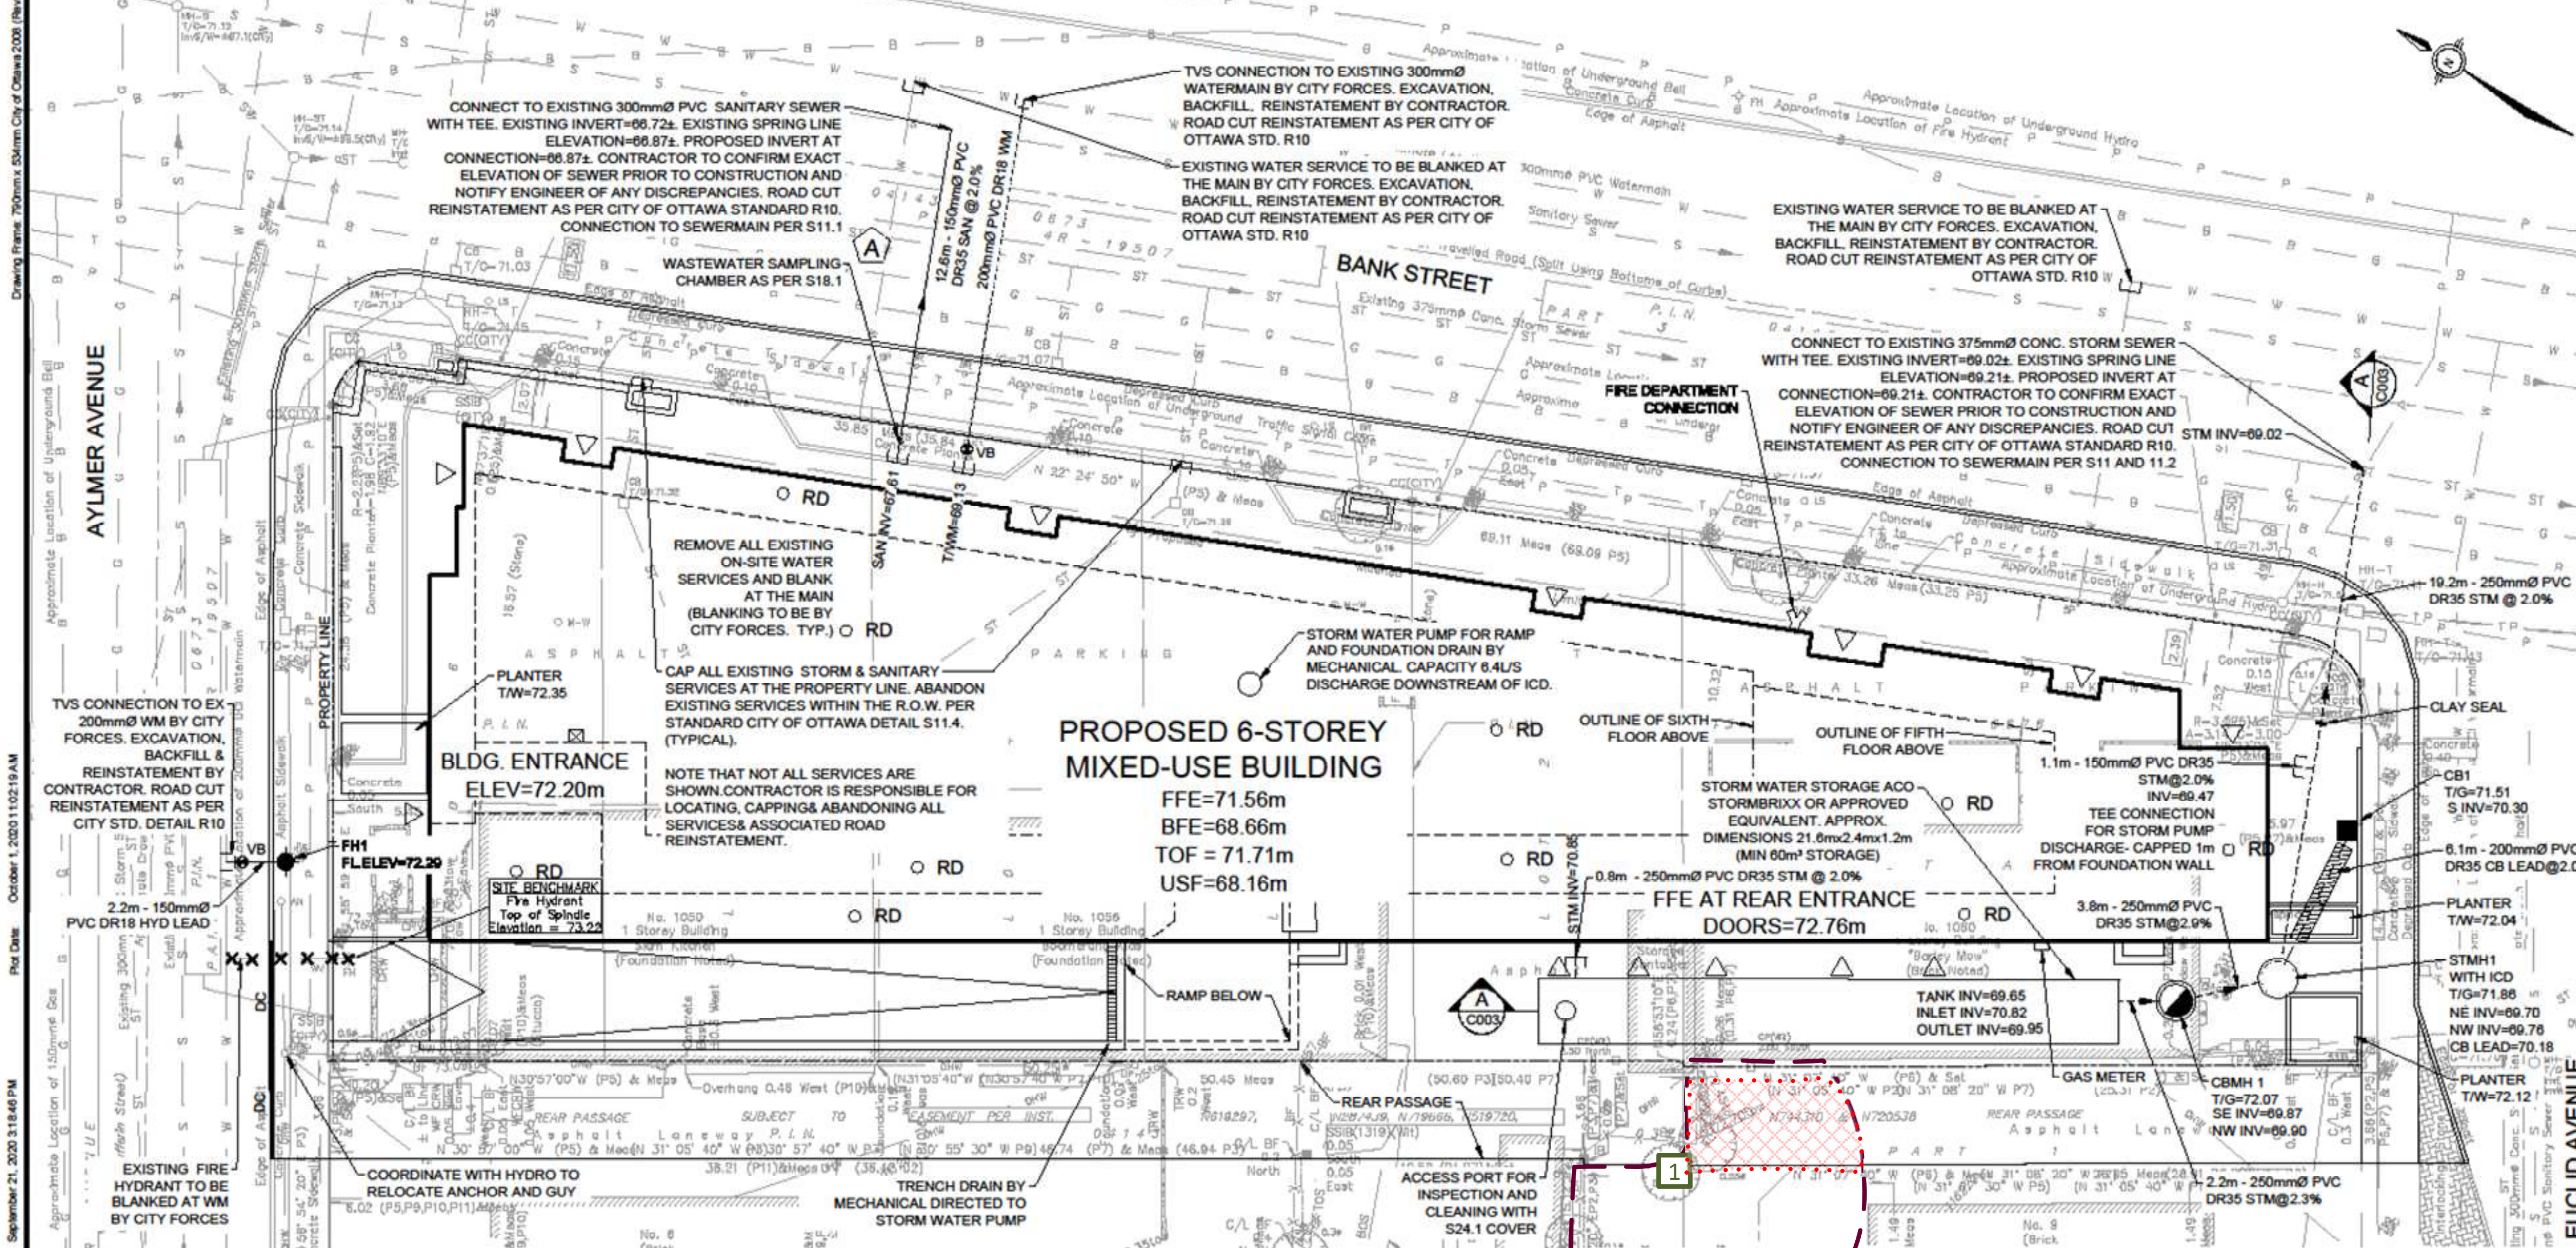
SITE SERVICING PLAN

In the portion of the city lane that is at a higher grade and most likely to contain some of the roots (as identified in red hatching on the enclosed map), the following measures are recommended:

Note that the tree layer has been added to the original site servicing plan supplied by the client in pdf format. This layer refers to the trees only, and the original site servicing plan has not been altered in the process.

- Avoid tearing of the roots. If the roots do tear, they should be pruned with a clean cut to increase the likelihood of sealing properly and reduce the risk of pathogens from entering the tree.
- Roots should not be left exposed and be covered with soil as quickly as possible, or temporarily with a moist, organic material such as mulch and/or burlap
- The trees should be watered during dry summer months to reduce stress they will encounter from the laneway construction
