October 14, 2020  
File: PE3651-LET.03

Subject: **Phase II - Environmental Site Assessment Update  
Proposed Residential Development  
176 Nepean Street and 293 to 307 Lisgar Street  
Ottawa, Ontario**

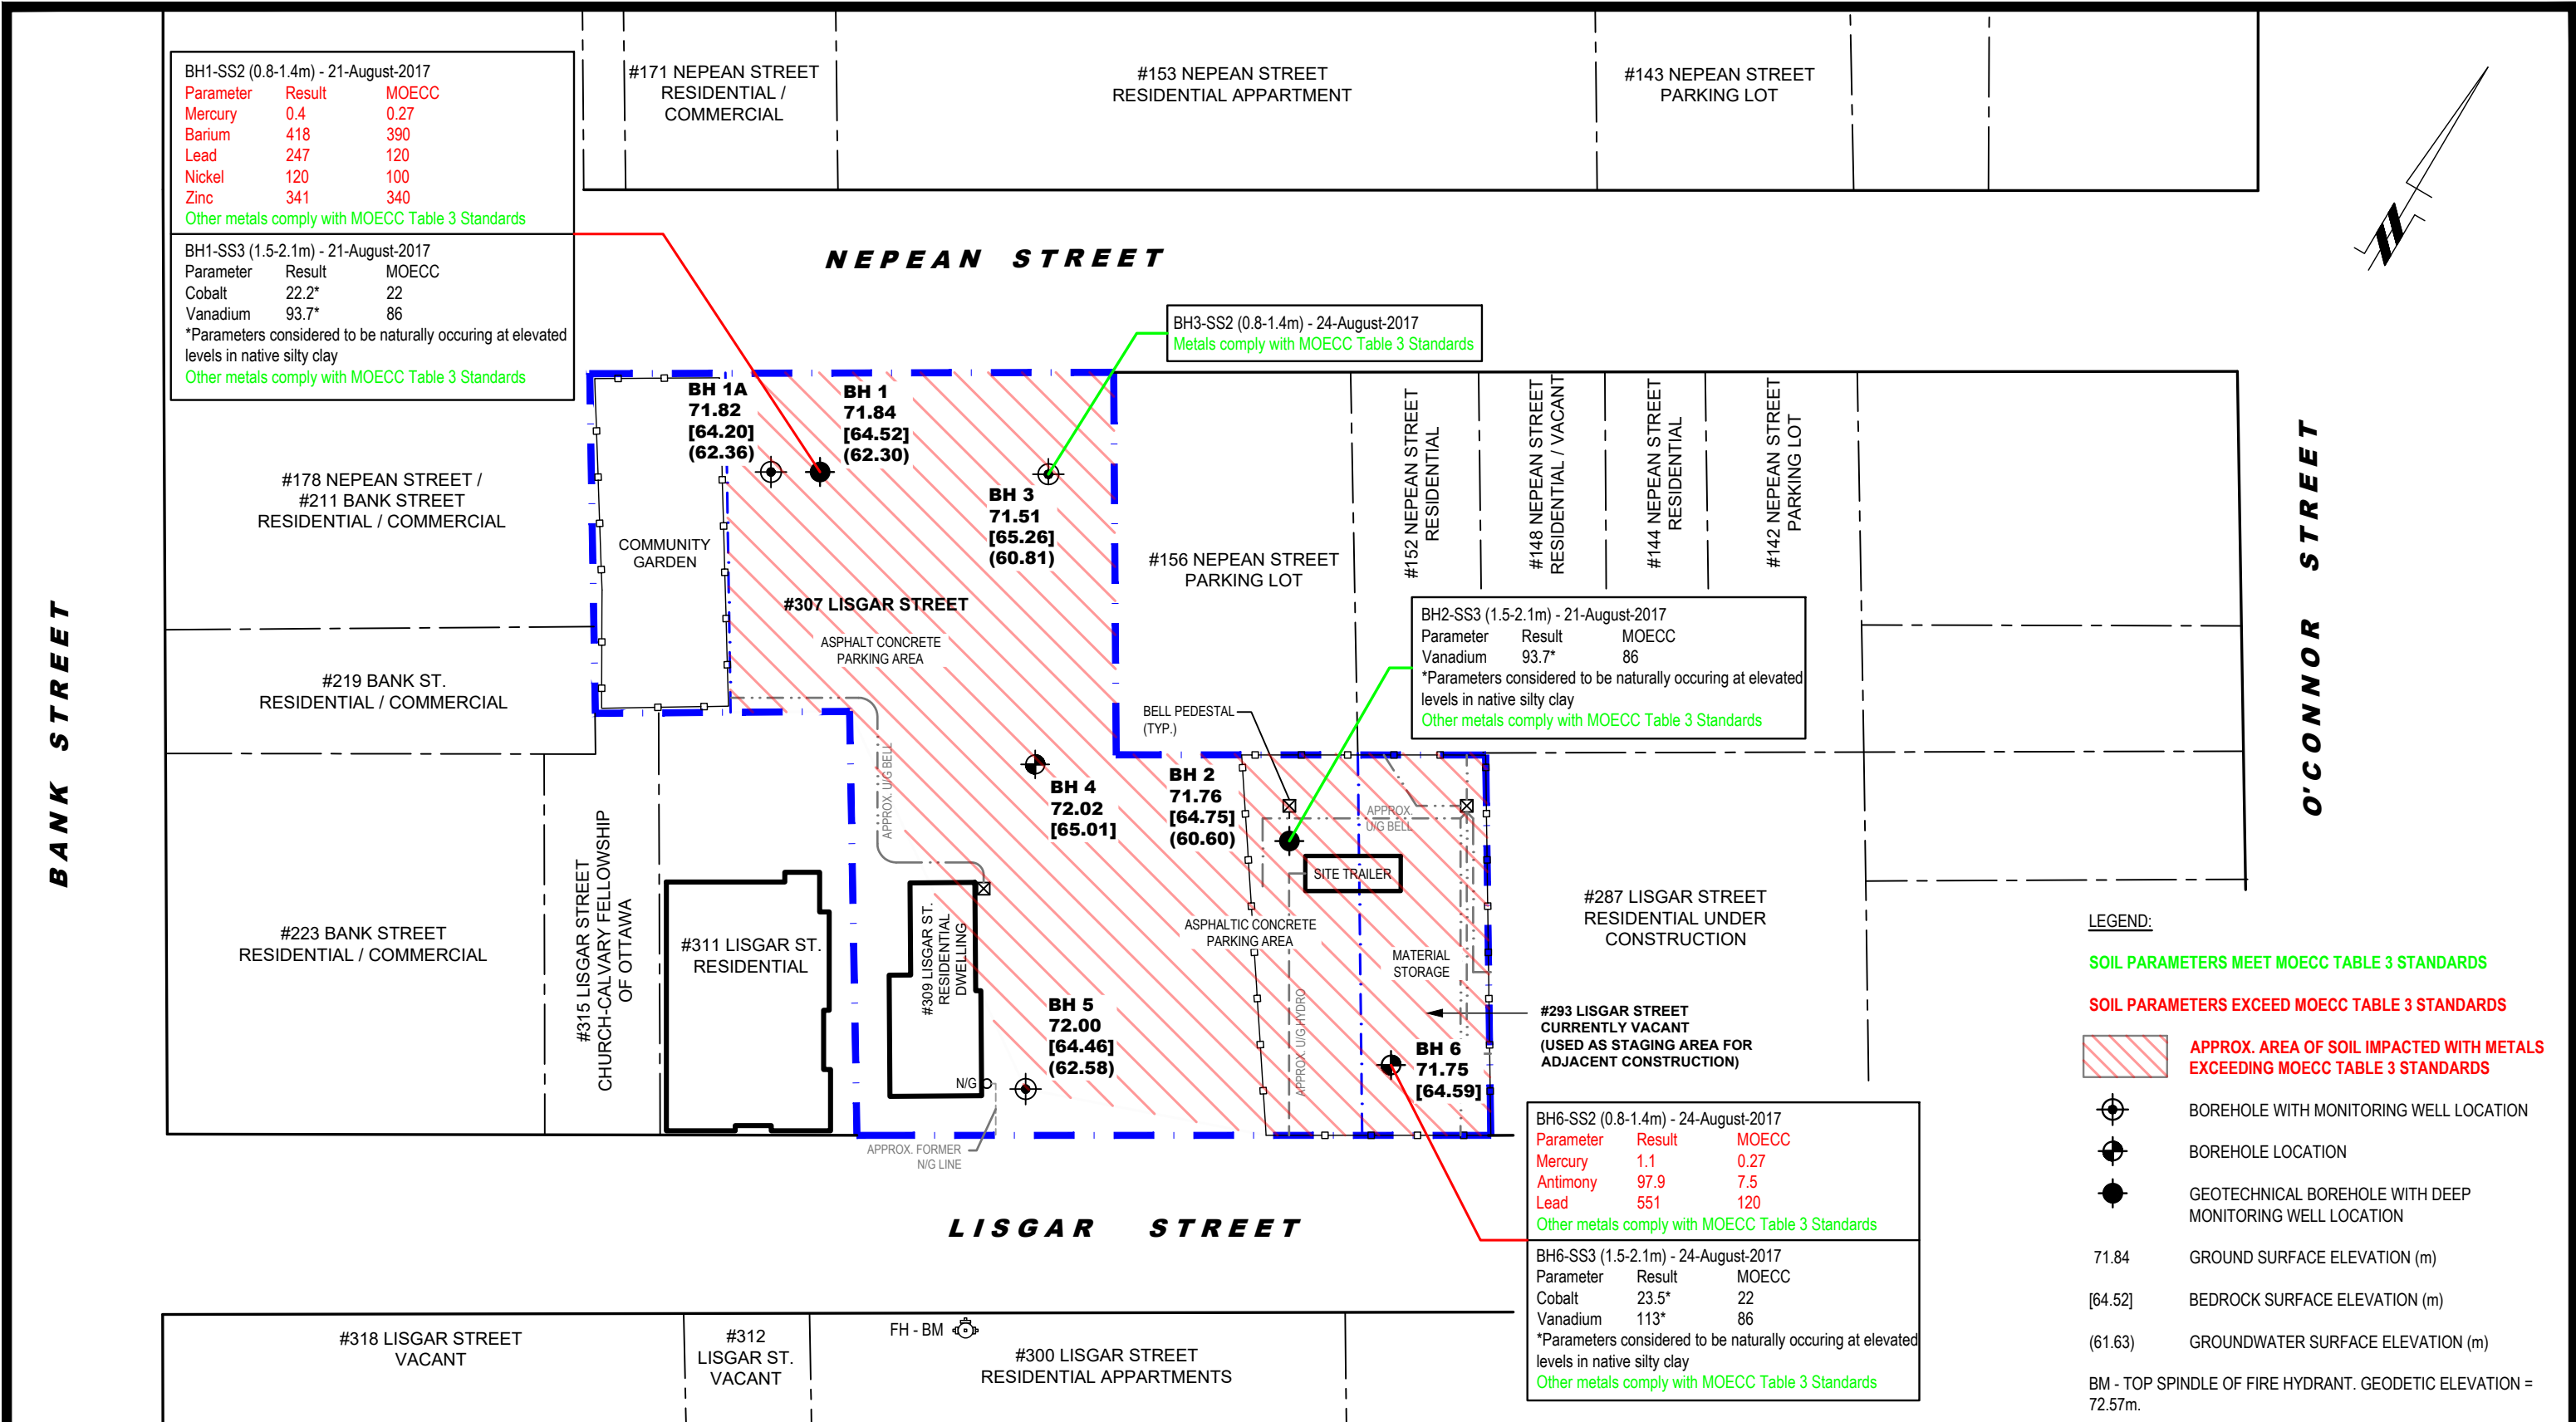
Parameter	Result	MOECC
Cobalt	23.5*	22
Vanadium	113*	86

\*Parameters considered to be naturally occurring at elevated levels in native silty clay  
Other metals comply with MOECC Table 3 Standards

It is our recommendation that an environmental site remediation program, involving the removal of all impacted fill material, be completed concurrently with the site redevelopment. Prior to offsite disposal at a licenced landfill site, a leachate analysis of a representative sample of contaminated soil must be conducted in accordance with Ontario Regulation 347/558.

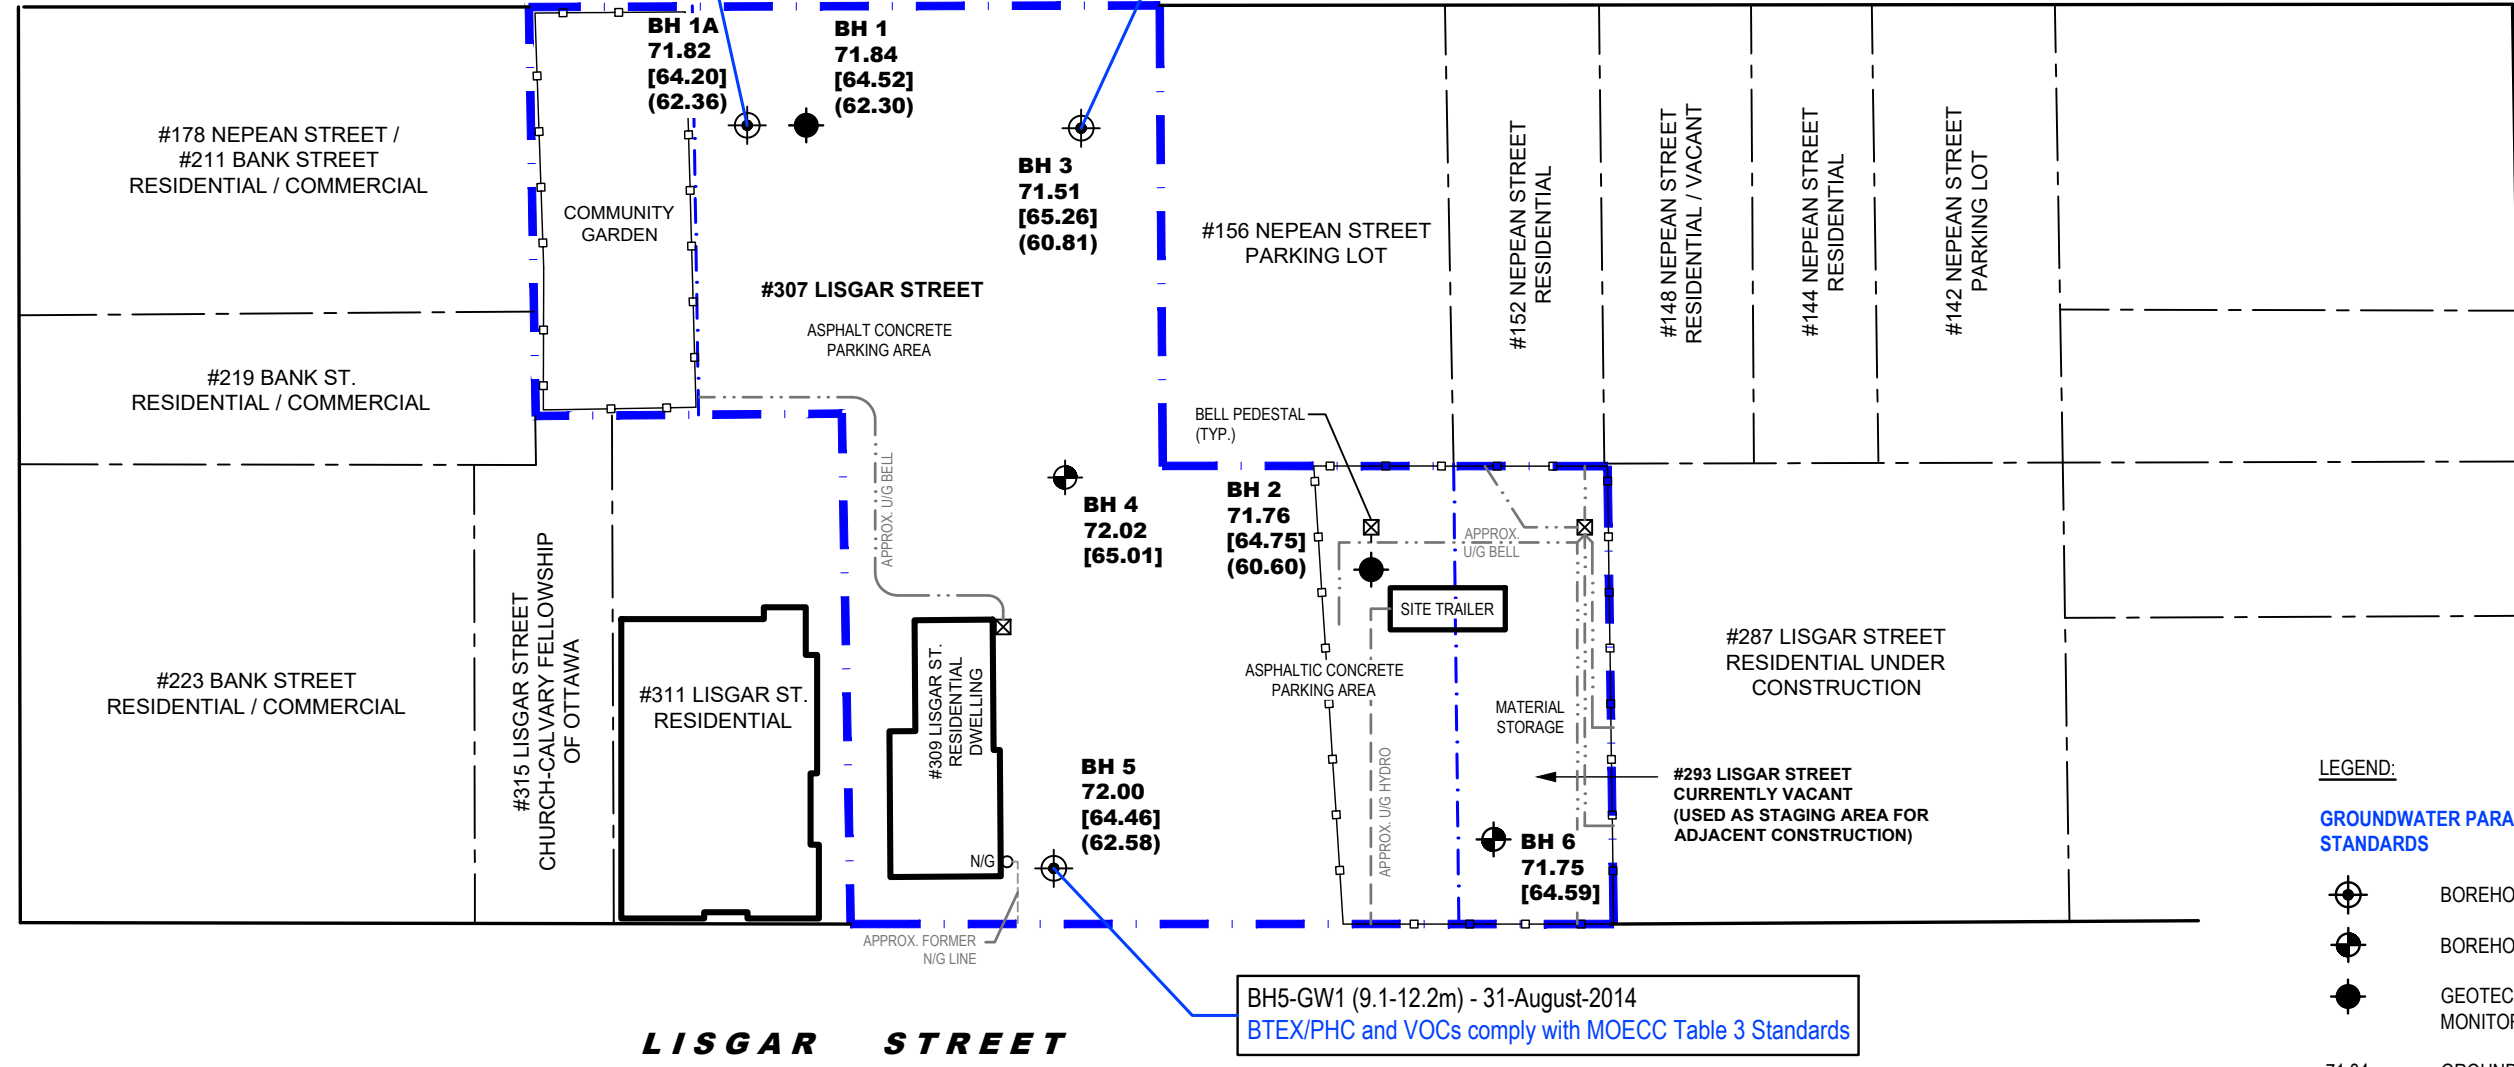
Scale:	1:500	Date:	10/2020
Drawn by:	MPG	Report No.:	PE3651-LET.03
Checked by:	KM	Dwg. No.:	<b>PE3651-5R</b>
Approved by:	MSD	Revision No.:	0

BH3-GW1 (10.1-13.2m) - 31-August-2014  
 BTEX/PHC, VOCs, PAHs comply with MOECC Table 3 Standards

BH5-GW1 (9.1-12.2m) - 31-August-2014  
 BTEX/PHC and VOCs comply with MOECC Table 3 Standards

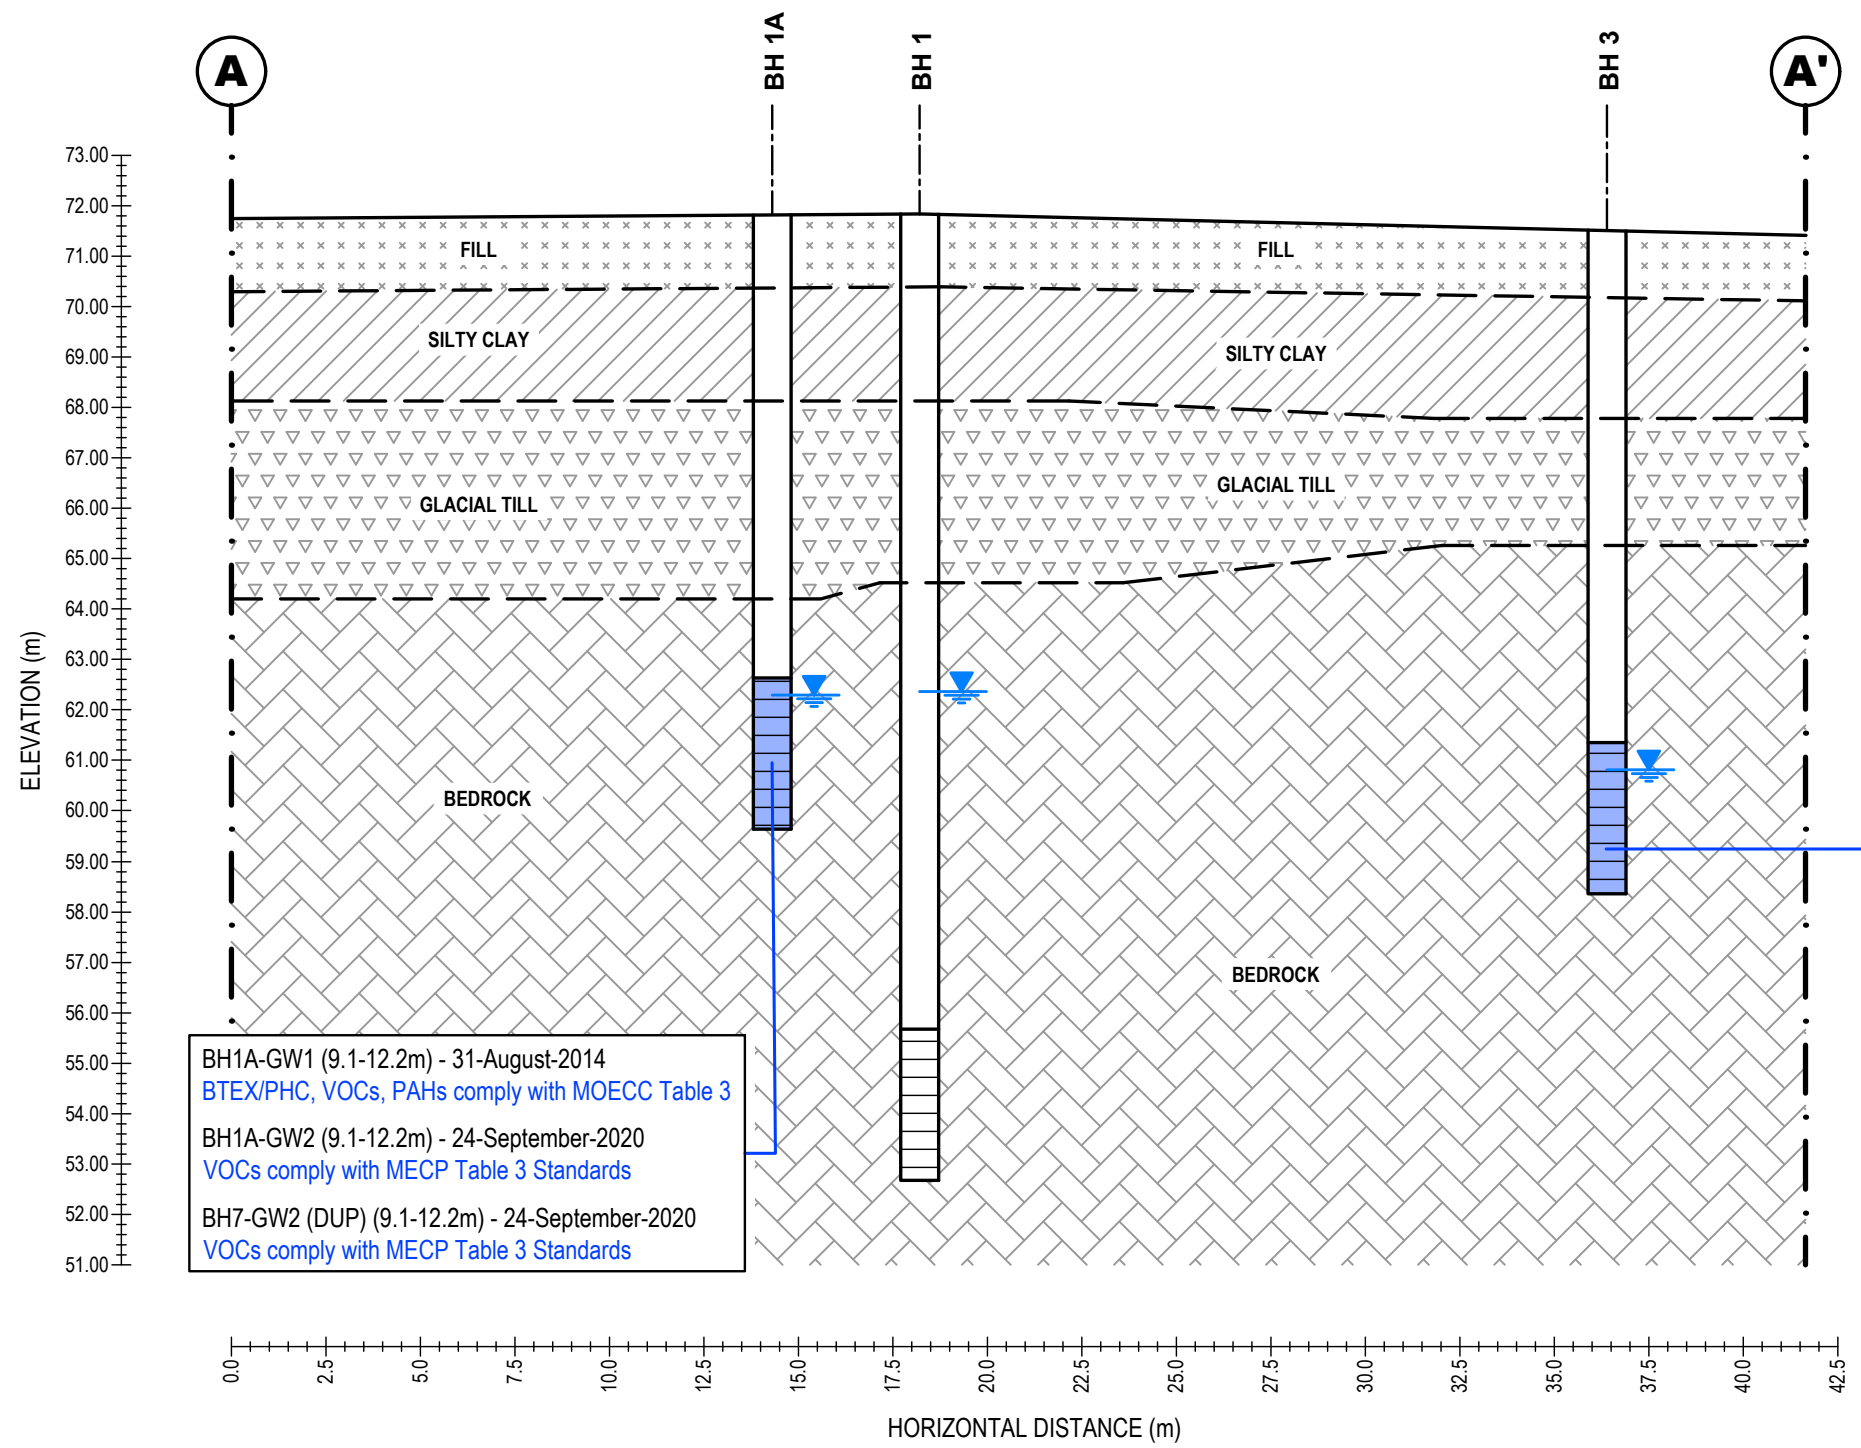
Scale: <b>AS SHOWN</b>	Date: <b>10/2020</b>
Drawn by: <b>MPG</b>	Report No.: <b>PE3651-LET.03</b>
Checked by: <b>KM</b>	Dwg. No.: <b>PE3651-7DR</b>
Approved by: <b>MSD</b>	Revision No.: <b>0</b>

No detectable VOC concentrations were identified in the groundwater samples analyzed. The results comply with the selected MECP Table 3 Standards.

BH3-GW1 (10.1-13.2m) - 31-August-2014  
 BTEX/PHC, VOCs, PAHs comply with MOECC Table 3 Standards

BH1A-GW1 (9.1-12.2m) - 31-August-2014  
 BTEX/PHC, VOCs, PAHs comply with MOECC Table 3  
 BH1A-GW2 (9.1-12.2m) - 24-September-2020  
 VOCs comply with MECP Table 3 Standards  
 BH7-GW2 (DUP) (9.1-12.2m) - 24-September-2020  
 VOCs comply with MECP Table 3 Standards
