# Clifton Road Arborist Report

**Clifton Property Development, City of Ottawa**

Date: August 28, 2020 [*Updated May 12, 2021*]

A001062

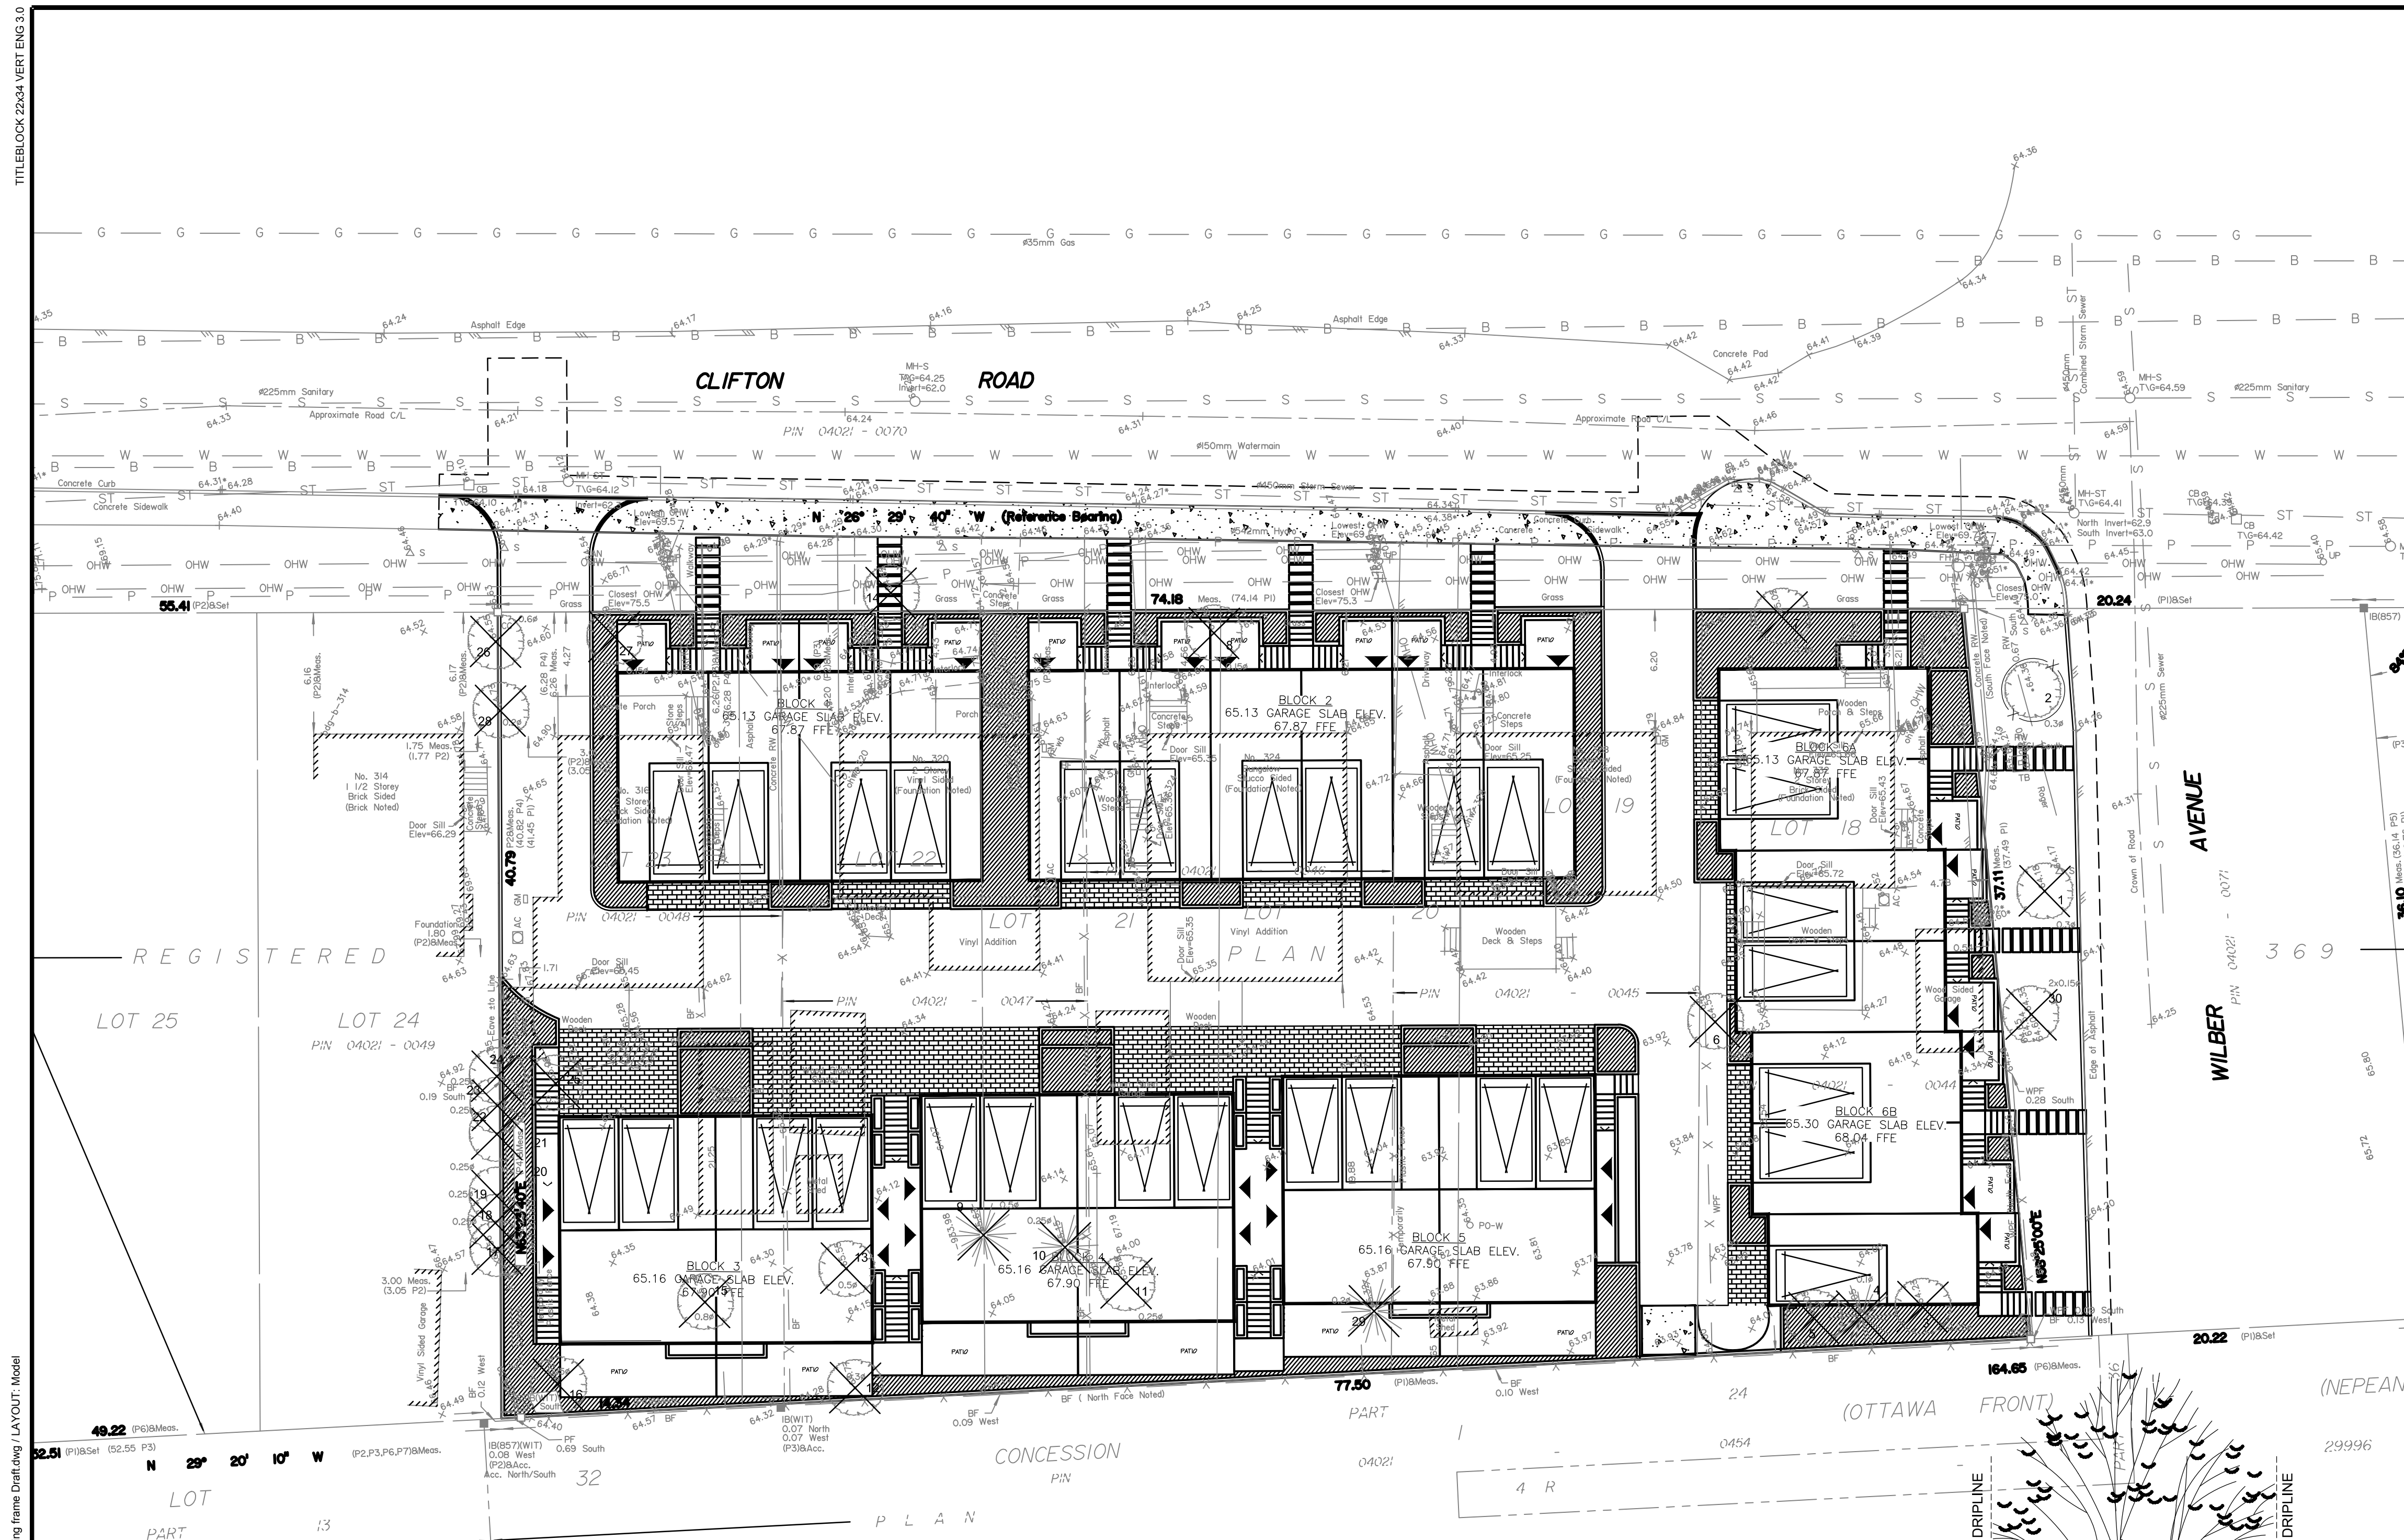
SHEET TITLE:  
**TREE INVENTORY, ASSESSMENT AND PROTECTION PLAN**

Tree #	Common name	Scientific name	DBH (cm) approx.	Height (m)	Structural Defects										Ownership	Overall Condition (D, F, G, or E)	Tree Impacts (Significant or Remove)	Comments		
					GR	COD	NA	INCL	CRB	MBR	DPR	SMD	ADV							
1	Norway Maple	Acer platanoides	31	15			X		X								City	F	R	Canker
2	Norway Maple	Acer platanoides	36	16													City	F	R	Canker
3	Silver Maple	Acer saccharinum	24	15				X					X			private	F	R		
4	White Spruce	Picea glauca	14	12												private	F	R		
5	Littleleaf Linden	Tilia cordata	22	13					X							private	G	R		
6	Manitoba Maple	Acer negundo	41	20	X											private	G	R		
7	Ivory Silk Tree	Syringa reticulata	33	6	X					X	X	X				private	F	R		
8	Poplar	Populus sp.	21	10	X					X						private	G	R		
9	White Pine	Pinus strobus	51	18			X									private	F	R		
10	White Pine	Pinus strobus	30	18							X					private	F	R	Invasive buckthorn undergrowth	
11	Norway Maple	Acer platanoides	23	12												private	G	R

12	Norway Maple	Acer platanoides	47	14		X	X	X	X							private	F	R		
13	Bur Oak	Quercus macrocarpa	52	17						X	X	X				private	P	R		
14	Amur Maple	Acer ginnala	22	7	X					X	X	X				City	F	R	Crown appears to have been pruned due to proximity of power lines	
15	Silver Maple	Acer saccharinum	71	16	X			X	X	X	X					private	F	R	Canker	
16	Common Hackberry	Celtis occidentalis	19	10					X	X						private	F	R		
17	Norway Maple	Acer platanoides	22	15	X	X			X	X						boundary	G	R	4 codominant trunks at breast height. Invasive buckthorn	
18	Norway Maple	Acer platanoides	22	15	X	X			X	X						boundary	G	R	Small invasive buckthorn around tree base	
19	Norway Maple	Acer platanoides	16	15		X				X						boundary	P	R	Horizontal shear of bark around entire circumference of tree. Potential hazard.	
20	Norway Maple	Acer platanoides	21	15		X										boundary	F	R		
21	Norway Maple	Acer platanoides	14	15								X				boundary	G	R	Part of tightly packed group of Norways

22	Norway Maple	Acer platanoides	21	15	X	X	X	X	X			X				boundary	F	R	Codominant trunk above 2m. Second trunk removed. Cut point well healed	
23	Norway Maple	Acer platanoides	29	15	X			X	X	X	X					boundary	F	R	Canker	
24	Norway Maple	Acer platanoides	21	15		X	X	X	X	X	X					boundary	F	R	On boundary of 314 and 316. Canker. Branches high up	
25	Norway Maple	Acer platanoides	32	16	X	X	X	X	X	X						private	F	R		
26	Norway Maple	Acer platanoides	34	12	X	X	X	X	X	X						boundary	F	R	Multiple codominant trunks	
27	Norway Maple Crimson King	Acer platanoides 'Crimson King'	17	6	X					X	X					private	G	R	Crown growing near power lines, but doesn't appear to have been cut back	
28	Norway Maple	Acer platanoides	32	11					X	X						boundary	G	R		
29	White Pine	Pinus strobus	20	15							X					private	F	R		
30	Manitoba Maple	Acer negundo	9	10	X	X	X	X								City	F	R	Multiple codominant trunks (4+)
