Clifton Road Arborist Report

Clifton Property Development, City of Ottawa

Date: August 28, 2020

A001062

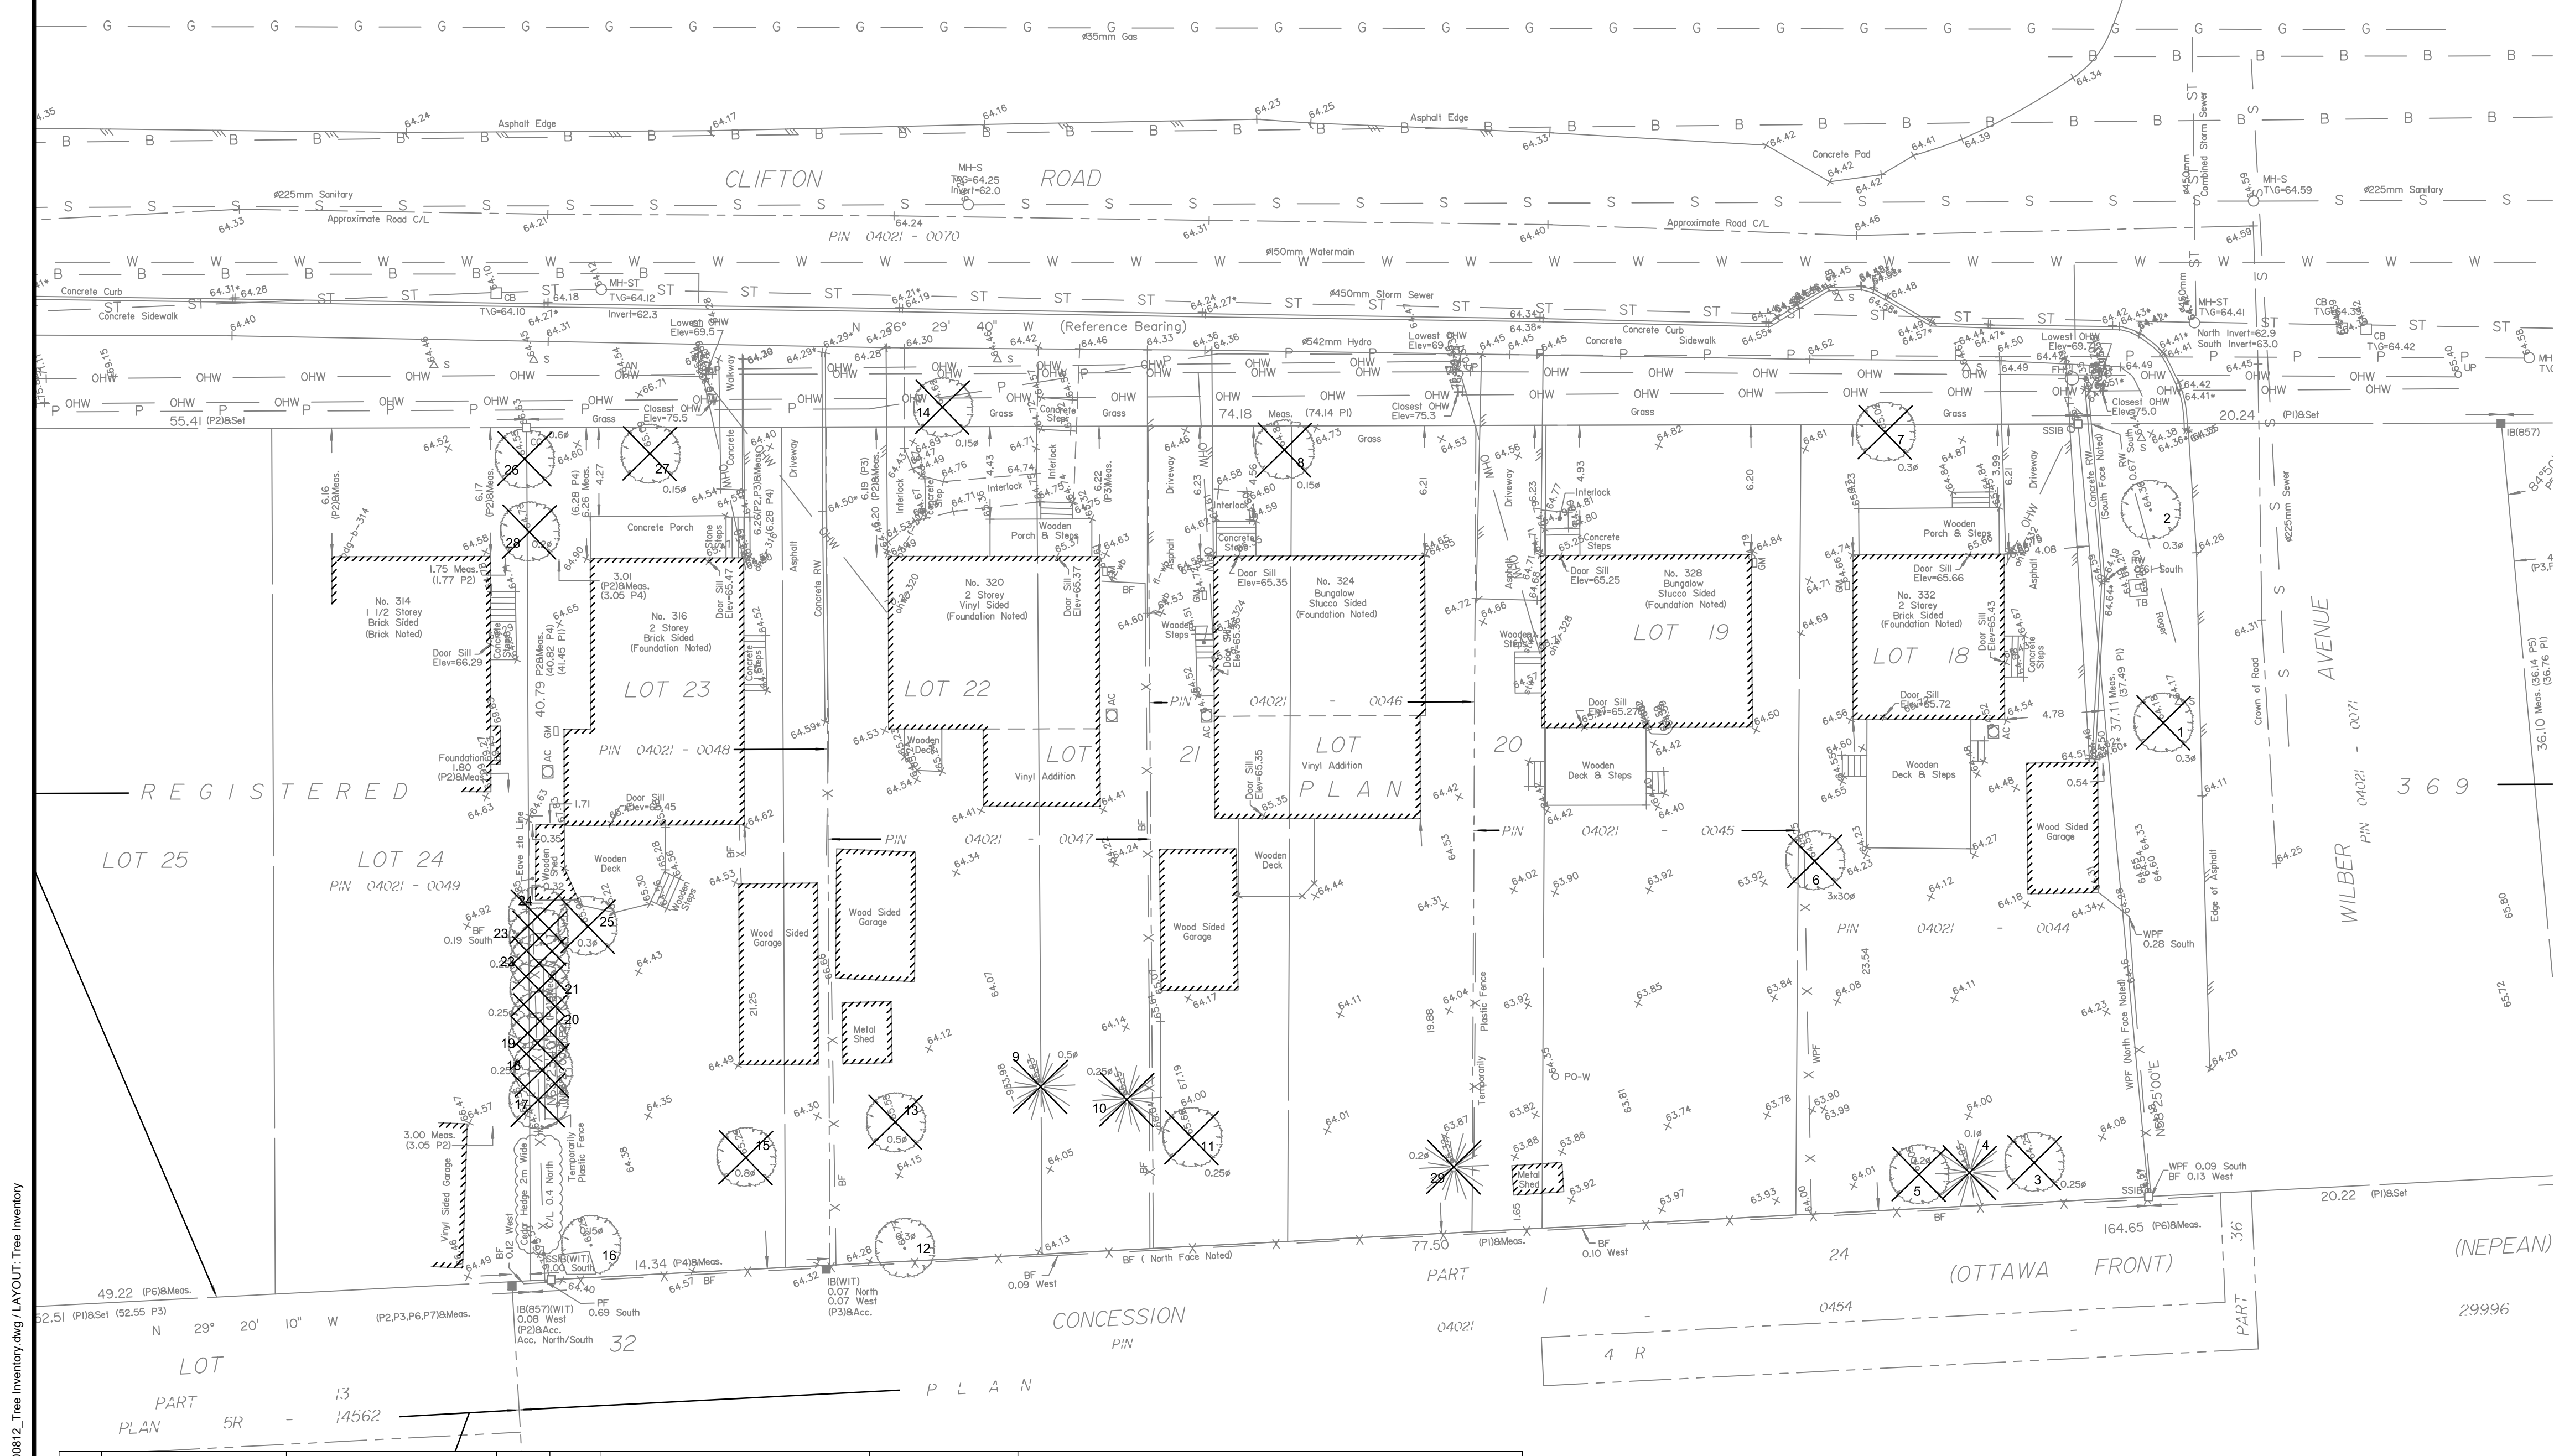
TREE INVENTORY AND ASSESSMENT

Tree #	Common name	Scientific name	DBH (cm) * approx	Height (m)	Structural Defects										Overall Condition (D, (F), (P), (G), or (E))	Tree Impacts (Injury / Remove)	Comments	
					GR	COD	NA	INCL	CRB	M/R	DPR	SMD	ADV					
1	Norway Maple	Acer platanoides	31	15		X										F	R	Canker
2	Norway Maple	Acer platanoides	36	16									X			F	R	Canker
3	Silver Maple	Acer saccharinum	24	15				X								F	R	
4	White Spruce	Picea glauca	14	12												F	R	
5	Littleleaf Linden	Tilia cordata	22	13				X								G	R	
6	Manitoba Maple	Acer negundo	41	20		X										G	R	
7	Ivory Silk Tree	Syringa reticulata	33	6				X				X	X			F	R	
8	Poplar	Populus sp.	21	10			X					X				F	R	
9	White Pine	Pinus strobus	51	18					X							F	R	Invasive buckthorn undergrowth
10	White Pine	Pinus strobus	30	18								X				F	R	
11	Norway Maple	Acer platanoides	23	12												F	R	
12	Norway Maple	Acer platanoides	47	14		X	X	X								F	R	
13	Bur Oak	Quercus macrocarpa	52	17						X	X	X				P	R

14	Amur Maple	Acer ginnala	22	7		X						X	X			F	R	Crown appears to have been pruned due to proximity of power lines
15	Silver Maple	Acer saccharinum	71	16		X			X	X	X	X				F	R	Canker
16	Common Hackberry	Celtis occidentalis	19	10						X						F	R	
17	Norway Maple	Acer platanoides	22	15		X	X			X						G	R	4 codominant trunks at breast height. Invasive buckthorn
18	Norway Maple	Acer platanoides	22	15		X	X					X				G	R	Small invasive buckthorn around tree base
19	Norway Maple	Acer platanoides	16	15				X			X					P	R	Horizontal shear of bark around entire circumference of tree. Potential hazard.
20	Norway Maple	Acer platanoides	21	15												F	R	
21	Norway Maple	Acer platanoides	14	15						X						F	R	Part of tightly packed group of Norways
22	Norway Maple	Acer platanoides	21	15		X	X	X			X	X				F	R	Codominant trunk above 2m. Second trunk removed. Cut point well healed
23	Norway Maple	Acer platanoides	29	15		X			X	X	X					F	R	Canker

24	Norway Maple	Acer platanoides	21	15		X			X	X	X	X				F	R	On boundary of 314 and 316. Canker. Branches high up
25	Norway Maple	Acer platanoides	32	16		X	X				X					F	R	
26	Norway Maple	Acer platanoides	34	12		X	X	X	X	X	X					F	R	Multiple codominant trunks
27	Norway Maple Crimson King	Acer platanoides 'Crimson King'	17	6		X				X	X	X				G	R	Crown growing near power lines, but doesn't appear to have been cut back
28	Norway Maple	Acer platanoides	32	11					X	X						G	R	
29	White Pine	Pinus strobus	20	15						X						F	R

A total of 26 trees are expected to require removal to facilitate the proposed development. Trees #2, #12 and #16 are to be retained and protected.
