February 7, 2023

File: 64913.01 – R03

**Re: Slope Stability Assessment
5497 Manotick Main Street
Manotick (Ottawa), Ontario**

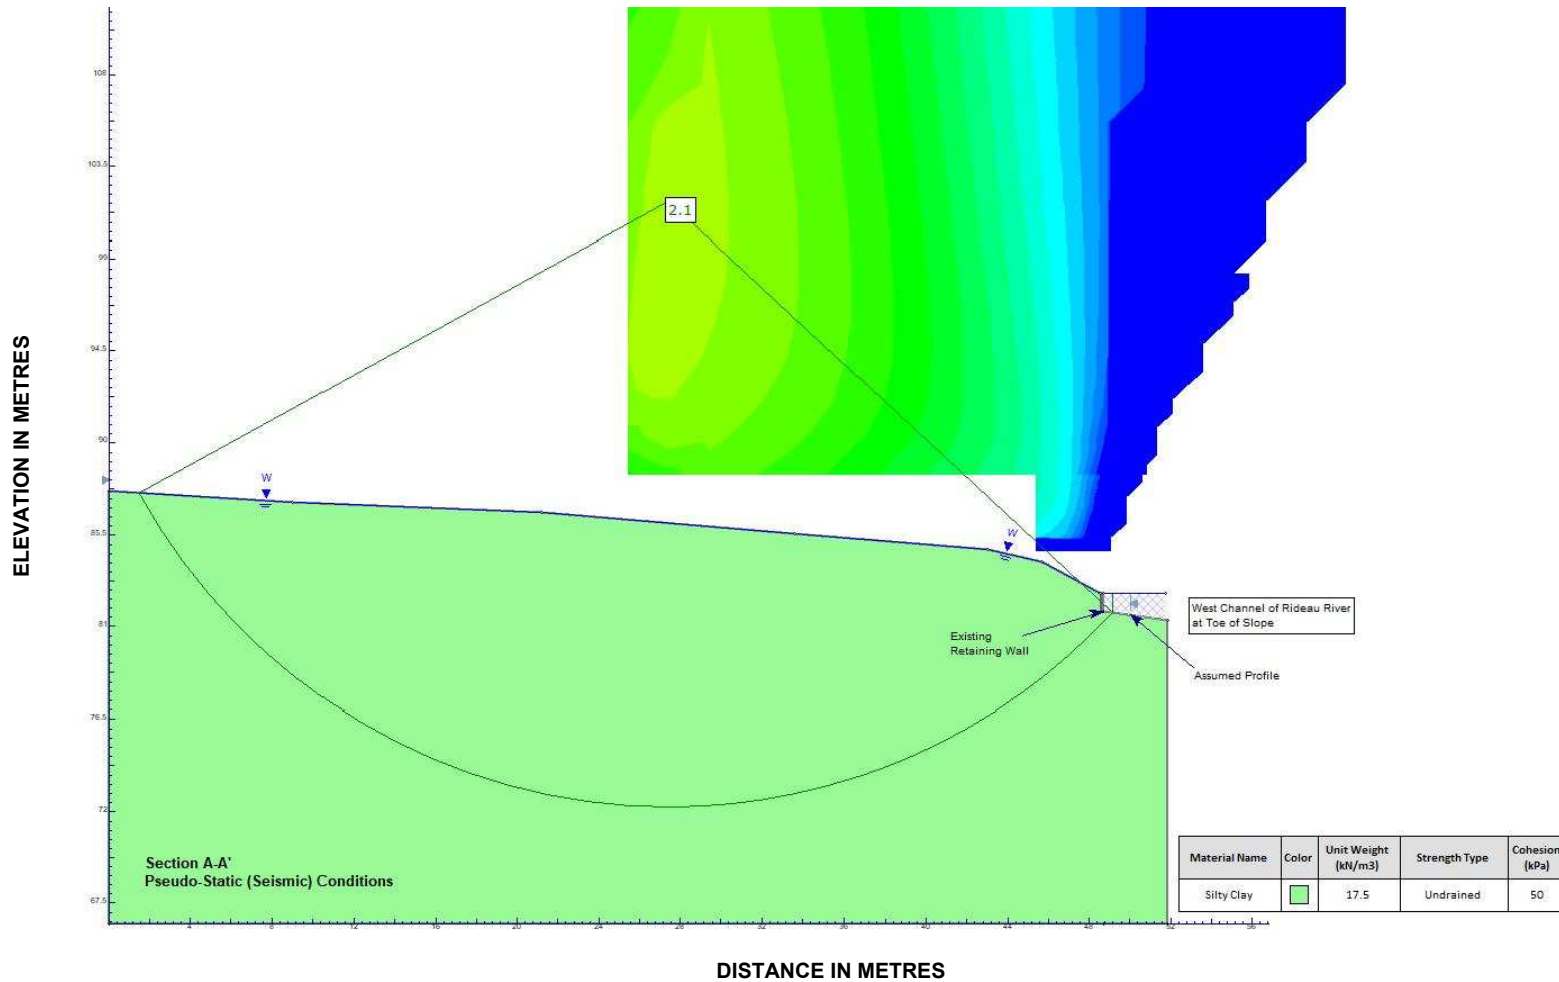
The slopes at Sections A-A' and B-B' were analysed for pseudo-static (seismic) conditions using the undrained silty clay strength parameters. A seismic coefficient of 0.14 was used in the pseudo-static analyses (i.e., half of the Peak Ground Acceleration for Ottawa (Barrhaven) according to the Ontario Building Code 2015). The slope stability analyses indicate that the existing slopes, in their current configurations, have a factor of safety against failure of greater than 1.1 for pseudo-static (seismic) conditions, which is considered acceptable. The results of the pseudo-static stability analyses are provided on Figures A3 and A4 in Attachment A.
