Muncaster  
Environmental  
Planning Inc.

March 28, 2025

**RE: 2167 McGee Side Road**  
**Review of Mapped Watercourse**

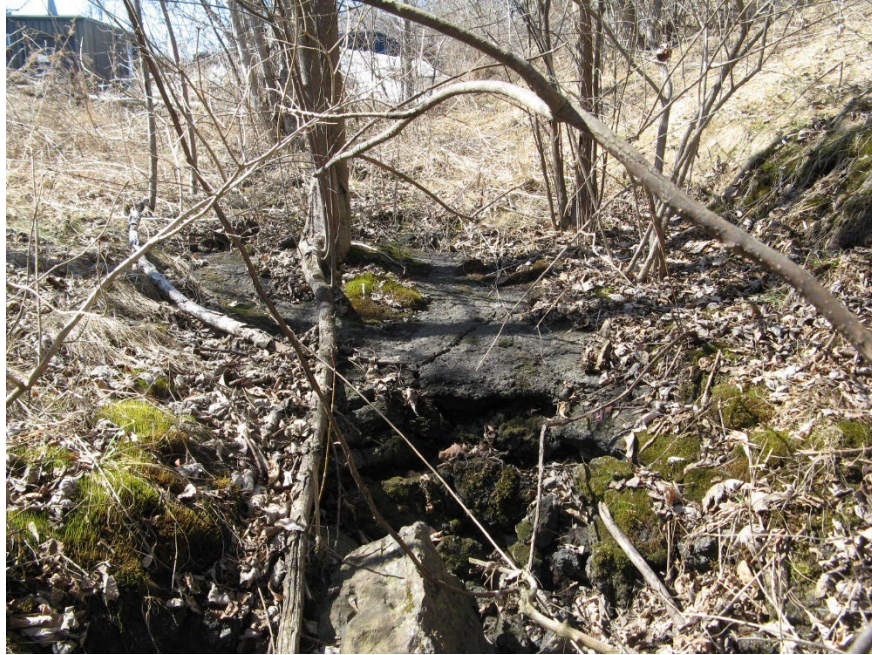
*Photo 1 – The west end of the mapped watercourse alignment in the northwest corner of the site, with a rise in elevation preventing any access to the west of the site. View looking west*

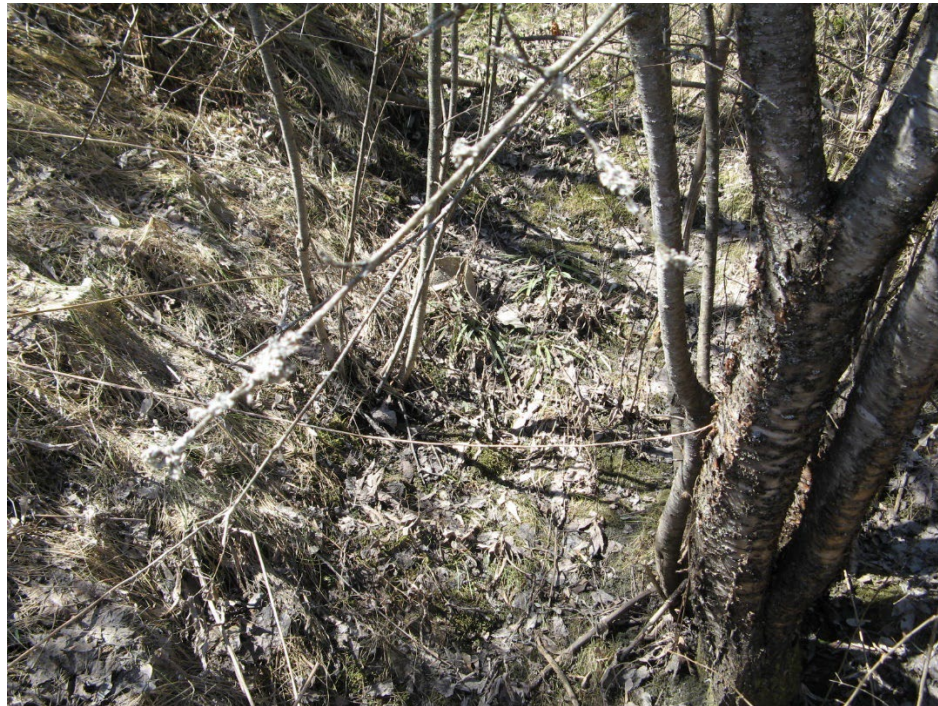
*Photo 2 – No defined channel in the alignment of the mapped watercourse in the north-central edge of the site. View looking west along the alignment of the mapped watercourse*

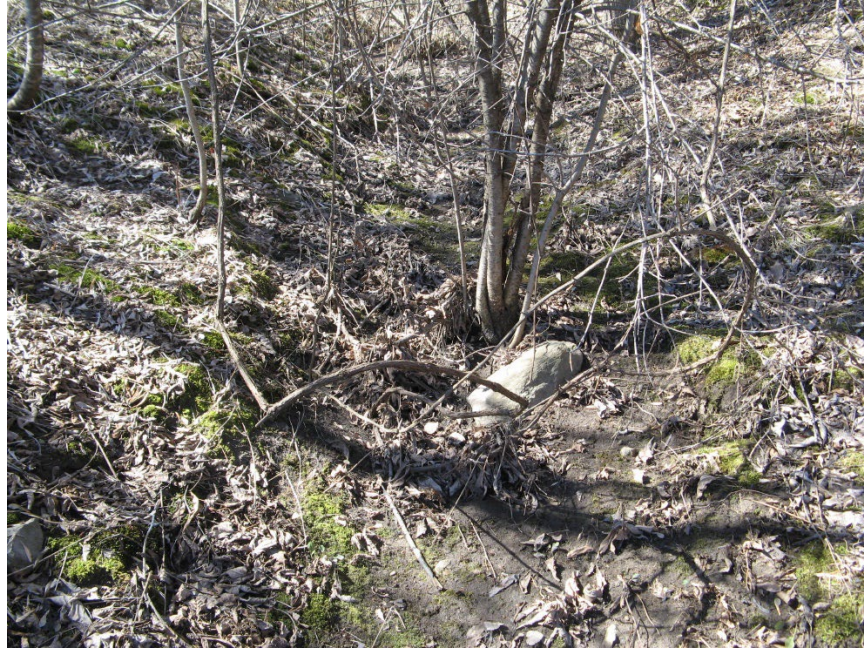
*Photo 3 – No defined channel in the alignment of the mapped watercourse in the northeast edge of the site. View looking east along the alignment of the mapped watercourse.  
Note rise in elevation approaching John Cavanaugh Drive*

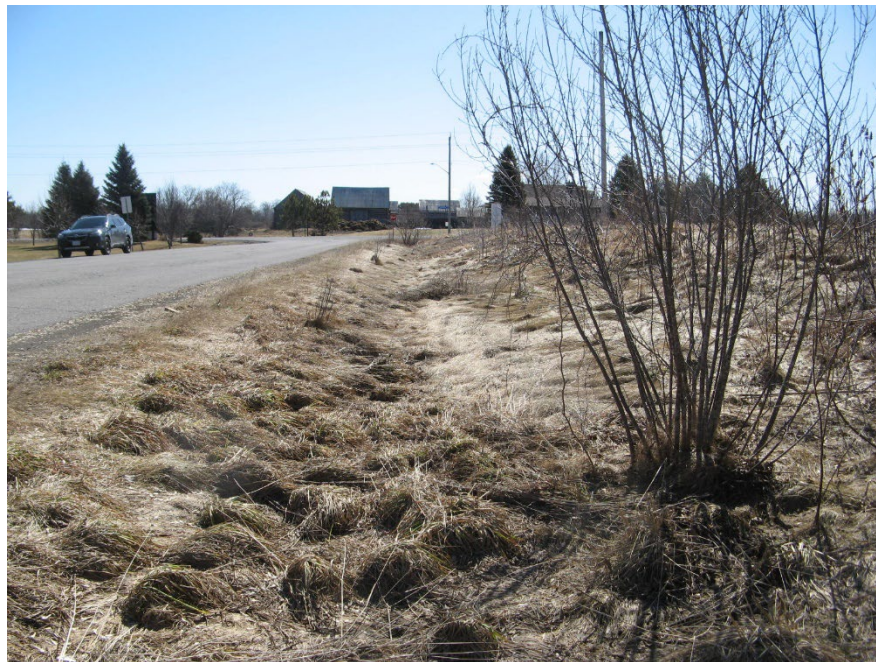
*Photo 4 – No potential connection to a channel along the west side of John Cavanaugh Drive. View looking south to McGee Side Road along the alignment of the mapped watercourse where the mapped watercourse joins from the west but there is a clear rise in elevation*

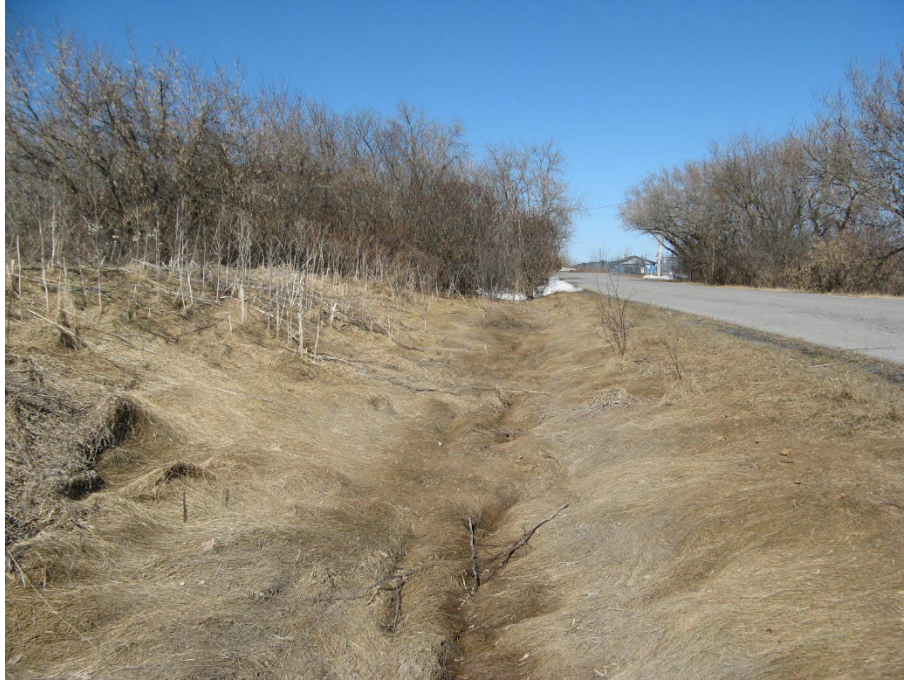
*Photo 5 – View looking north along the alignment of the mapped watercourse on the west side of John Cavanaugh Drive, north of McGee Side Road*

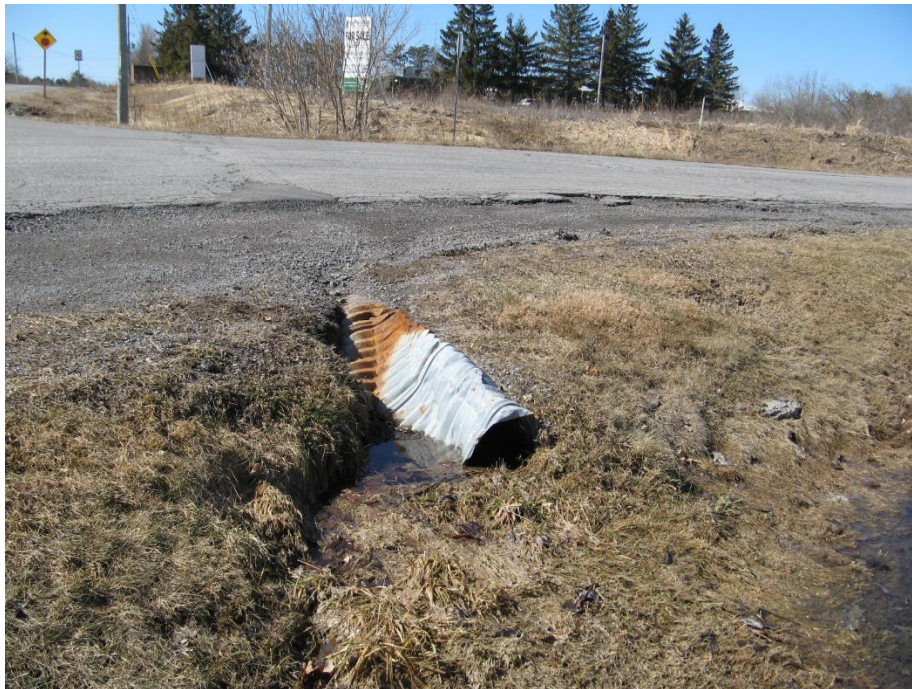
*Photo 6 – Downstream end of culvert on the east side of John Cavanaugh Drive is damaged and there is no connection to the swale on the north side of McGee Side Road.  
View looking west*
