# STAGE II CULTURAL HERITAGE IMPACT STATEMENT & CONSERVATION PLAN

145 Loretta Avenue & 951 Gladstone Avenue, Ottawa,  
Ontario

**Revision V5 January 2022**

**RE: 951 Gladstone Avenue  
 Building Condition Review**

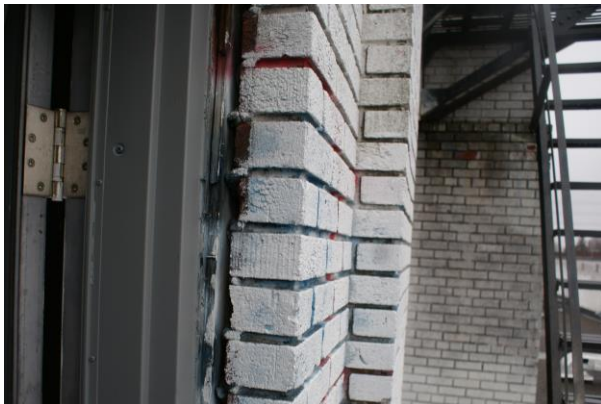
*Figure 32: View of the exterior brickwork from a second-floor fire escape. Note the highly textured brick surfaces and recessed joint profile. Source: Commonwealth 2020.*

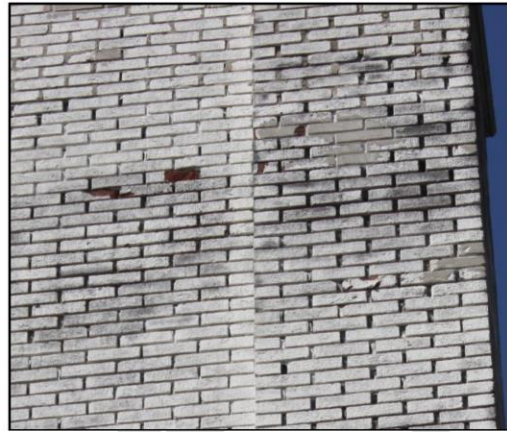
The exterior brick veneer in general is in good condition but does have localized areas of eroded mortar joints and face spalled bricks. These conditions were typically observed below window sills and other areas of high exposure to water, such as on the pilasters on the west and east elevations. Specifically on the west elevation, the bricks adjacent to the concrete corbels are in poor condition. The concrete corbels have minor vertical and horizontal cracks and typically have exposed rebar. Similarly, on the east elevation localized areas of masonry deterioration was observed.

**Photo 5:** Typical localized area of eroded joints and face spalled bricks [JCAL 2018].

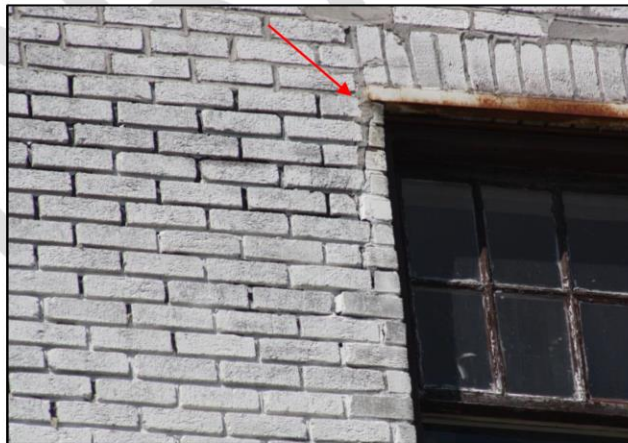
**Photo 6:** Third floor window on east elevation with deteriorated bricks around the perimeter [JCAL 2018].
