# STAGE II CULTURAL HERITAGE IMPACT STATEMENT & CONSERVATION PLAN

145 Loretta Avenue & 951 Gladstone Avenue,  
Ottawa, Ontario

**PREPARED BY: COMMONWEALTH HISTORIC RESOURCE MANAGEMENT**

**Revision V5 October 2022**

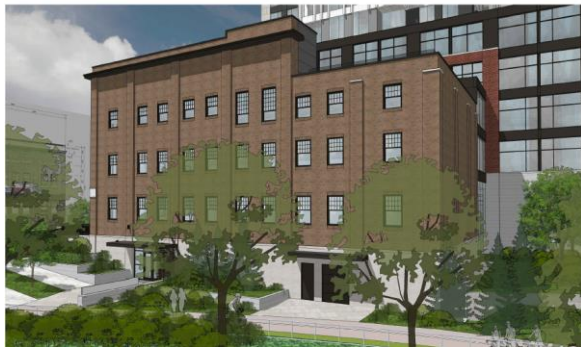
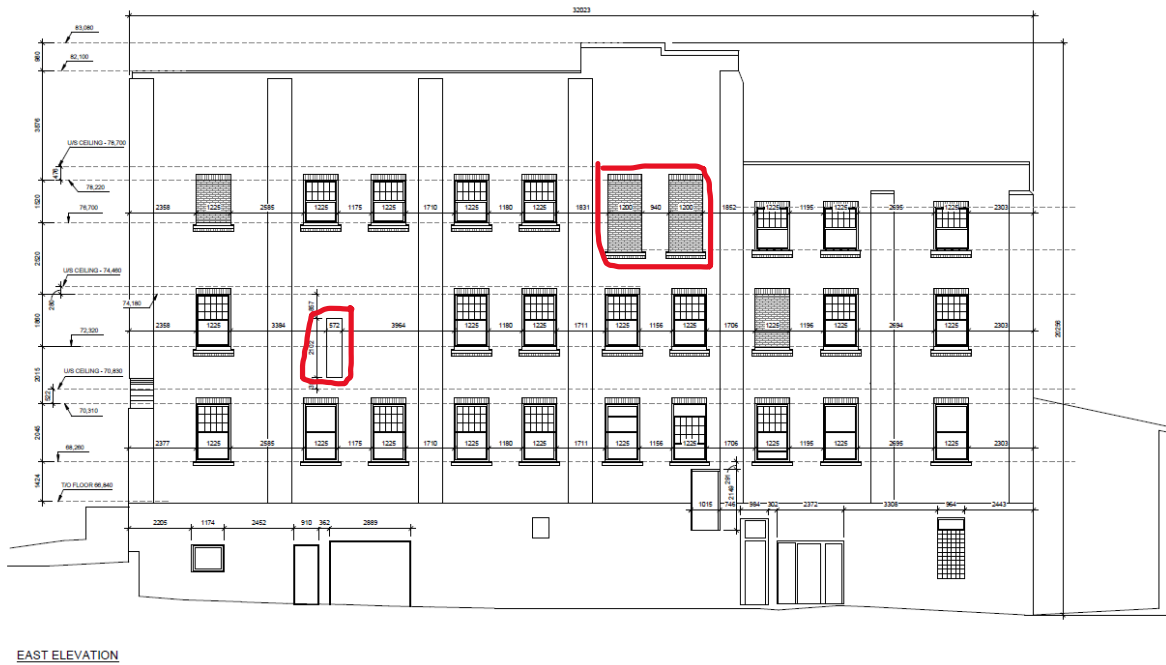
Figure 26: As-Found recording of the east and west elevation illustrating the configuration of windows and openings will provide a guide to the rehabilitation. The two areas highlighted in red are areas that the window configuration is proposed to be changed. Source: Hobin Architecture 2021.

The fenestration pattern on the east elevation overlooking the rail corridor is noted to be a character-defining feature reflecting its industrial use adjacent to a railway siding when constructed in 1924. The existing fenestration pattern will be retained including doors, and windows. At present the drawings illustrate the replacement of doors on the third floor with windows and the introduction of windows that are not original. These are noted on Figure 26.

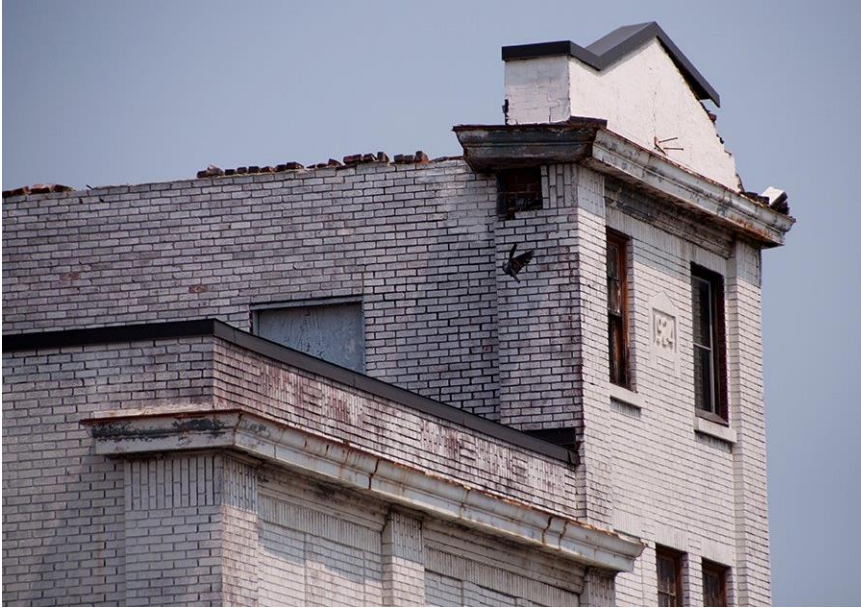
The gabled brick and metal parapets are in poor condition (figure 30) and will require restoration and for whole sections, the flashing and cornice profile details will have to be fabricated based on the photographs and remaining elements.

*Figure 30: The gabled brick and metal parapets will be re-instated to their original form and design. The height of the parapet can be determined from period photos. The original colour of the brick is evident in areas where the paint has worn off. Bricked-in windows will be opened and reglazed retaining the glazing pattern.*

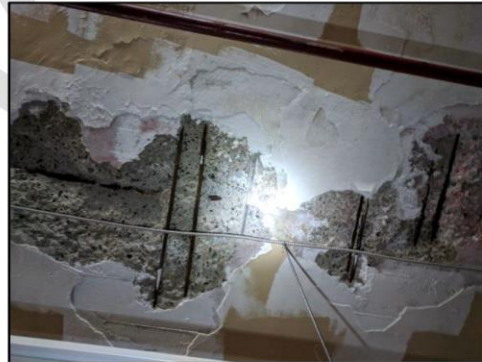
Photo 3: Corroding rebars have caused the concrete to spall on the underside of the third floor. [JCAL]

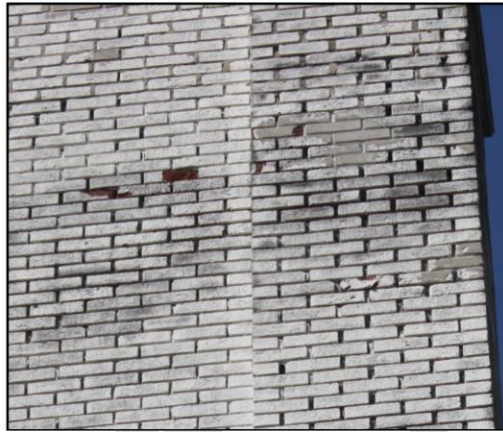
**Photo 5:** Typical localized area of eroded joints and face spalled bricks [JCAL 2018].

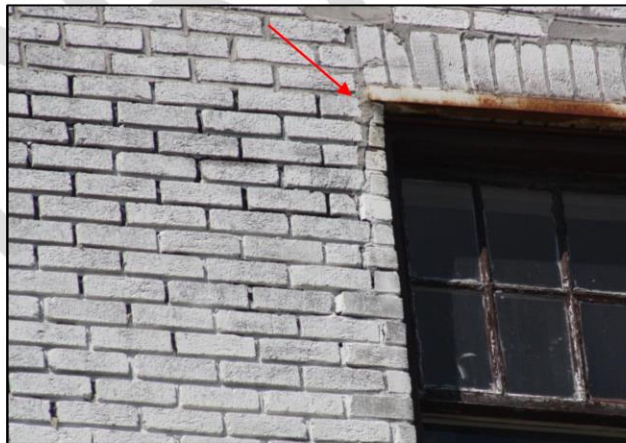
**Photo 6:** Third floor window on east elevation with deteriorated bricks around the perimeter [JCAL 2018].

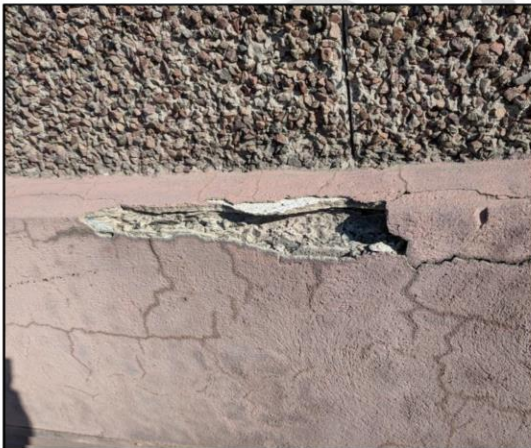
Photo 7: Debonded parging on the south elevation [JCAL 2018].

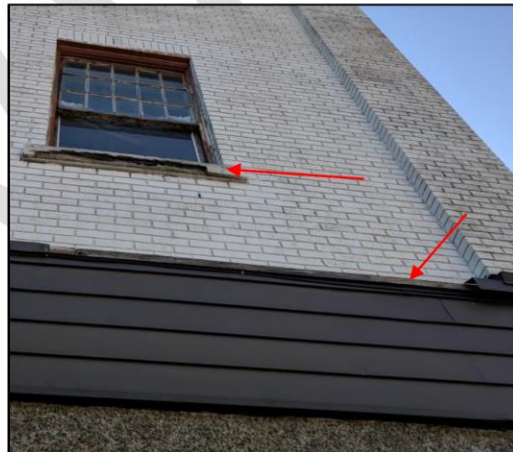
Photo 8: Deteriorated concrete window sill and damaged flashing on west elevation [JCAL 2018].

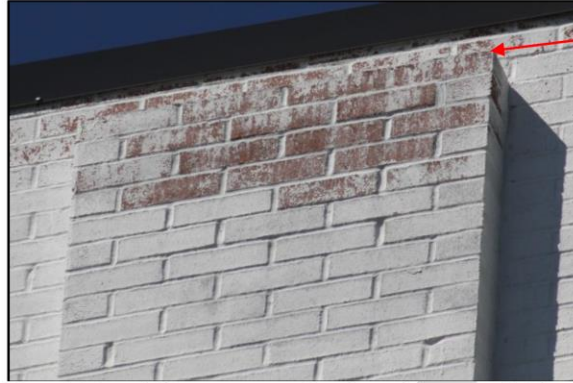
Photo 9: Top of pilaster, on east elevation, with no cap flashing [JCAL 2018].
