**2490 Orient Park  
Ottawa, Ontario**

## SEWER CCTV INSPECTION REPORT

**Report ID**  
120475ST1

**Sewer Use**  
Storm

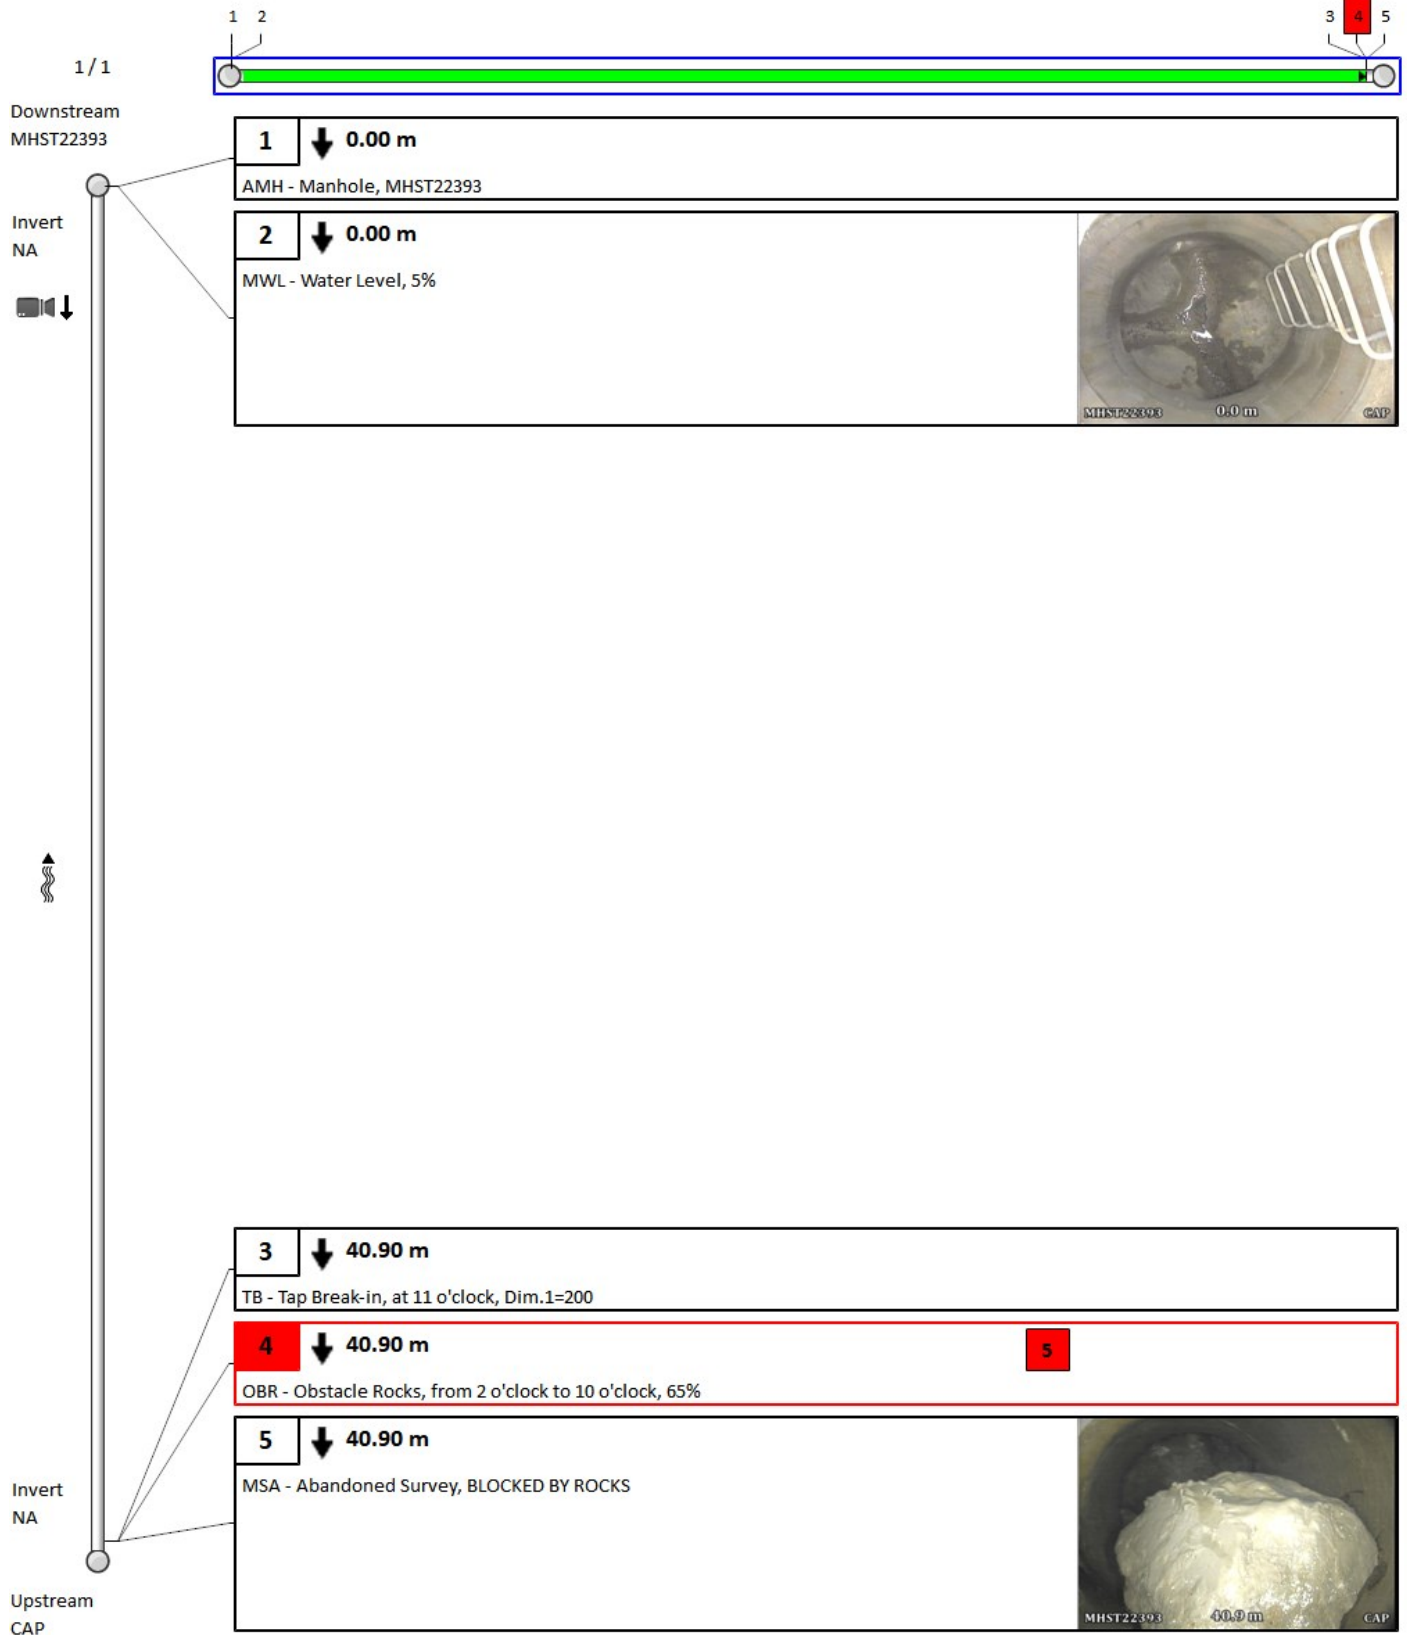
LINE IS AROUND 41.5m BLOCKED BY ROCK
--------------------------------------
