URBAN FORESTRY & FOREST MANAGEMENT CONSULTING

February 14, 2022

RE: TREE CONSERVATION REPORT FOR 180 KANATA AVENUE, OTTAWA

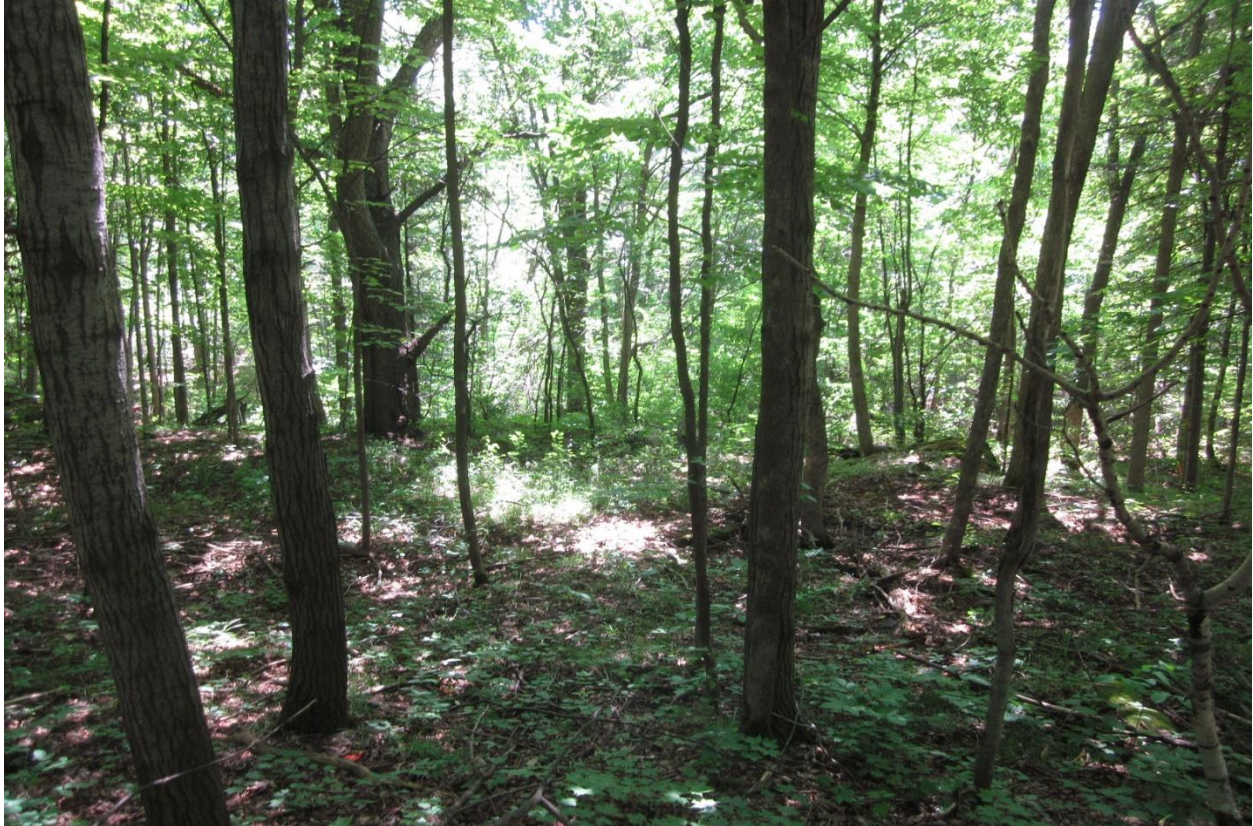
Picture 1. Typical over- and understory conditions at 180 Kanata Avenue property (looking southeastward)

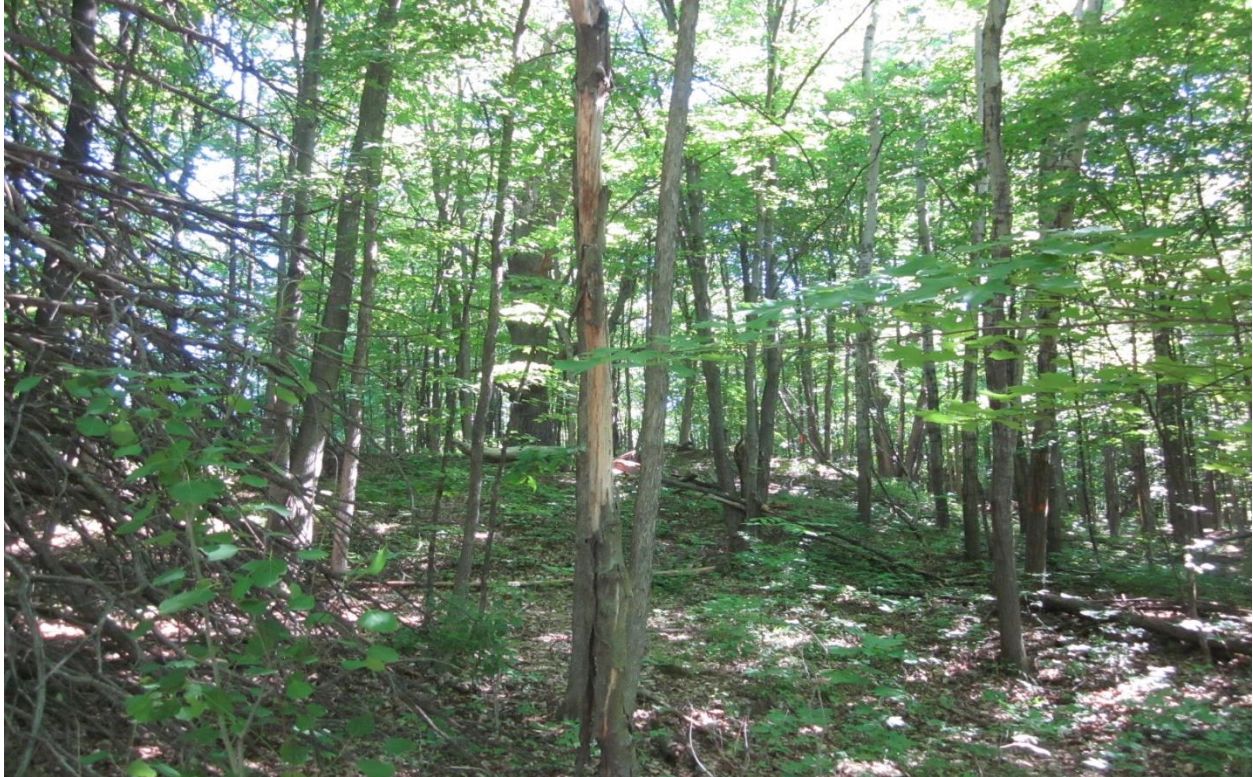
Picture 2. Typical over- and understory conditions at 180 Kanata Avenue property (looking northeastward)

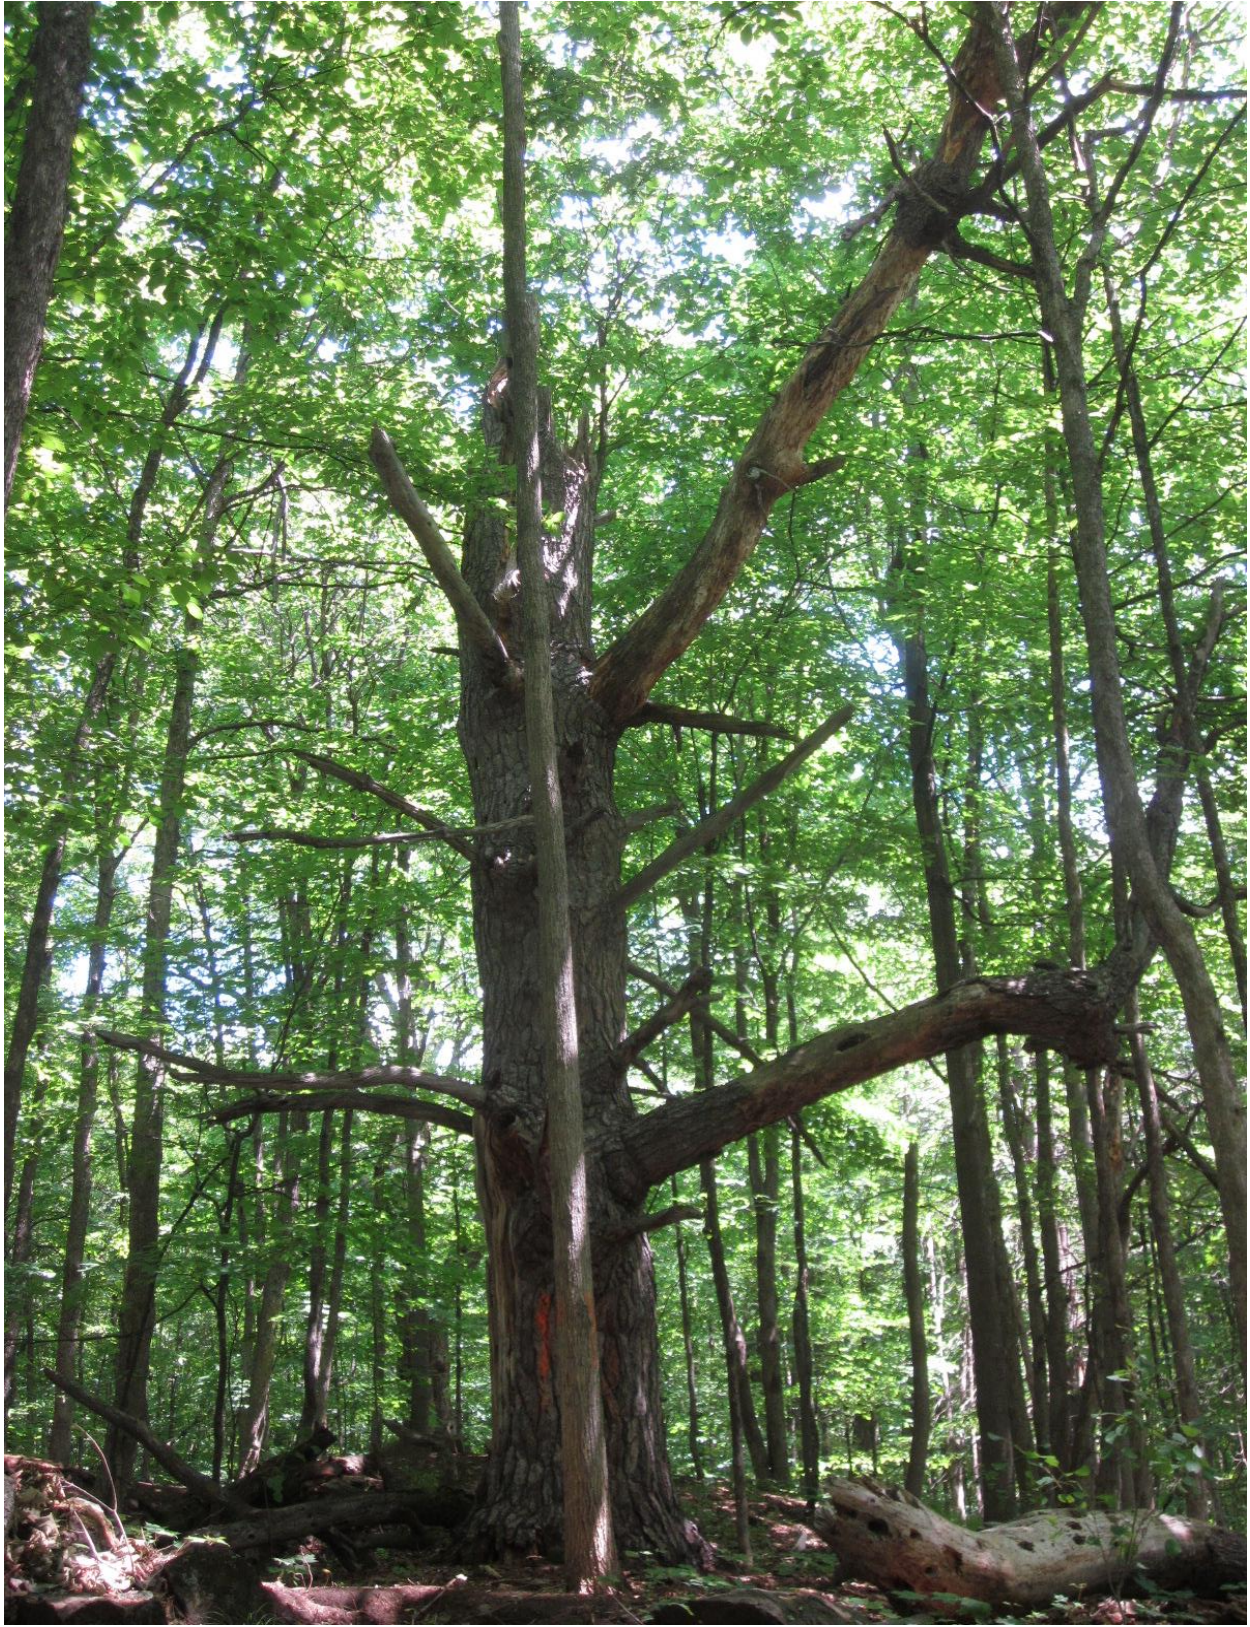
Picture 5. Standing dead veteran white pine tree at 180 Kanata Avenue property (notice closed canopy above broken stem).

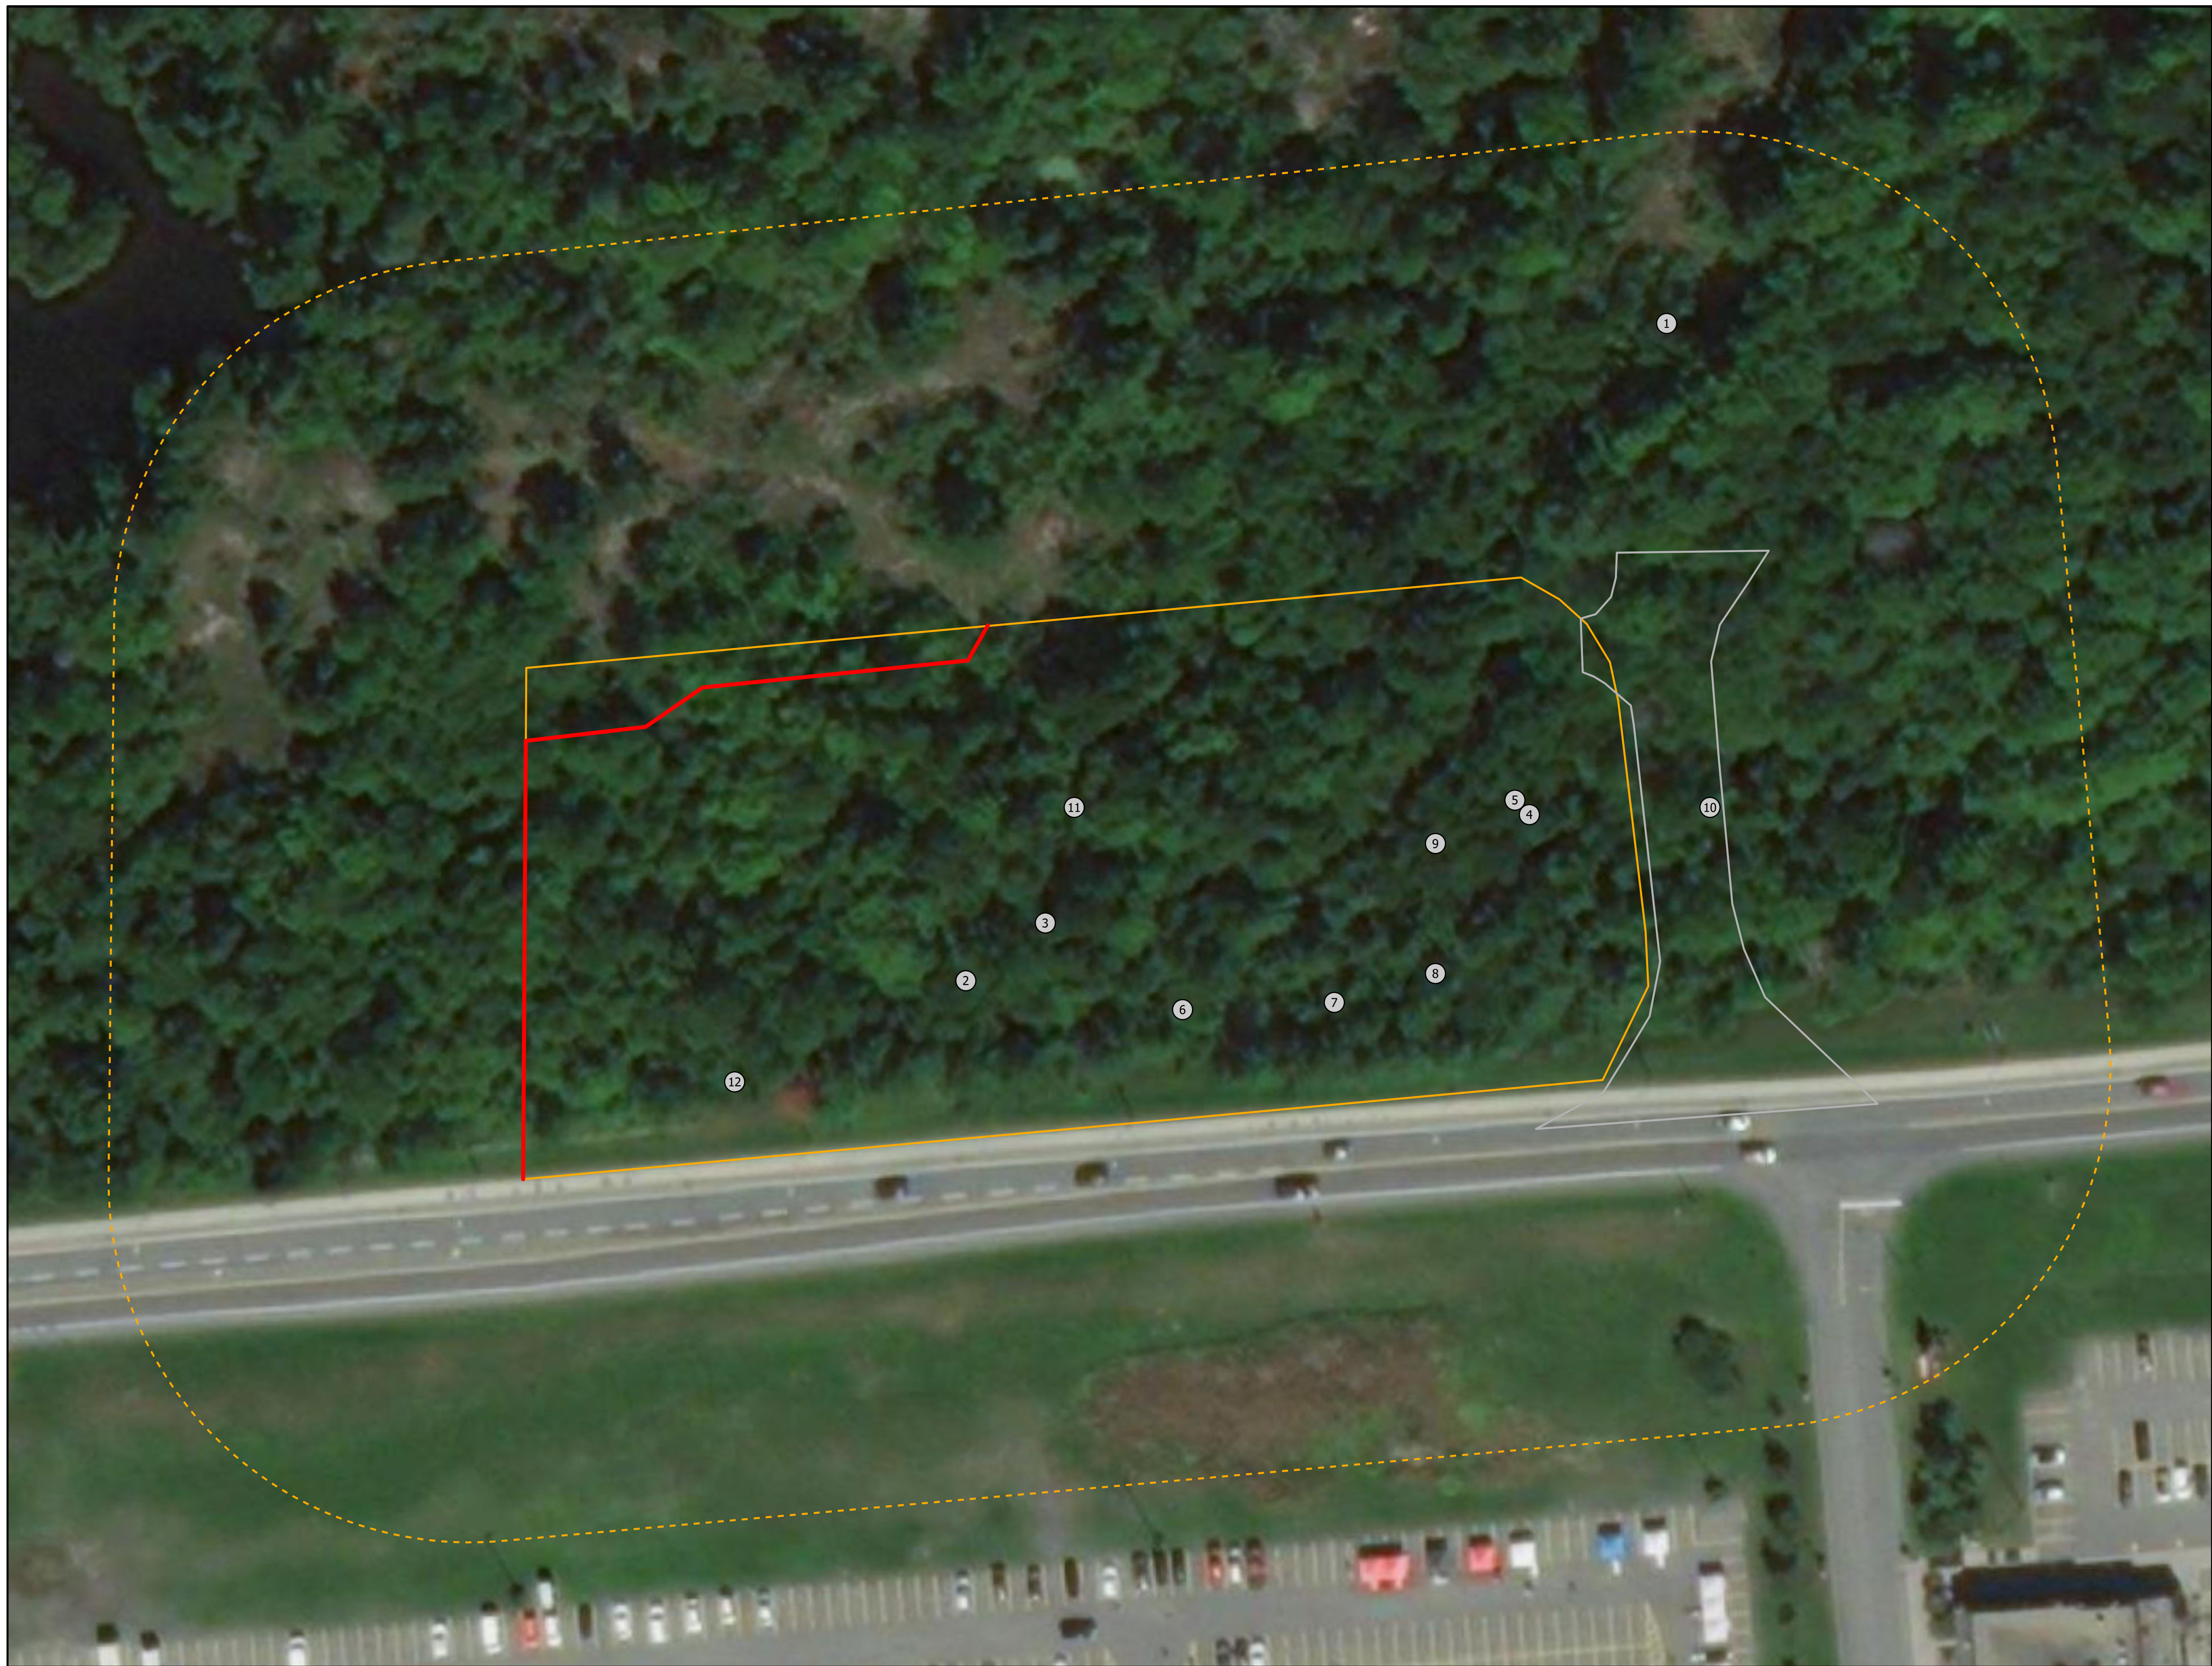
DRAWING: Locations of Butternut

A total of twelve butternuts (*Juglans cinerea*) were found on or within 50m of the subject property (see plan on page 15). This tree species is listed as endangered under the Province of Ontario’s Endangered Species Act (2007) and so is protected from harm. Through the completion of a butternut health assessment all twelve trees were determined to be Category 1 (*i.e.* non-retainable). This assessment was sent to the Ontario Ministry of Environment, Conservation and Parks in June 2021.

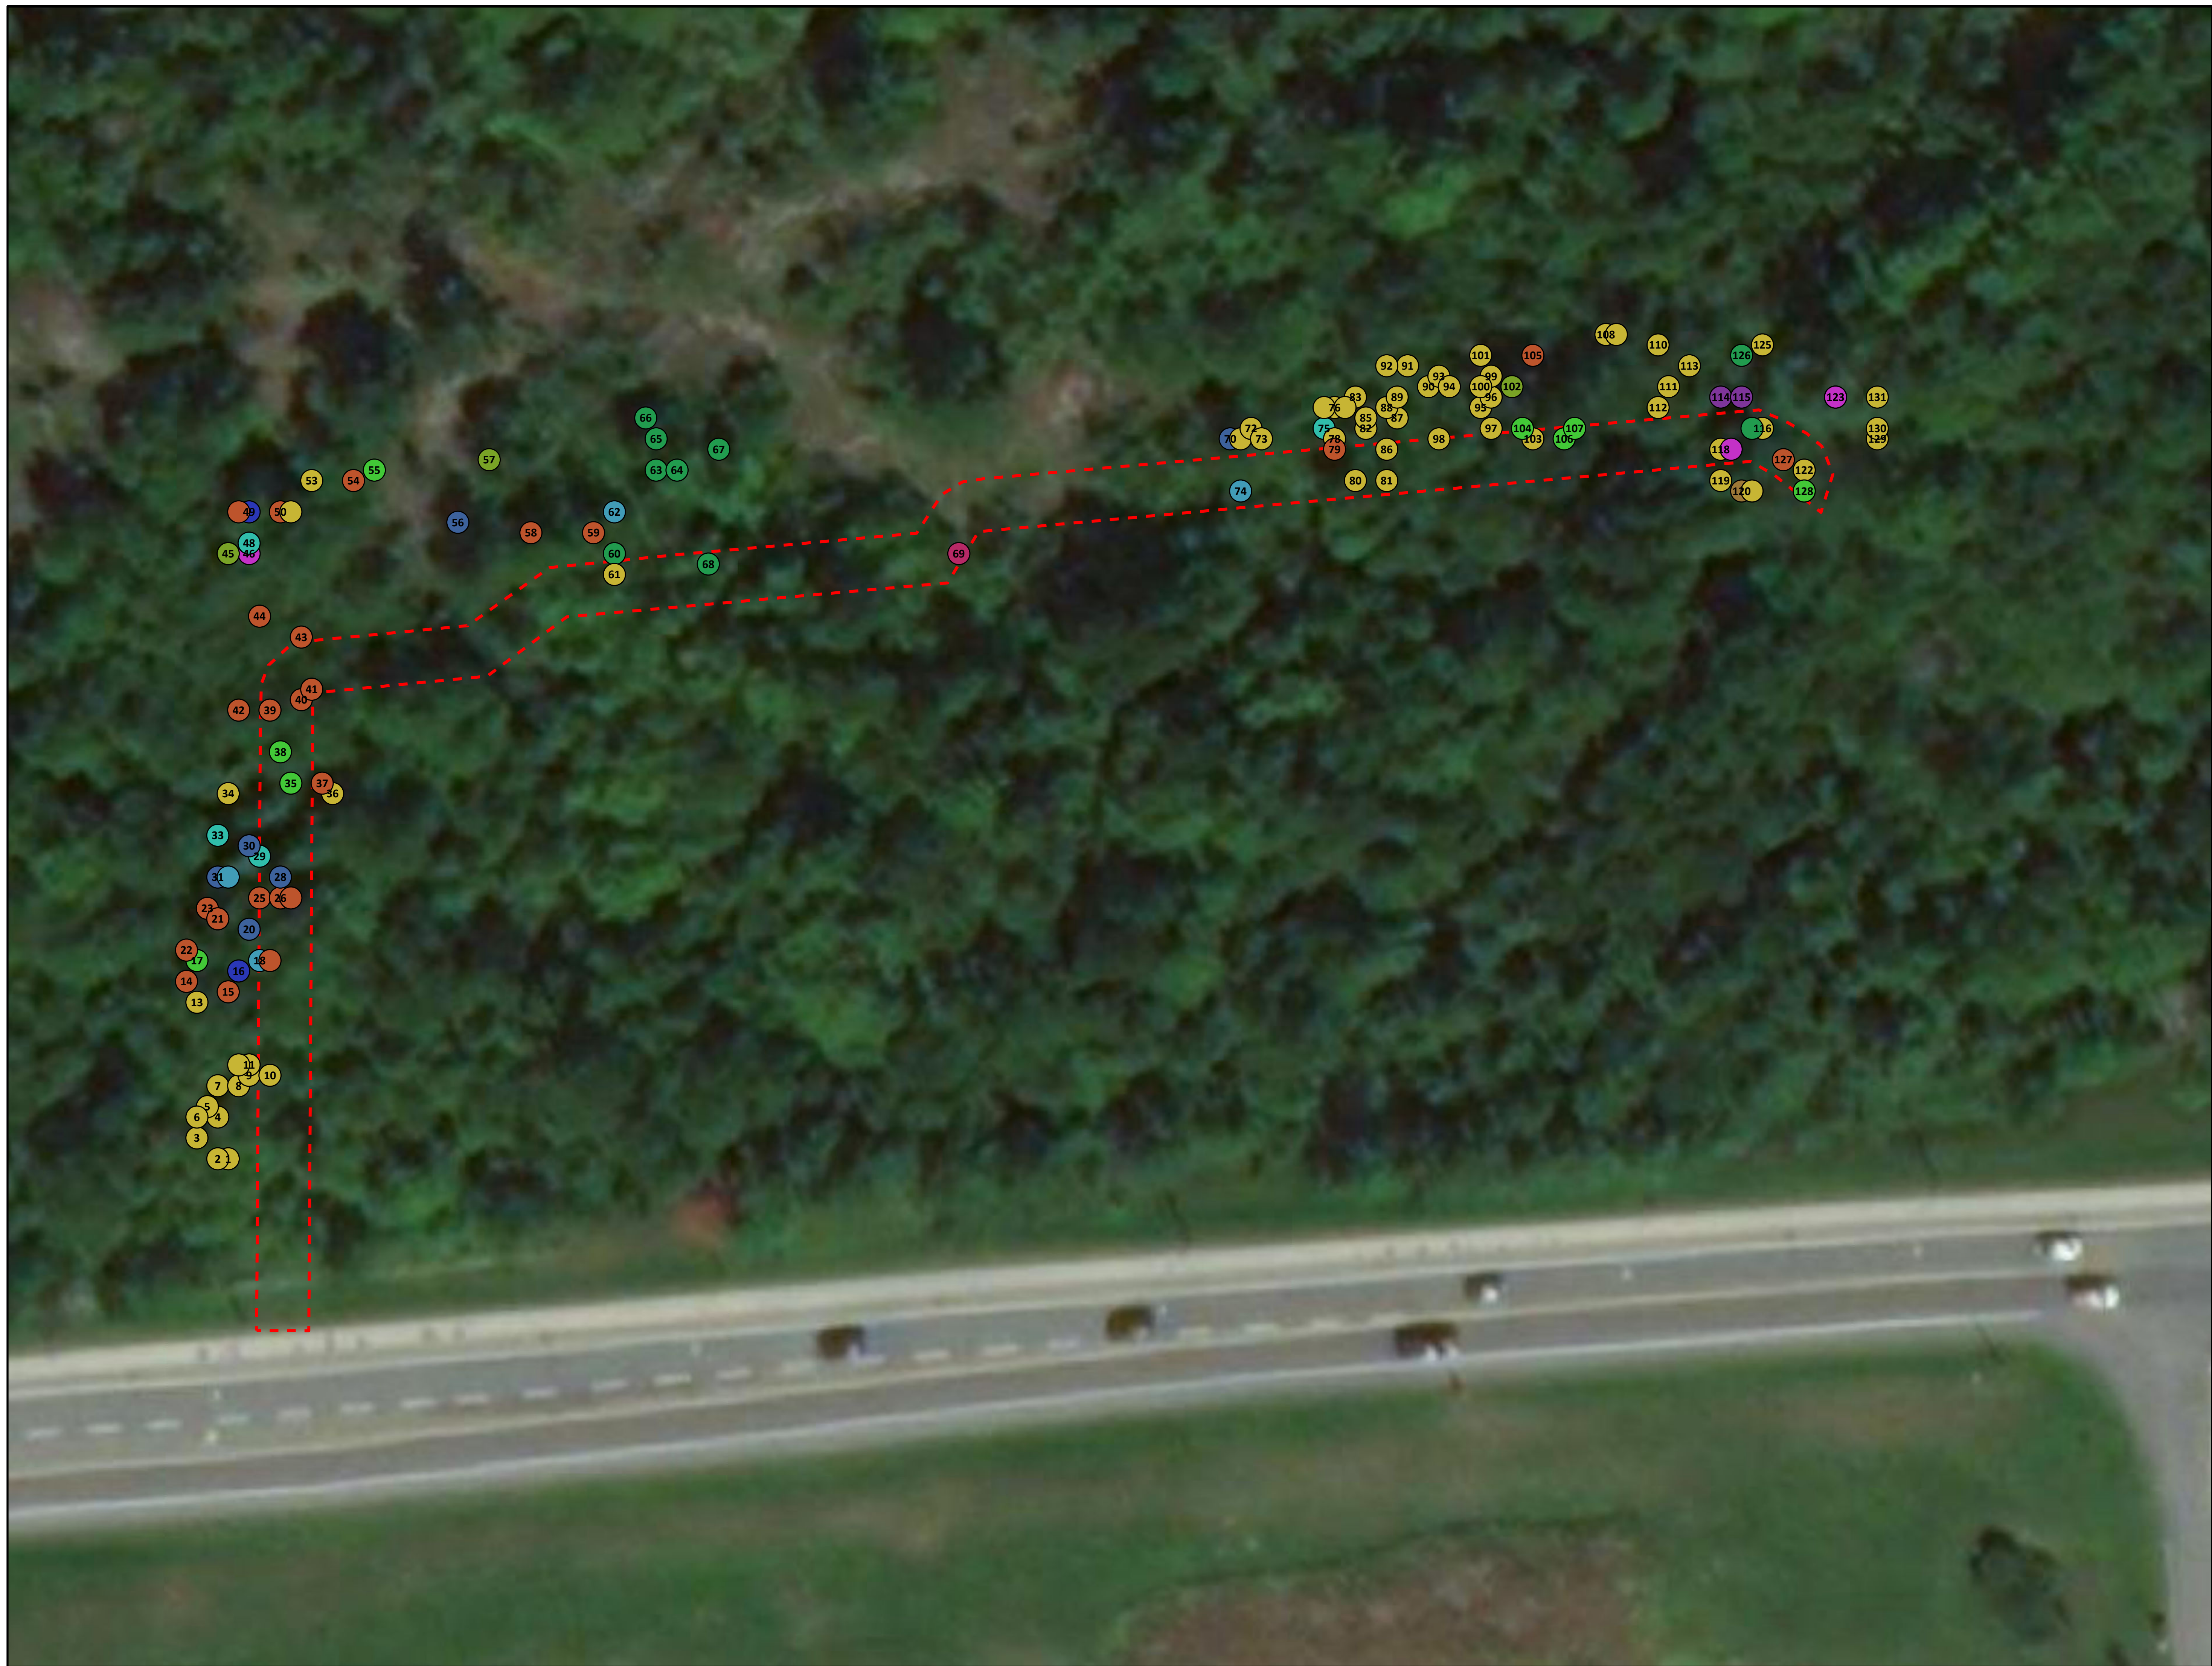
DRAWING:
Distinctive Trees on or
Near City Lands

Blasting will be necessary to remove bedrock as grades are dropped throughout the site. If not done carefully this work will have far-reaching consequences for retained trees as their root-soil interfaces will likely be disturbed by vibrations travelling through the substrate. It is these intimate interfaces which allow for the absorption of moisture and nutrients from the soil. To this end a survey of trees on City property within the vicinity of the shared western and northern property lines was undertaken. All trees 10cm and greater in diameter were located (via GPS) and assessed for health (poor/fair/good). A total of 132 such trees were found. Table 3 below details the findings of the survey and the aerial plan on page 16 shows locations and species of trees surveyed on City property.
