## Phase I - Environmental Site Assessment

770-774 Bronson Avenue  
Ottawa, Ontario

April 10, 2020

Report: PE4146-01

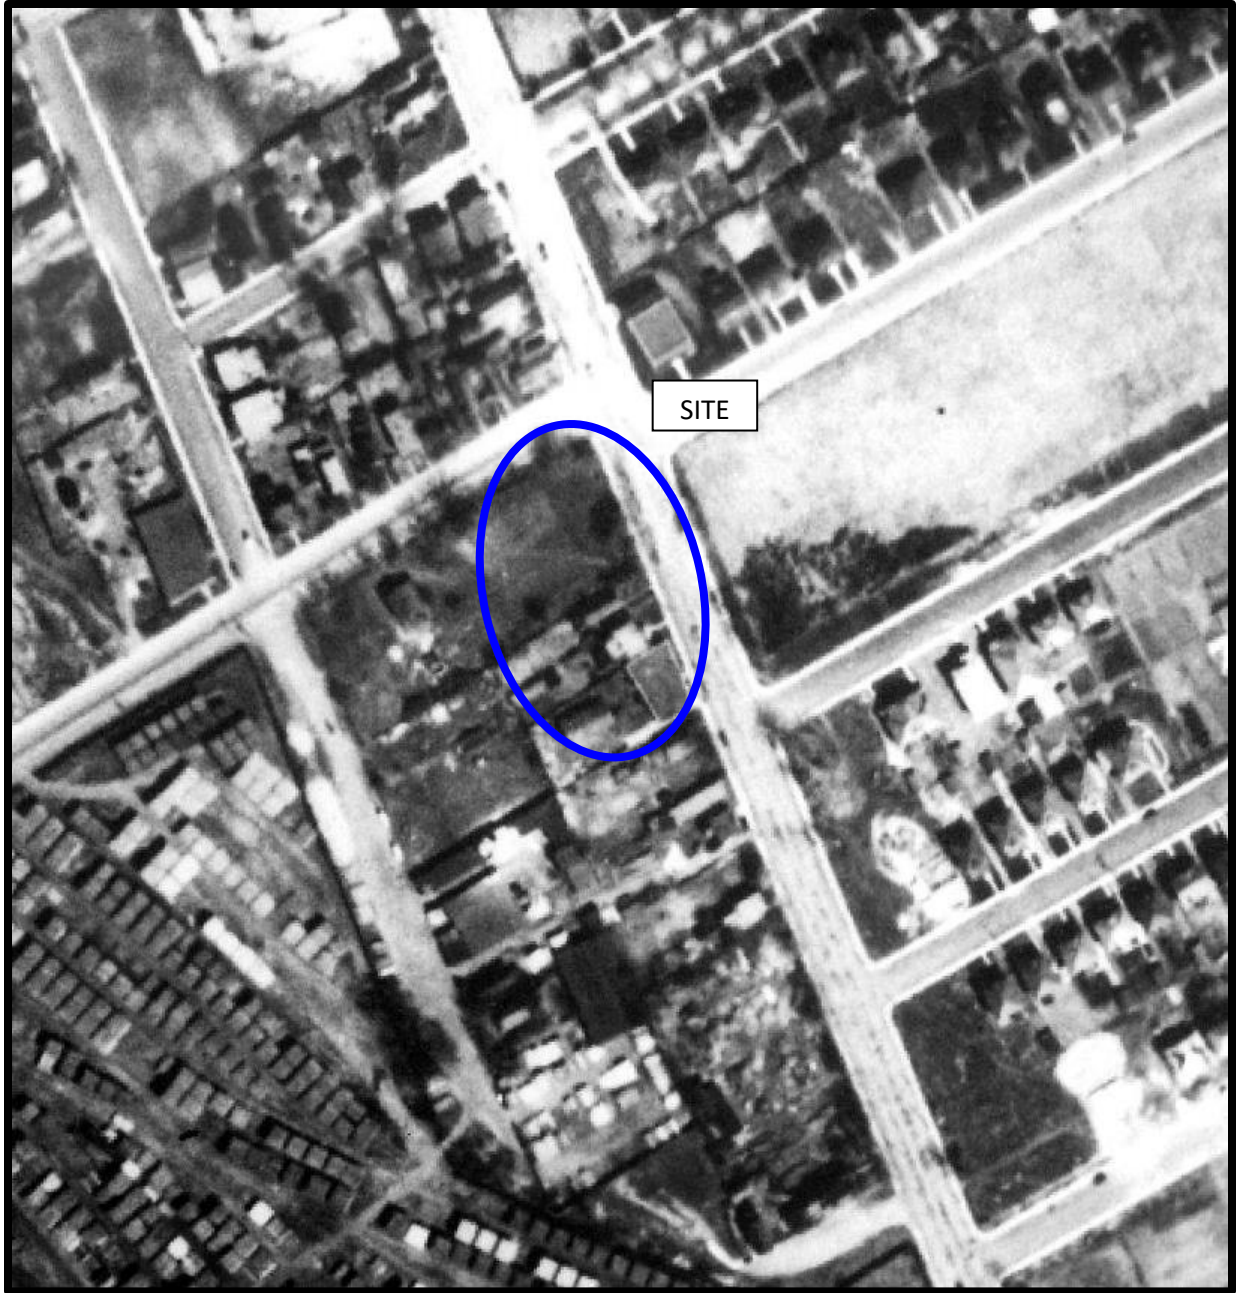
AERIAL PHOTOGRAPH  
1928

| 1928 | (City of Ottawa website) The property at 770 Bronson Avenue is vacant at this time. The property at 774 Bronson Avenue appears to be occupied by residential properties at this time. The neighbouring properties appear to be used for residential purposes at this time with the exception of the vacant property to the east of the site. Bronson Avenue and Carling Avenue can be seen in this photo. |

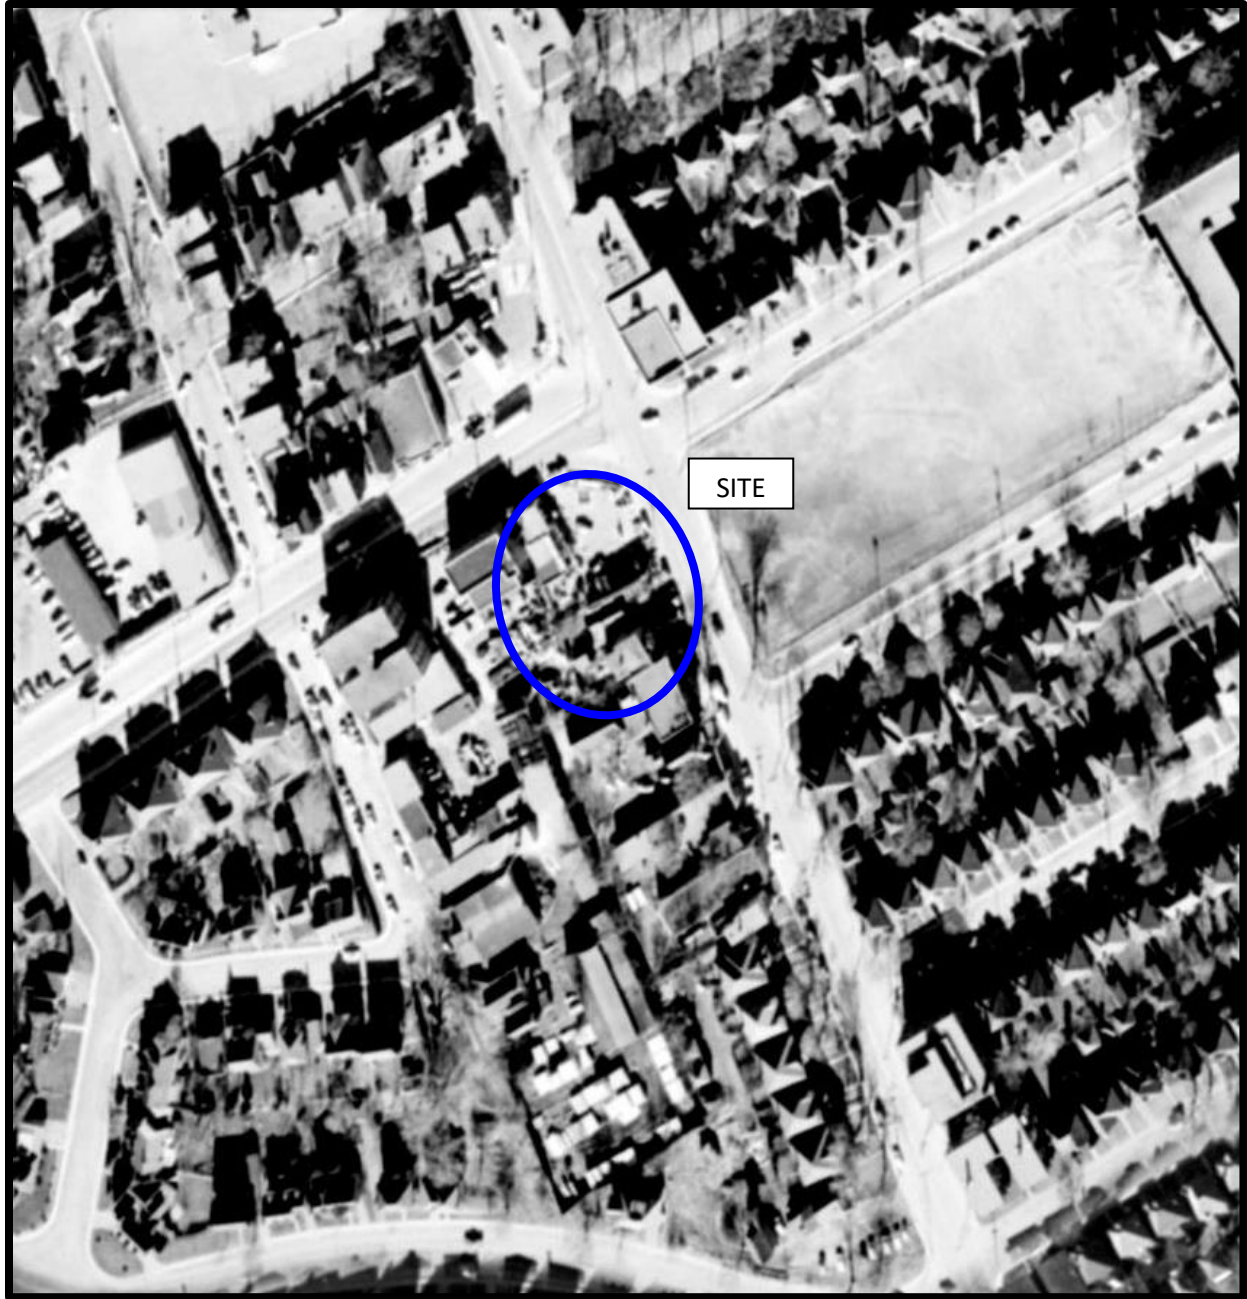
AERIAL PHOTOGRAPH  
1956

| 1956 | (City of Ottawa website) 770 Bronson Avenue is occupied by is occupied by a retail fuel outlet, while 774 Bronson Avenue is occupied by a commercial building at this time. The neighbouring properties to the north, south and west are occupied by commercial buildings at this time. An athletic field can be seen on the neighbouring property to the east at this time. |

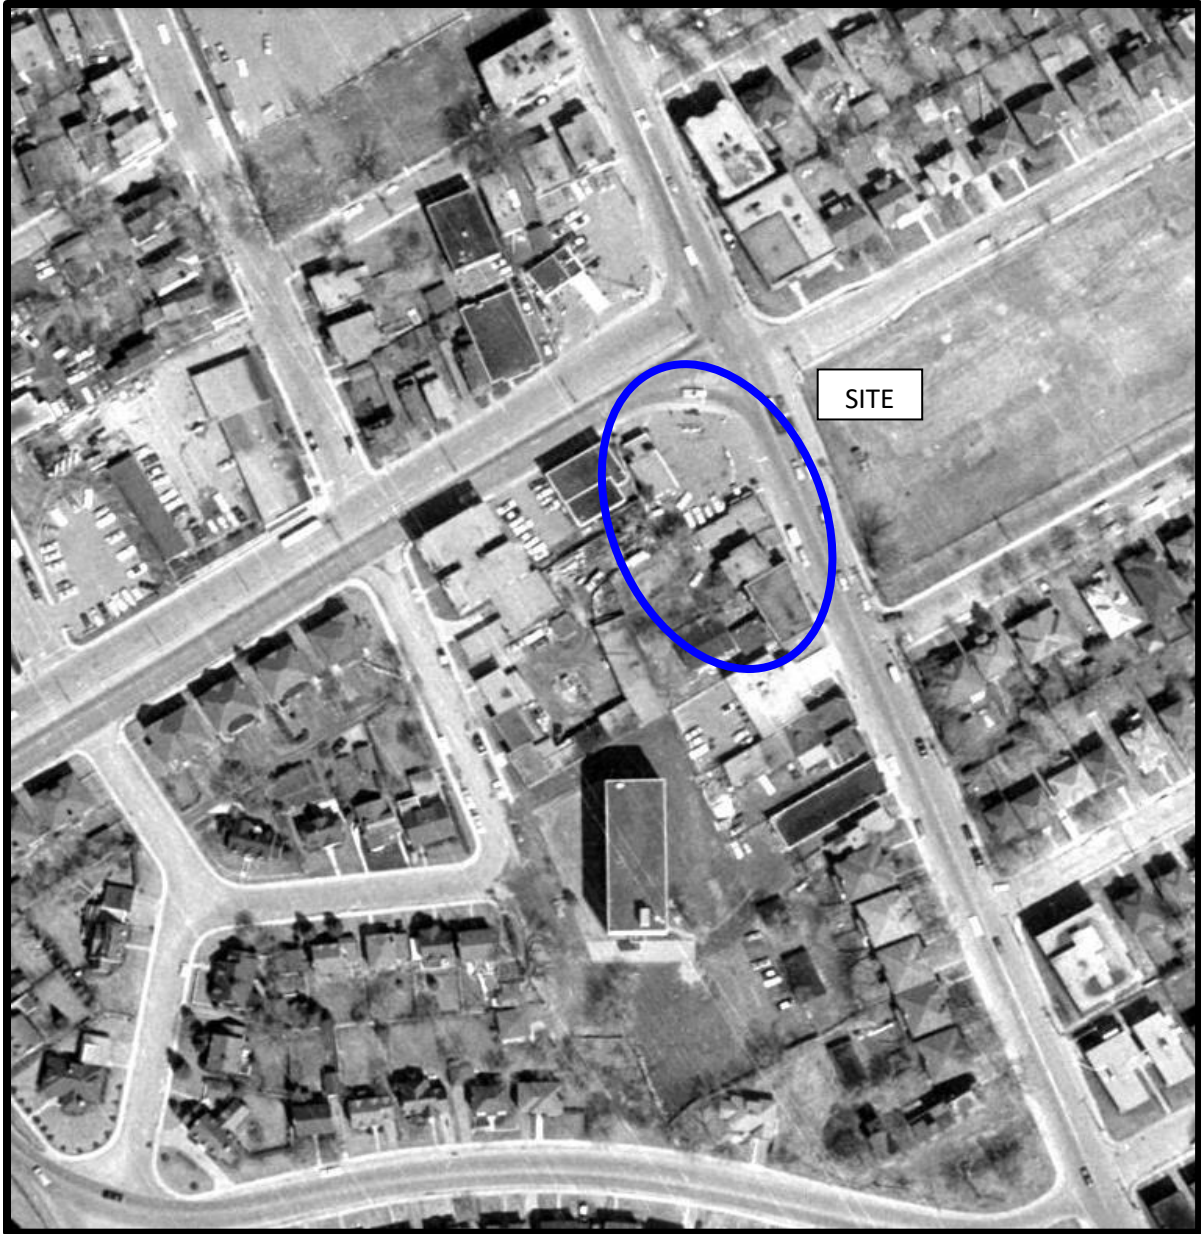
AERIAL PHOTOGRAPH  
1965

| 1965 | (City of Ottawa website) No significant changes can be seen on the subject or neighbouring properties since the previous photo. Additional commercial development can be seen in the general area of the subject site. |

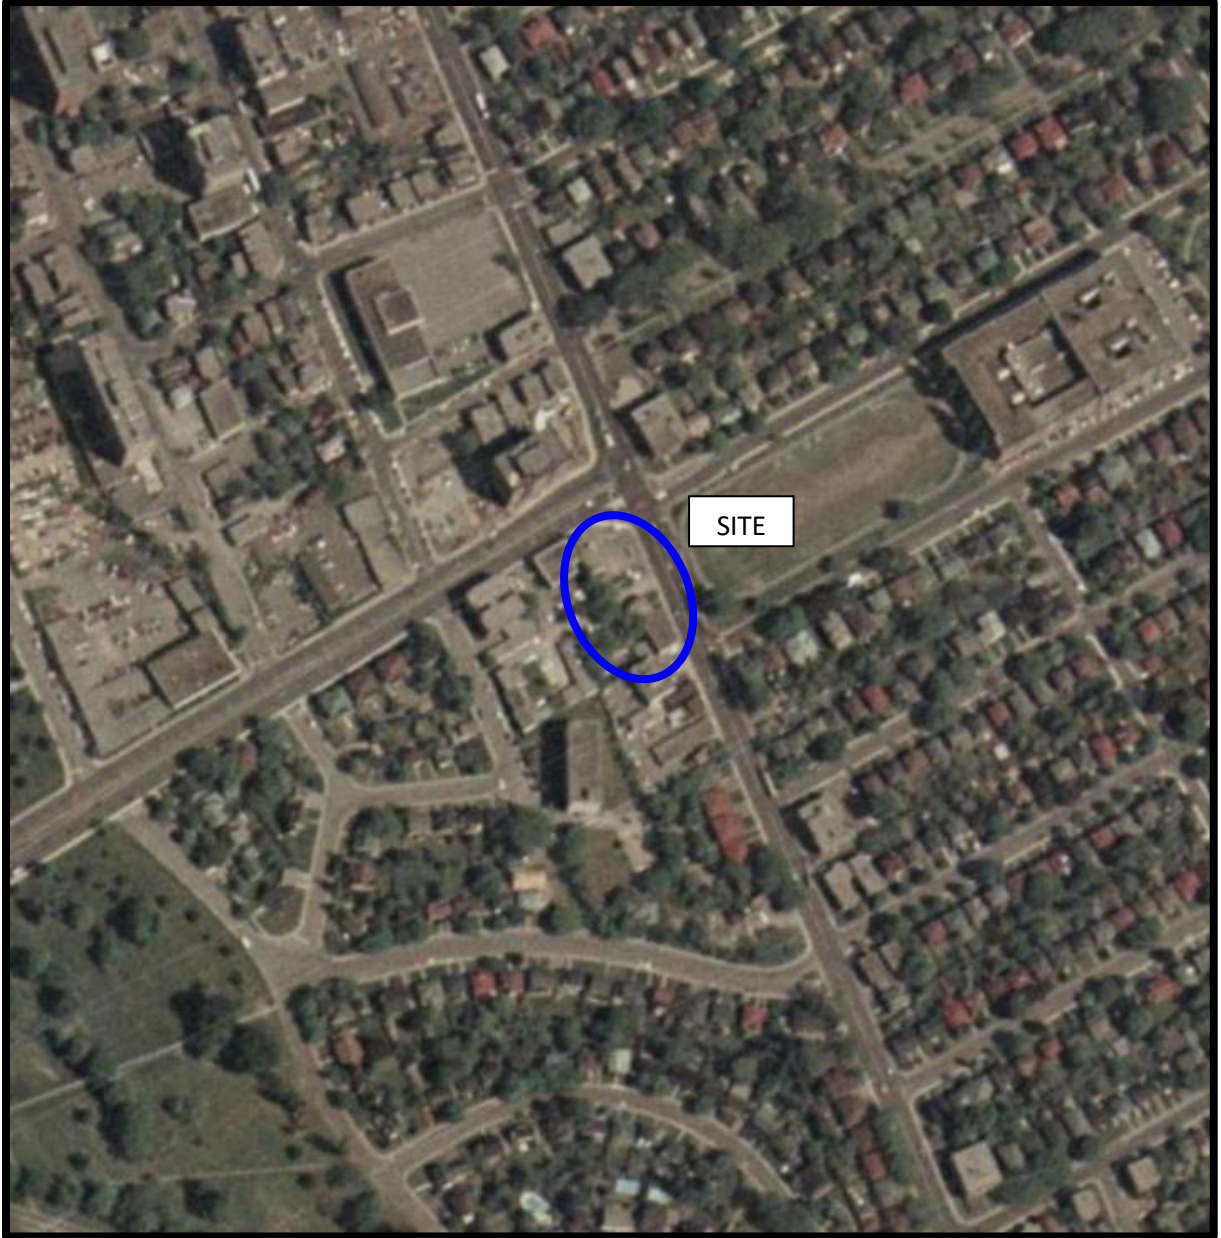
AERIAL PHOTOGRAPH  
1976

| 1976 | (City of Ottawa website) No significant changes can be seen on the subject or neighbouring properties since the previous photo. |

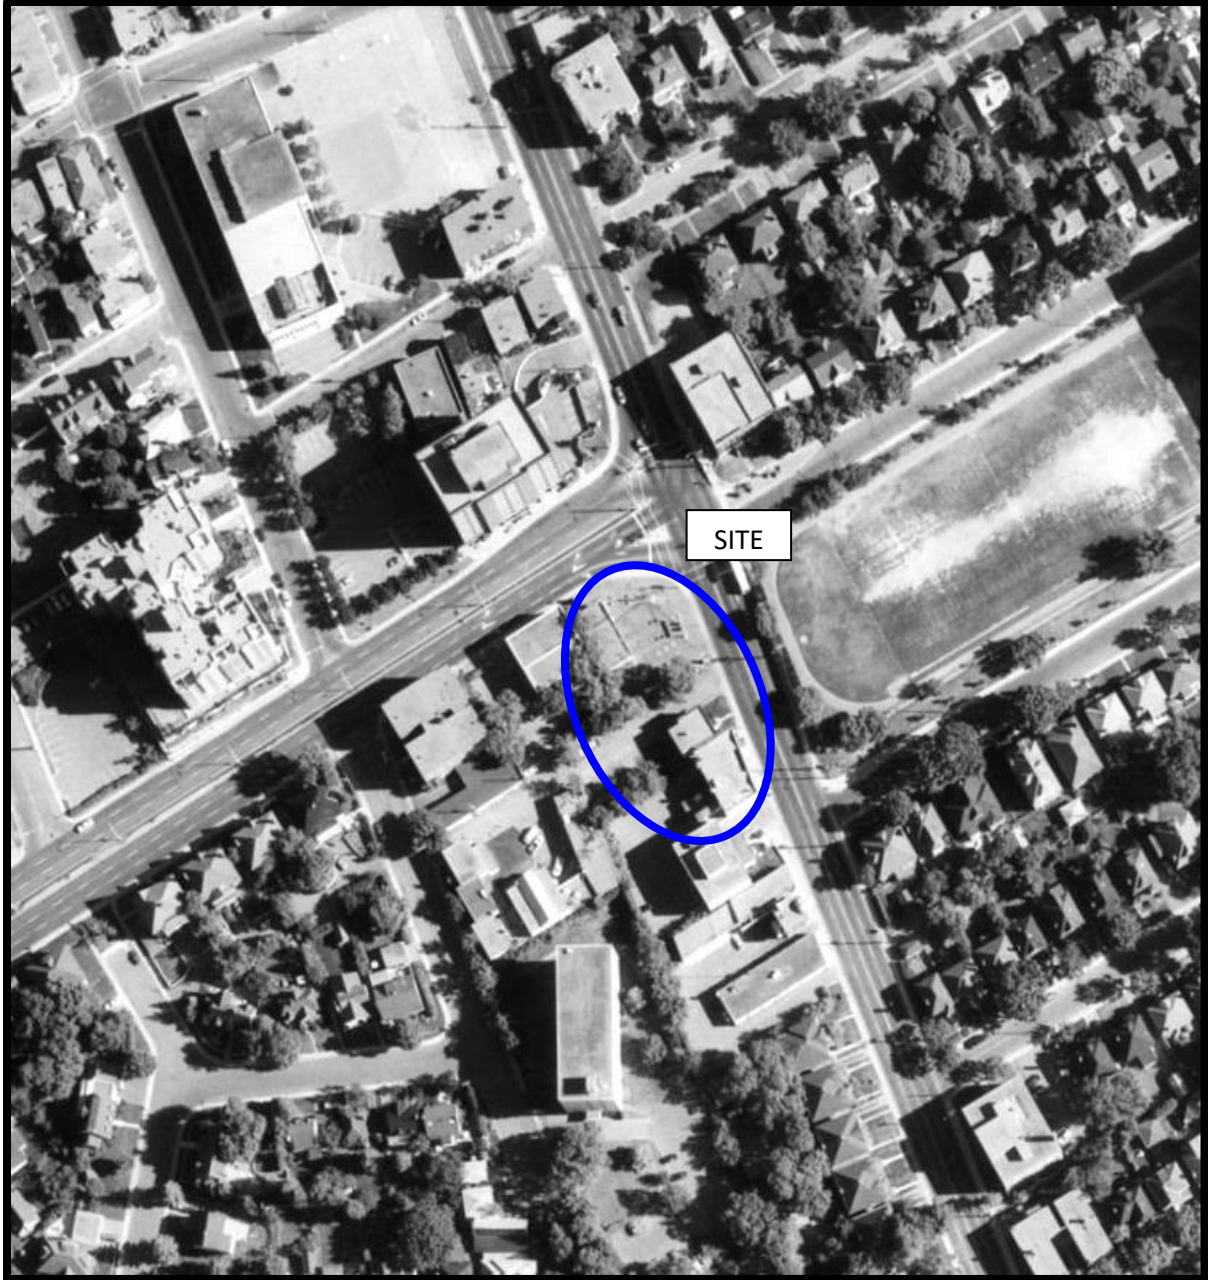
AERIAL PHOTOGRAPH  
1991

| 1991 | (City of Ottawa website) No significant changes can be seen on the subject or neighbouring properties since the previous photo. |

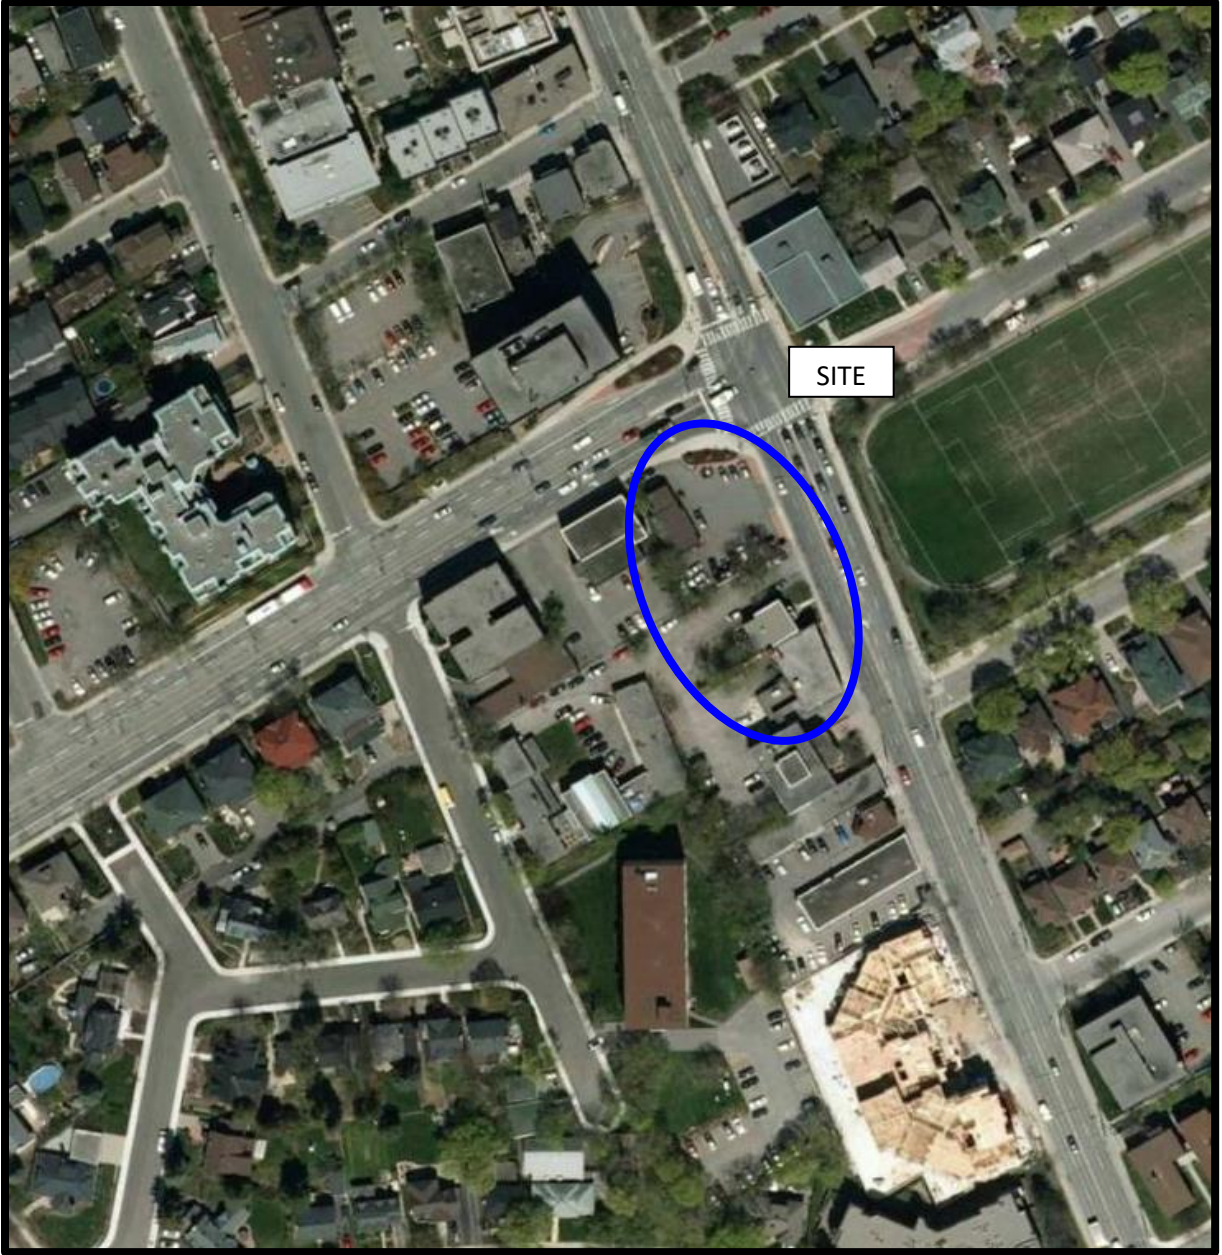
AERIAL PHOTOGRAPH  
2011

| 2011 | (City of Ottawa website) No significant changes can be seen on the subject or neighbouring properties since the previous photo. |

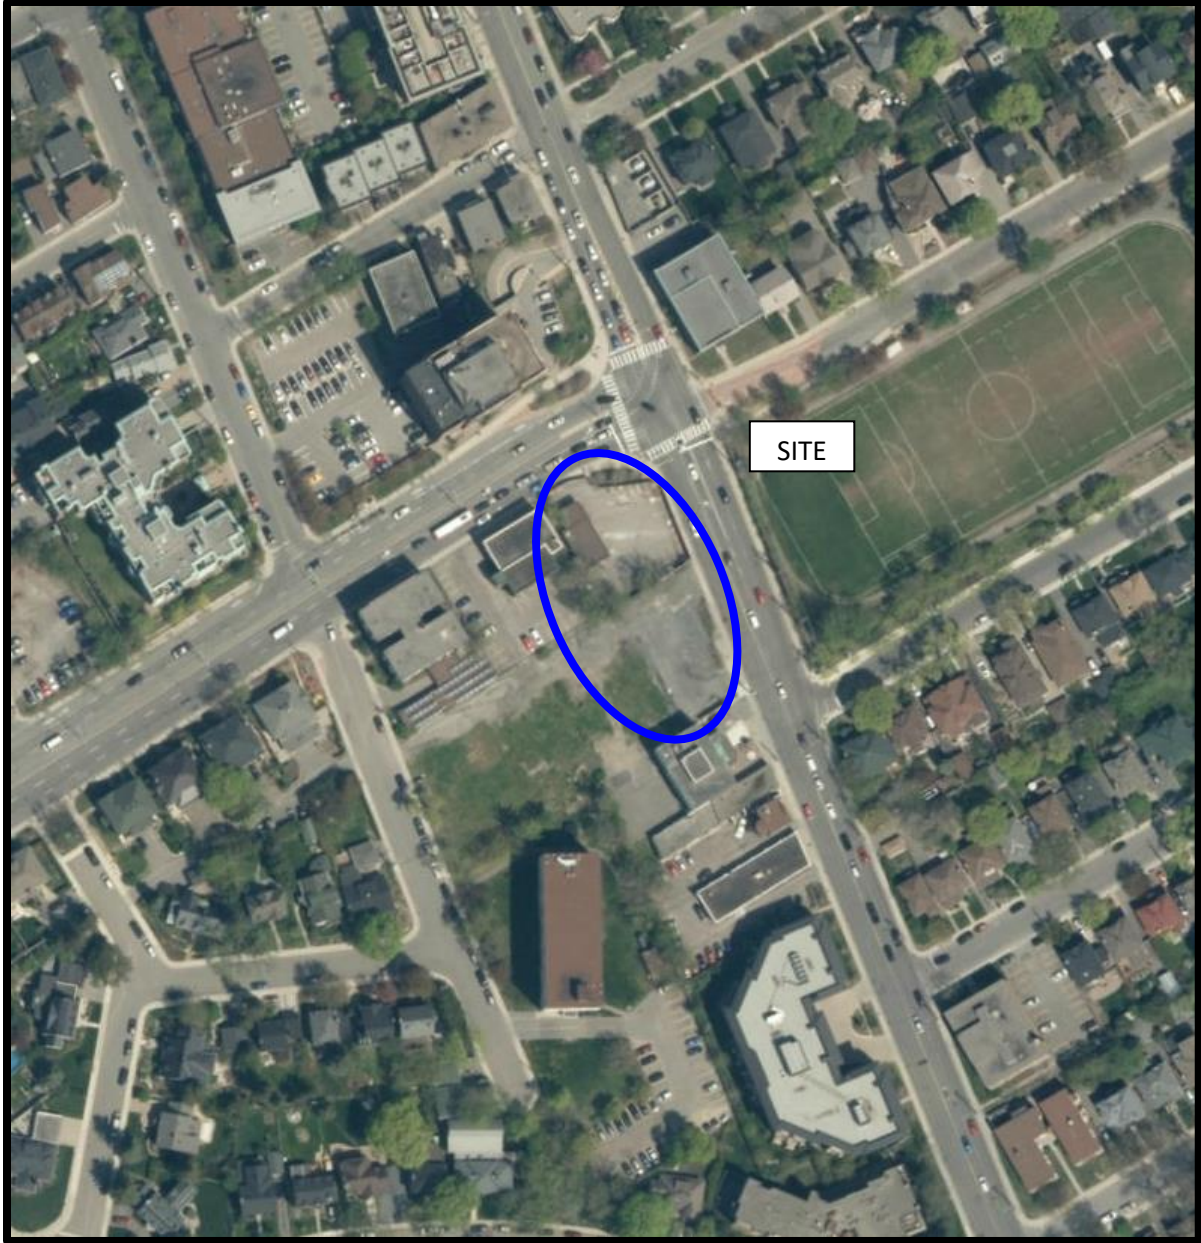
AERIAL PHOTOGRAPH  
2017

| 2017 | (City of Ottawa website) No significant changes can be seen on the subject or neighbouring properties since the previous photo. |
