July 23, 2019

File: 64153.85 – R01

**Re: Slope Stability Assessment and Meander Belt Setback
Proposed Residential Subdivision
1055 Klondike Road
Ottawa, Ontario**

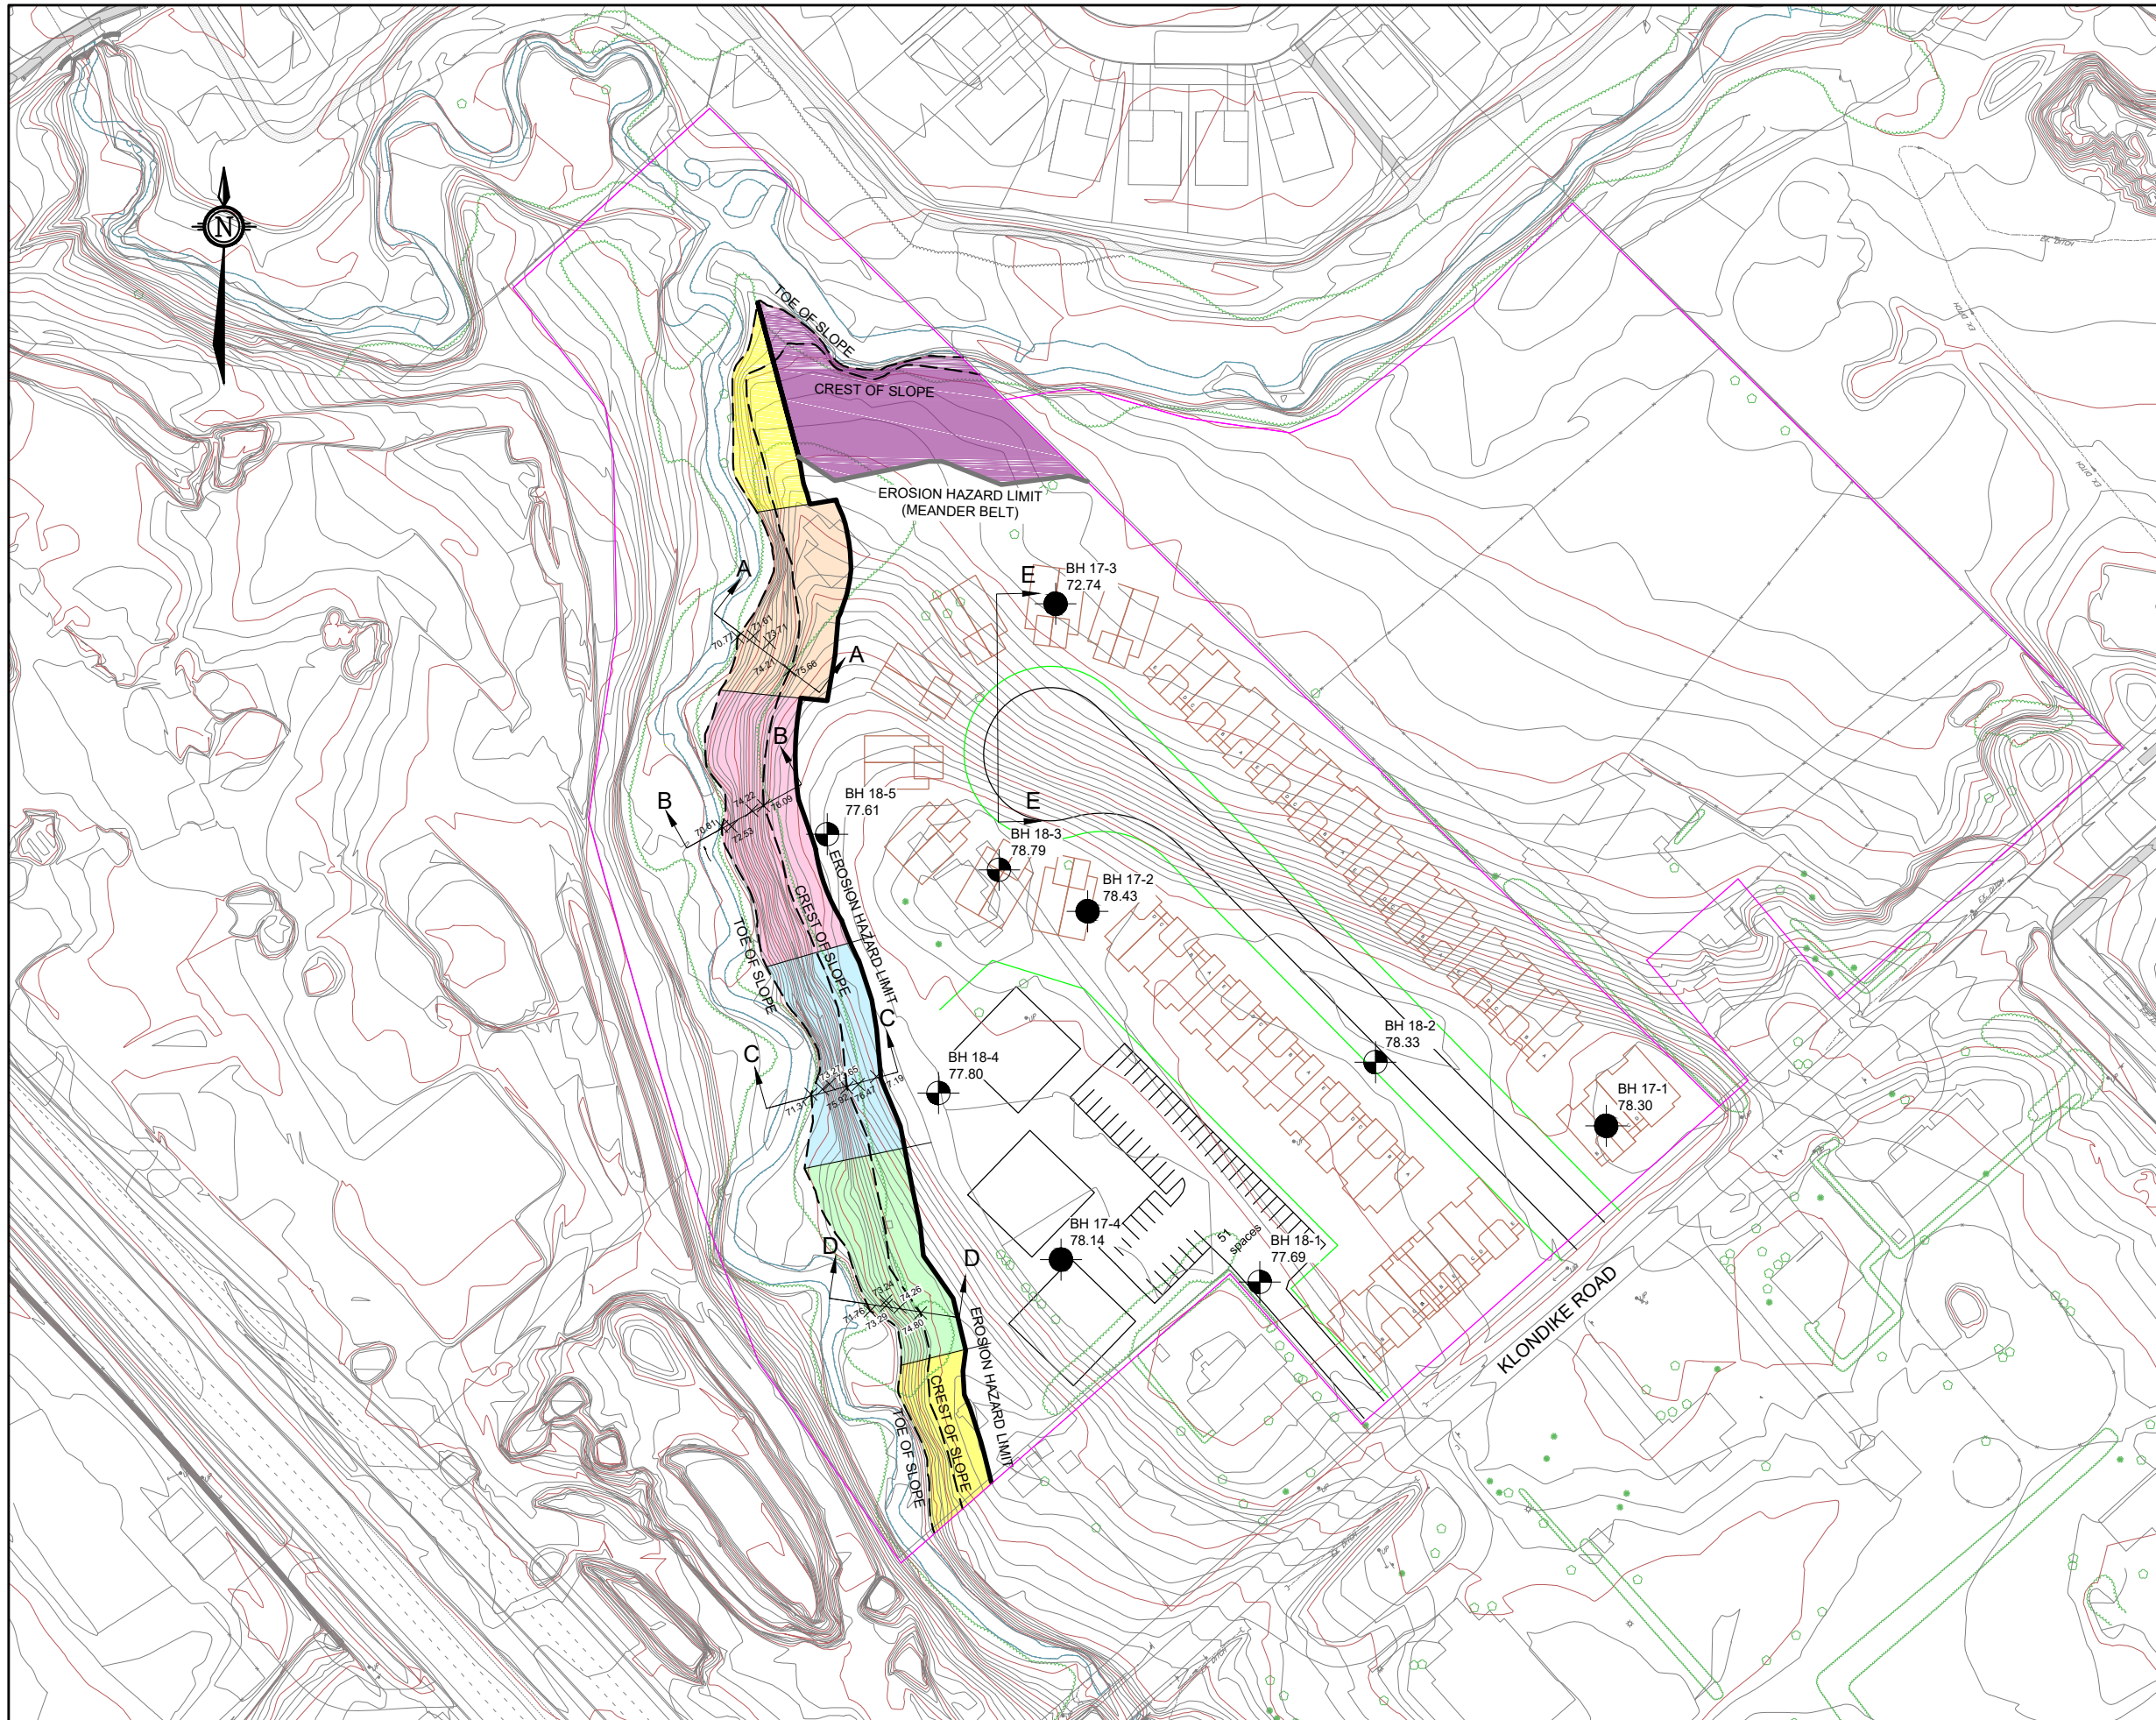
Client	NOVATECH	Project	64153.85
Location	1055 KLONDIKE ROAD OTTAWA, ONTARIO		
Drwn by	Chkd by	EROSION HAZARD LIMIT PLAN	
P.C.	G.D.		
Date	JULY 2019	Rev.	2
			FIGURE 1

Based on the results of the slope stability analyses, the extent of the Hazard Lands, as defined by the MNR, is summarized in Table 3 and shown on Figure 1.

Based on the above information, we have included a 27.5 metre setback (half of the belt width) on the attached Figure 1 for the portion of the site where the MVCA indicated that the creek is unconfined. Also, as indicated above, we have carried out a slope stability assessment for the slope across the central portion of the site in the event that the creek migrates to the boundary of the meander belt width. The results of this assessment indicate that there are no concerns with the stability of the slope in this area (factor of safety of 4.2).

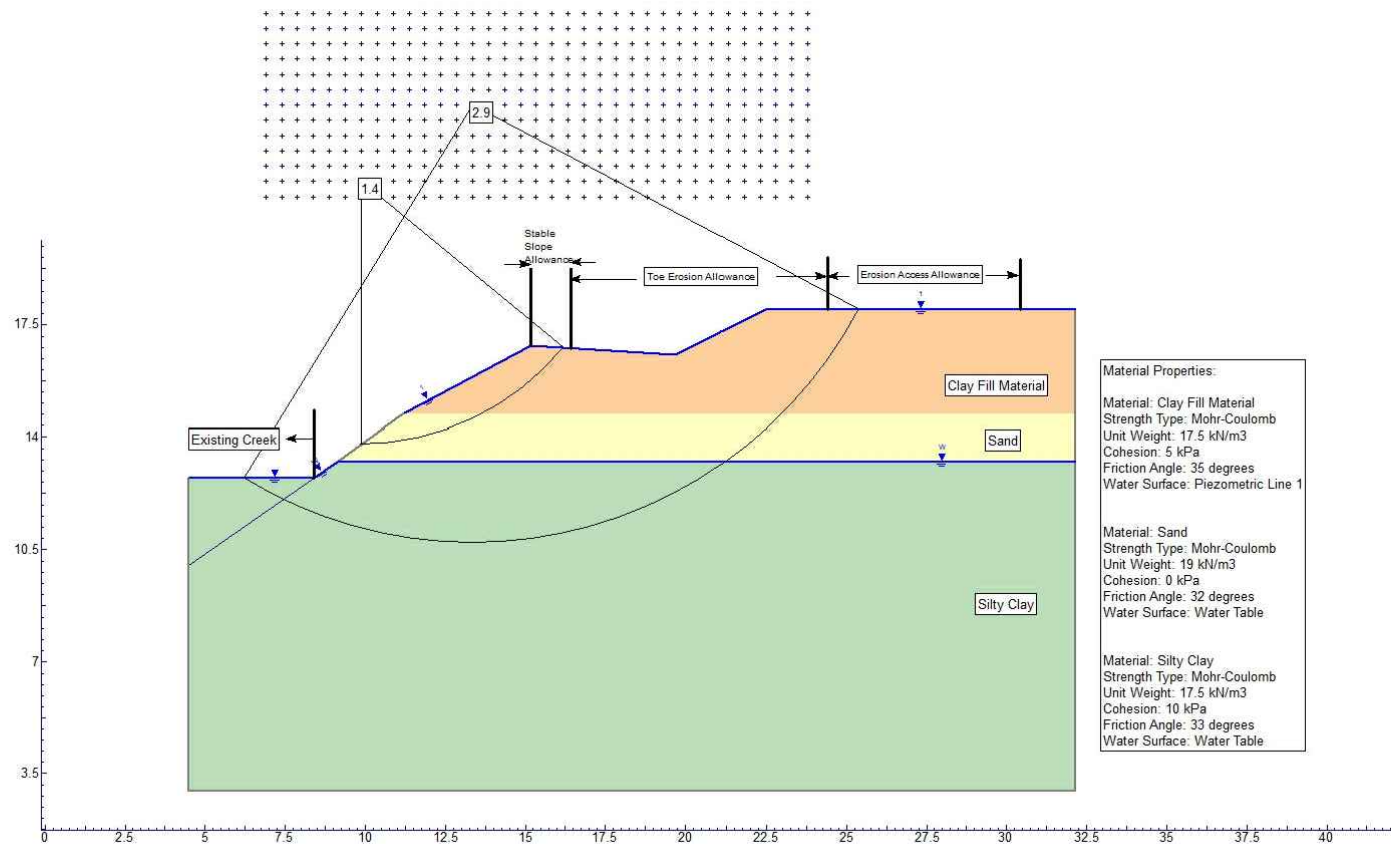
Based on the results of the analyses, the existing slopes at Sections 'B-B', 'C-C', 'D-D' and 'E-E', in their current configurations, are considered to be stable. At Section 'A-A', the calculated factor of safety against slope instability is 1.4, which is considered marginal to adequate.
