# TREE CONSERVATION REPORT

1058-1066 Silver Street  
and 1291-1305 Summerville Avenue

January 24, 2024

## Tree Conservation Report v2.0

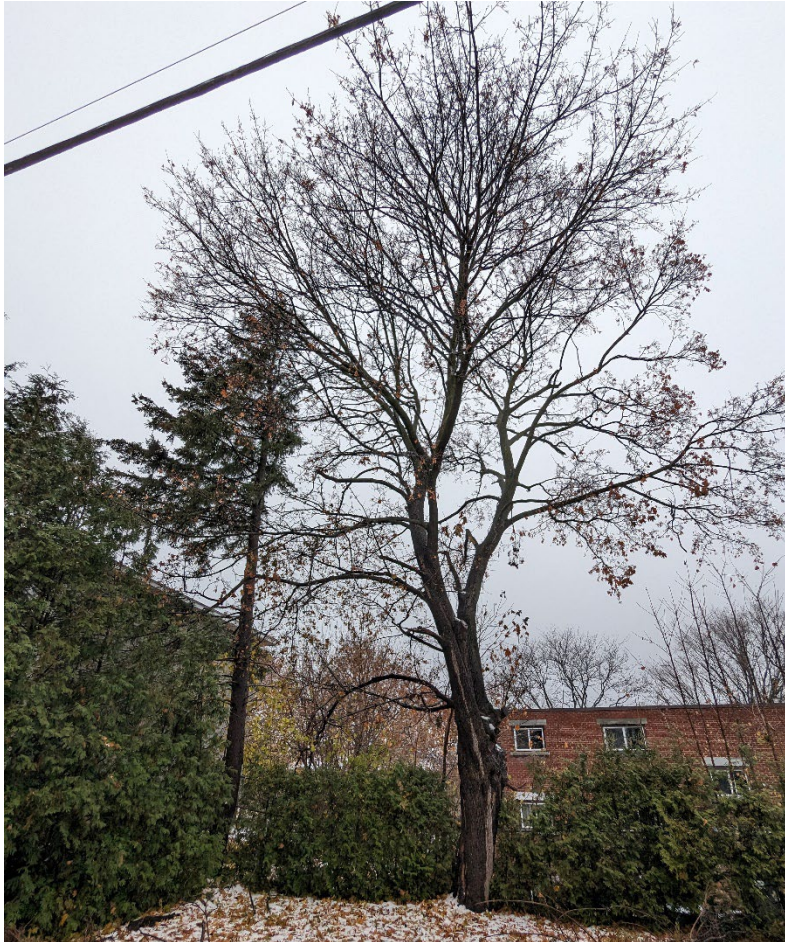
Tree <sup>1</sup>	Species	DBH (cm)	Ownership <sup>2</sup>	Tree Condition	Action	Forester recommendation
1	Norway maple ( <i>Acer platanoides</i> )	60	Private - 1058	Fair/Poor: multiple mechanical wounds on trunk; main union with poor form – included bark; large pruning wounds	Remove	Remove due to proximity of excavation and health condition.
2	White spruce ( <i>Picea glauca</i> )	36	Private - 1058	Fair: asymmetrical crown due to shading from Tree 1; slight lean W	Remove	Remove due to grade changes and impacts from construction.
3	Norway maple ( <i>Acer platanoides</i> )	47	Private - 1062	Fair/Poor: large branch attachment wound; asymmetrical crown	Remove	Remove due to proximity of excavation and health condition.
4	Norway maple ( <i>Acer platanoides</i> )	43	Private – 1062	Fair: asymmetrical crown; lean to S (approx. 10°)	Remove	Remove due to proximity of excavation and health condition.
5	Norway maple ( <i>Acer platanoides</i> )	18	Private – 1062	Poor: suppressed	Remove	Remove due to proximity of excavation and health condition.

Above: Tree 1 (right) - Private maple to be removed and Tree 2 (left) - private spruce to be removed. Below: main union of Tree 1

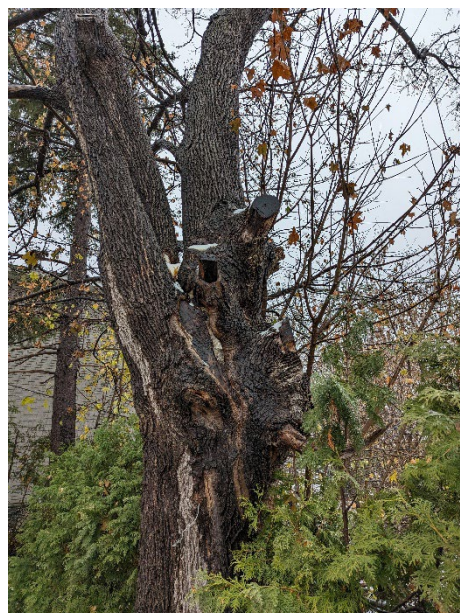
Above right: Canopies of Trees 3-5 - private maples to be removed.

Below right: trunk and pruned branches of Tree 4

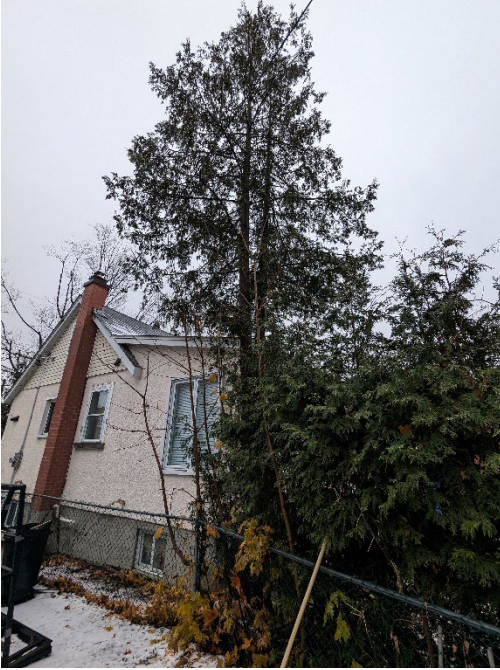
6	Eastern white cedar ( <i>Thuja occidentalis</i> )	25	Private – 1062	Fair: codominant leaders	Remove	Remove: within footprint of proposed building.
7 <sup>4</sup>	Norway maple ( <i>Acer platanoides</i> )	12	Boundary – 1058 and 1280 Silver	Poor: growing on fence – current growth is sprout from cut base	Remove	Remove due to health condition.
8	Sugar maple ( <i>Acer saccharum</i> )	59	City	Fair: pruned around wires; two leaders are dead	Remove	Remove due to grade changes and impacts from construction.
9	Norway maple ( <i>Acer platanoides</i> )	49	City	Fair/Poor: three large seams on trunk; girdling roots probable; asymmetrical crown due to pruning around wires	Remove	Remove due to grade changes and impacts from construction.
10	Cherry ( <i>Prunus spp.</i> )	7, 8, 11, 14	Joint – City and 1066	Poor/Fair: fungal bodies present 1m from ground; pruning wounds with decay beginning	Remove	Remove due to grade changes and impacts from construction.

Above: Tree 6 - private cedar to be removed.

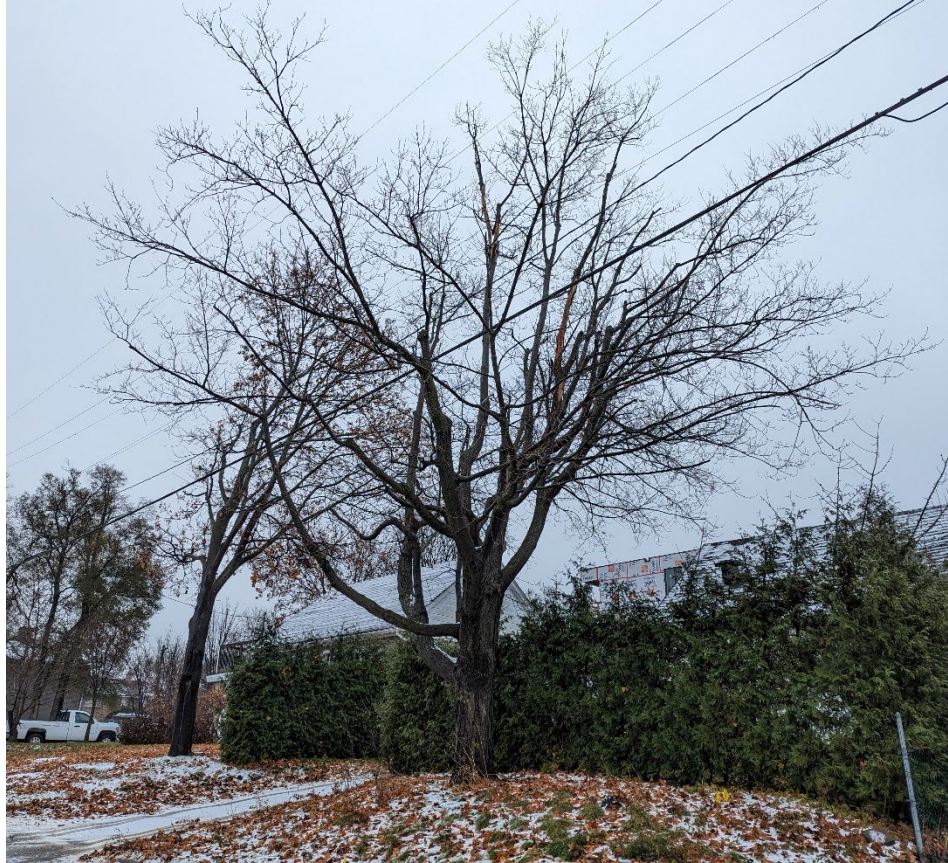
Above: Tree 9 (left) and Tree 8 (right) - City maples to be removed.

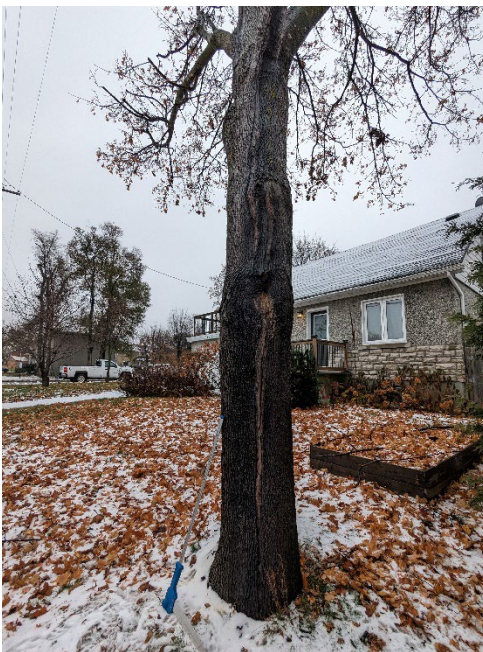
Left: Trunk of Tree 9.

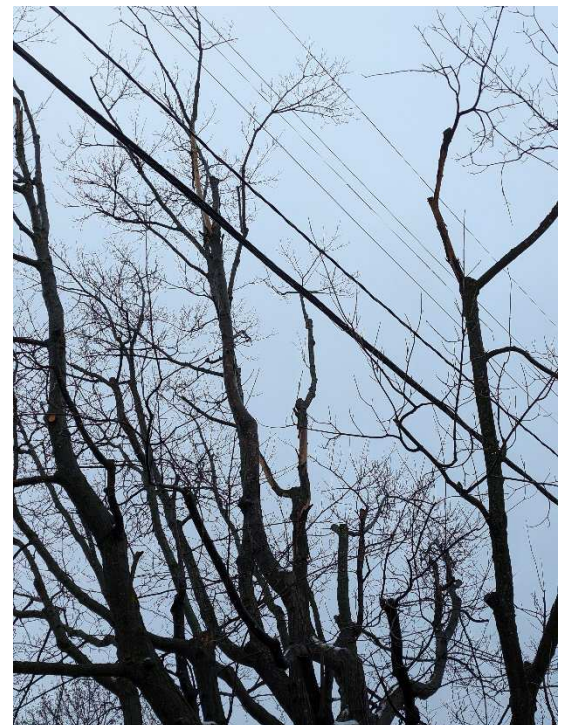
Right: Canopy of Tree 8 pruned around wires with some dead central branches.

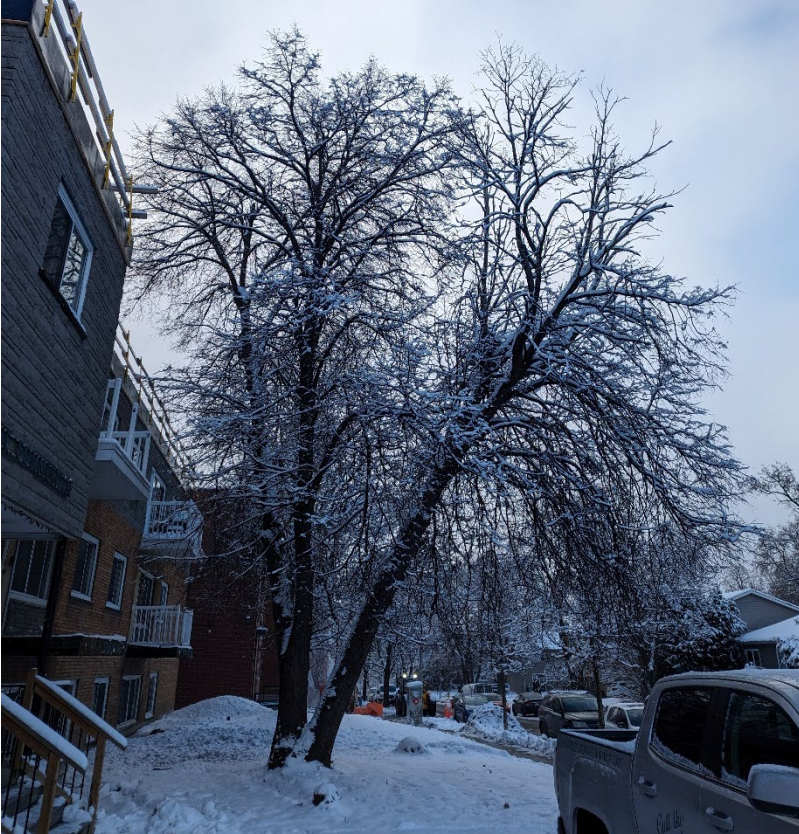
**Tree 18** has a large stem that is failing from the top. It is recommended this stem be removed as it is leaning towards the sidewalk and Summerville avenue.

18 <sup>4</sup>	Little leaf linden ( <i>Tilia cordata</i> )	44, 50	Private - 1305 Summerville	Fair: 44cm stem dying at top – leaning significantly towards road	Retain	Retain. Recommend removal of 44cm stem.
19 <sup>4</sup>	Red maple ( <i>Acer rubrum</i> )	20	Private – 1305 Summerville	Good: crown slightly asymmetrical	Retain	Retain and protect as per the City of Ottawa Tree Protection Specifications (March 2021)
20 <sup>4</sup>	Norway maple ( <i>Acer platanoides</i> )	64	Private – 1305 Summerville	Fair: large seams on two sides of trunk; minor decay in small wounds	Retain	Retain and protect as per the City of Ottawa Tree Protection Specifications (March 2021)
21 <sup>4</sup>	Manitoba maple ( <i>Acer negundo</i> )	21 stems 10-35cm	Boundary – 1291, 1295 Summerville and 1290 Dorchester	All stems poor: heavily pruned under hydro wires – most branching is epicormic shoots; many with significant leans	Remove	Remove due to impacts of expected retaining wall and parking refurbishment.

Above: Tree 20 - Private linden to be retained. Recommend removing the leaning stem.

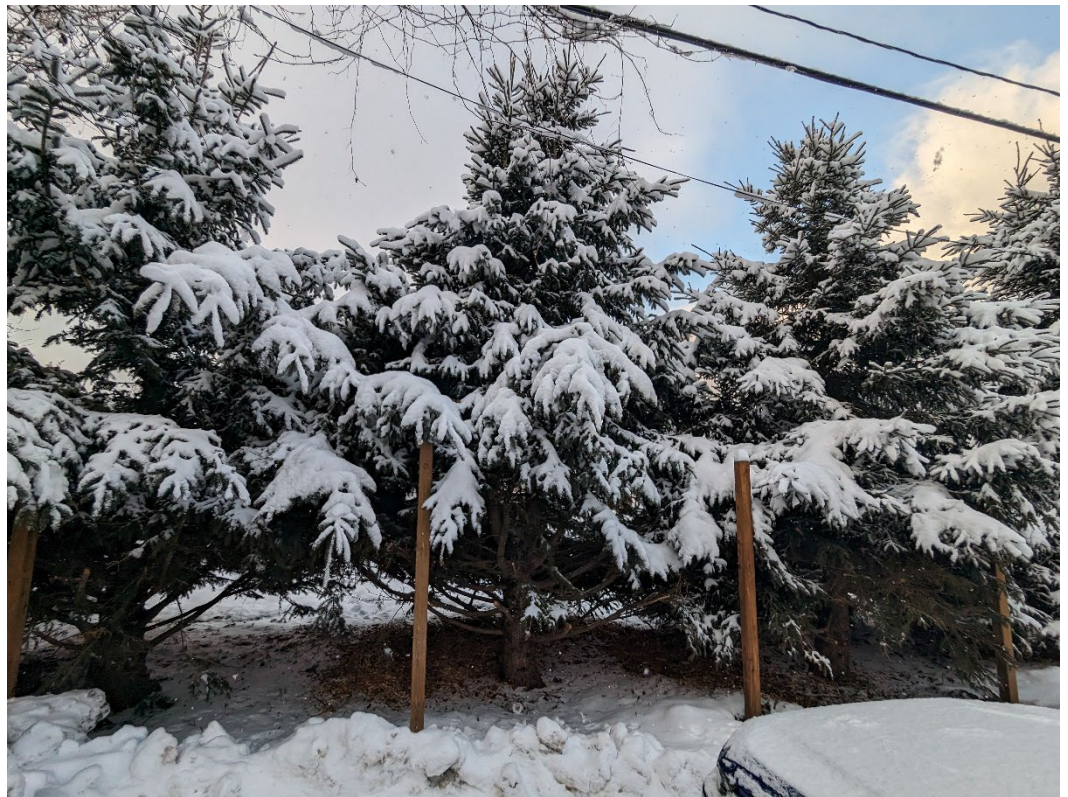
Right: Tree 26 – group of adjacent spruce to be retained.

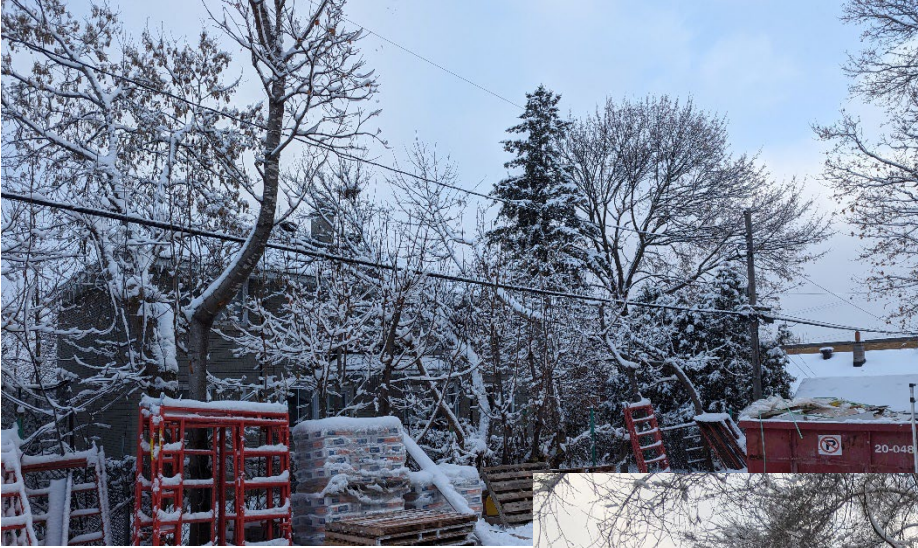
**Trees 21-25, 27 and 28** are in poor condition and will be impacted by replacing the asphalt in the rear-yard parking lot. In discussions with the client, it is expected a retaining wall will be required to complete the parking area – this retaining wall is expected to run along or near the property line, necessitating the removal of these trees.

Clockwise from upper left: Tree group 21 – heavily pruned Manitoba maples to be removed (crowns of Tree 1 and 2 in background).

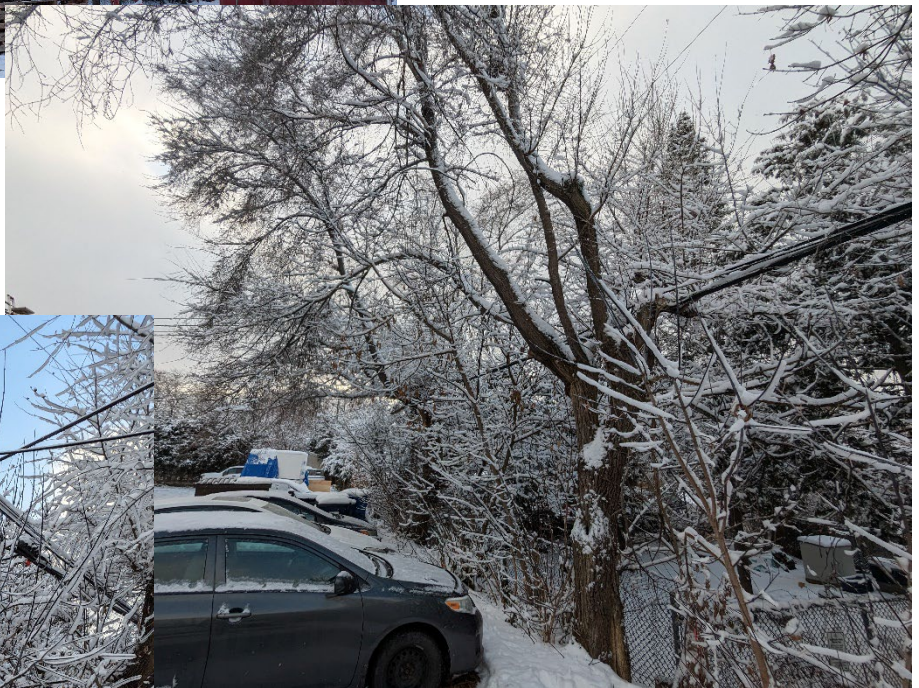
22 <sup>4</sup>	Siberian elm ( <i>Ulmus pumila</i> )	43	Boundary – 1305 Summerville and 1290 Dorchester	Poor: poor form; cavity in main bole; decay in wounds; broken branches; pruned around wires	Remove	Remove due to impacts of expected retaining wall and parking refurbishment.
23 <sup>4</sup>	Siberian elm ( <i>Ulmus pumila</i> )	42	Boundary – 1305 Summerville and 1312 Dorchester	Poor: pruned around wires; asymmetrical crown; decay in wounds; poor form	Remove	Remove due to impacts of expected retaining wall and parking refurbishment.

Tree 22 – Boundary Siberian elm to be removed.

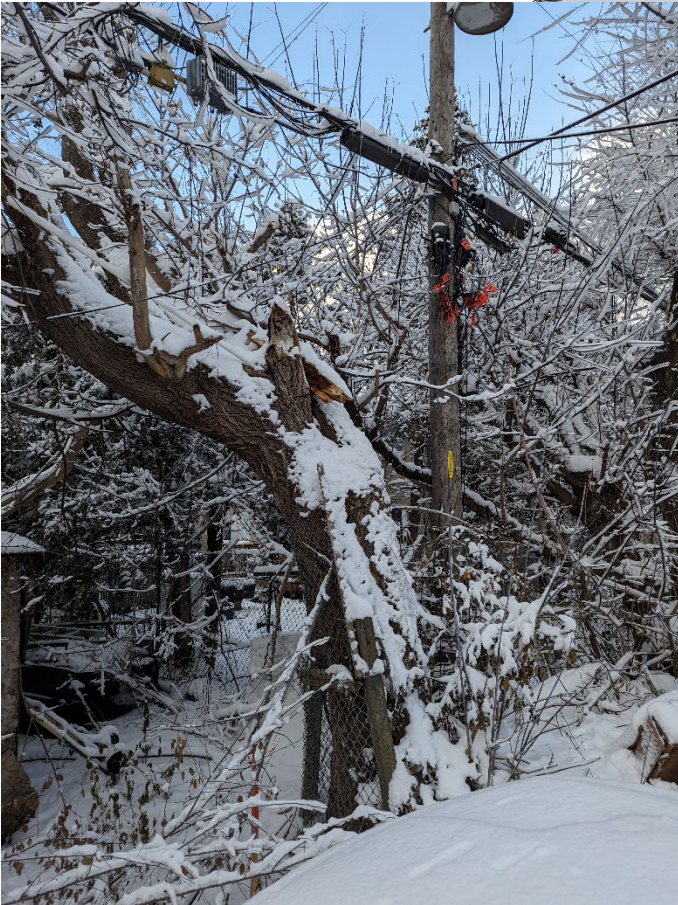
Tree 25 – Boundary Siberian elm to be removed.

25 <sup>4</sup>	Siberian elm ( <i>Ulmus pumila</i> )	55 (estimate)	Poor: heavy lean towards Dorchester; dead branches; poor form; growing on fence
26 <sup>4</sup>	White spruce ( <i>Picea glauca</i> )	4 stems ~15cm	Good/Fair: pruned under wires – some with poor form
27 <sup>4</sup>	Manitoba maple ( <i>Acer negundo</i> )	15	Fair: slight lean; canker in canopy; growing under wires
28 <sup>4</sup>	Manitoba maple ( <i>Acer negundo</i> )	15, 20	Fair/Poor: heavy lean to the south; epicormic shoots throughout canopy; growing on fence
29 <sup>4</sup>	Norway maple ( <i>Acer platanoides</i> )	18 (estimate)	Fair/Poor: moderate lean; grown around fencing
30 <sup>4</sup>	Eastern white cedar ( <i>Thuja occidentalis</i> )	18, 8 (estimate)	Fair: asymmetrical – growing beside house; chlorosis and dieback in canopy near A/C unit.
