June 15, 2021

RE: TREE CONSERVATION REPORT FOR 155 IBER ROAD, OTTAWA

Table 1. Species, condition, size (diameter) and status of trees at 155 Iber Road

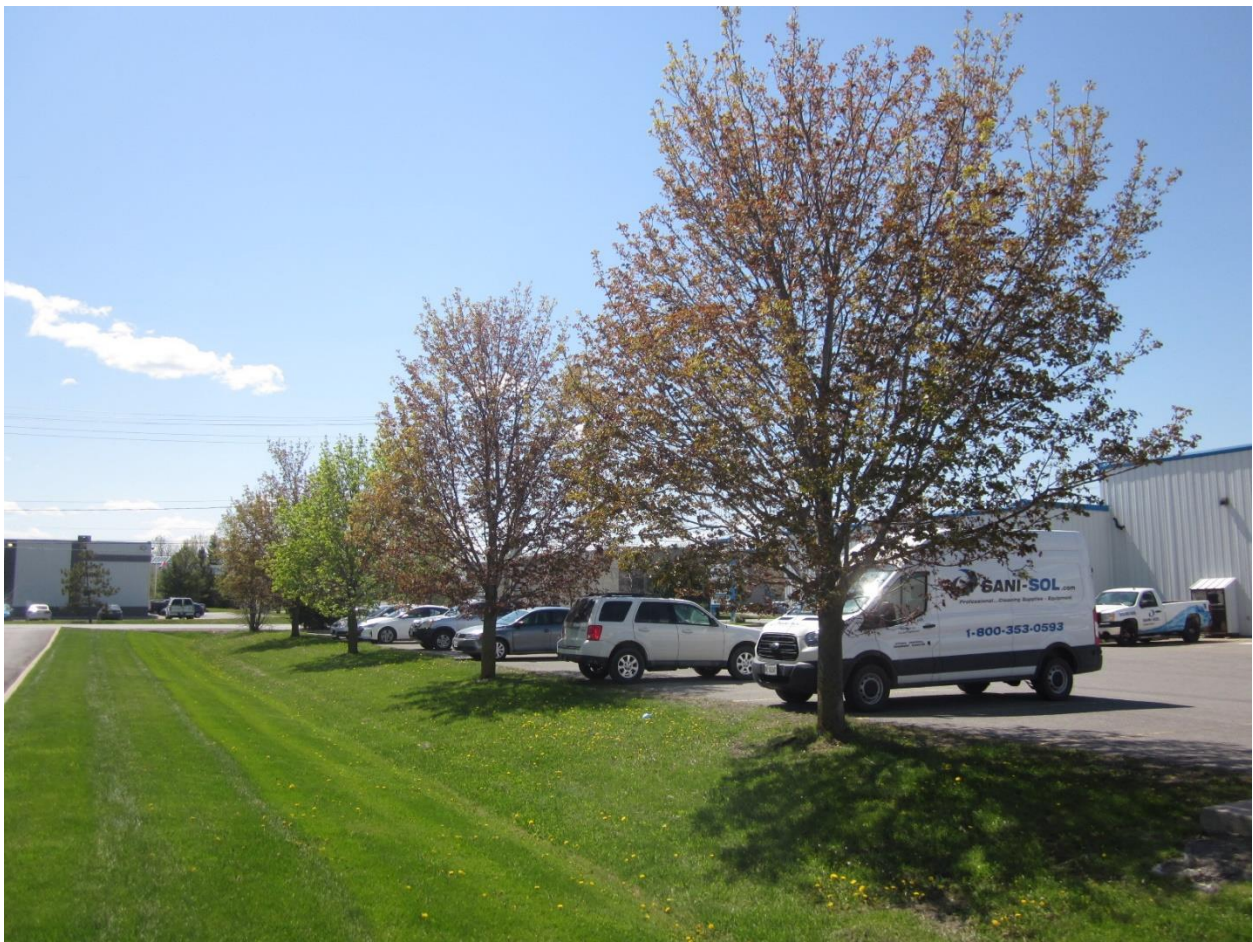
5	Norway maple	Good	27.5	Neighbour	Mature; central main stem with suppressed laterals starting at 1.5m from grade; broad dense crown; spiral seam at 0.1-1.4m on south side of main stem has healed; to be preserved and protected
6	Norway maple	Good	28.2	Neighbour	Mature; central main stem with suppressed laterals starting at 1.5m from grade; broad dense crown; lower lateral on north side broken by snow plow; to be preserved and protected
7	Colorado spruce	Good	23.2	Private	Mature; good crown density, growth increment and needle colour; restricted rooting area close to side of building; to be removed (conflicts with proposed new parking)

Picture 1. Neighbouring trees #2-6 located adjacent to 155 Iber Road

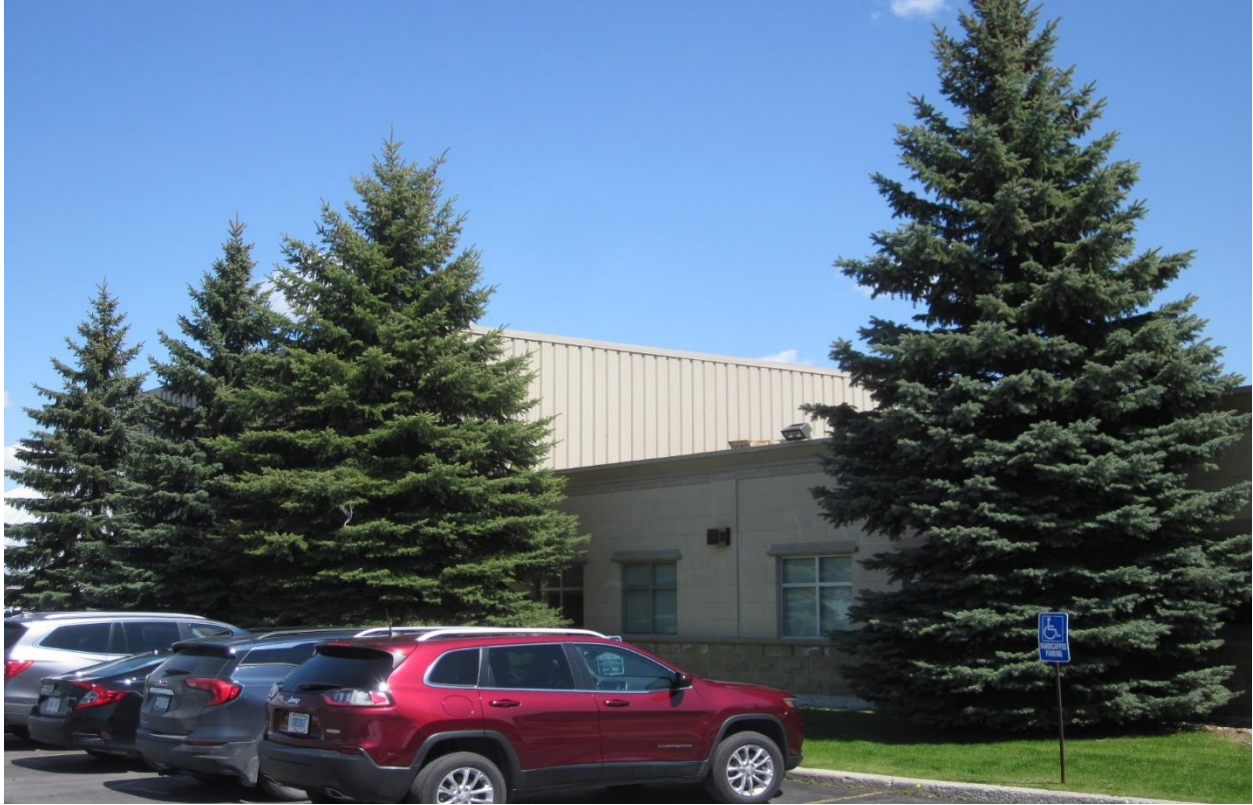
8	Colorado spruce	Good	24.1	Private	Mature; good crown density, growth increment and needle colour; restricted rooting area close to side of building; to be removed (conflicts with proposed new parking)
9	Colorado spruce	Good	29.3	Private	Mature; good crown density, growth increment and needle colour; moderately restricted rooting area close to corner of building; to be removed (conflicts with proposed new parking)
10	Colorado spruce	Good	27.7	Private	Mature; good crown density, growth increment and needle colour; restricted rooting area close to building – has been clearance pruned in past; to be removed (will not survive root loss associated with installation of new curb and concrete pad for bicycle parking)
11	Amur maple (<i>Acer tataricum</i> subsp. <i>ginnala</i>)	Poor	15.3	Private	Mature; 'standard' variety; crown form very divergent towards north due to influence of trees #12 and 13; suppressed growth; introduced invasive species; to be removed (conflicts with proposed new entranceway)

Picture 2. Trees #7-10 located at 155 Iber Road

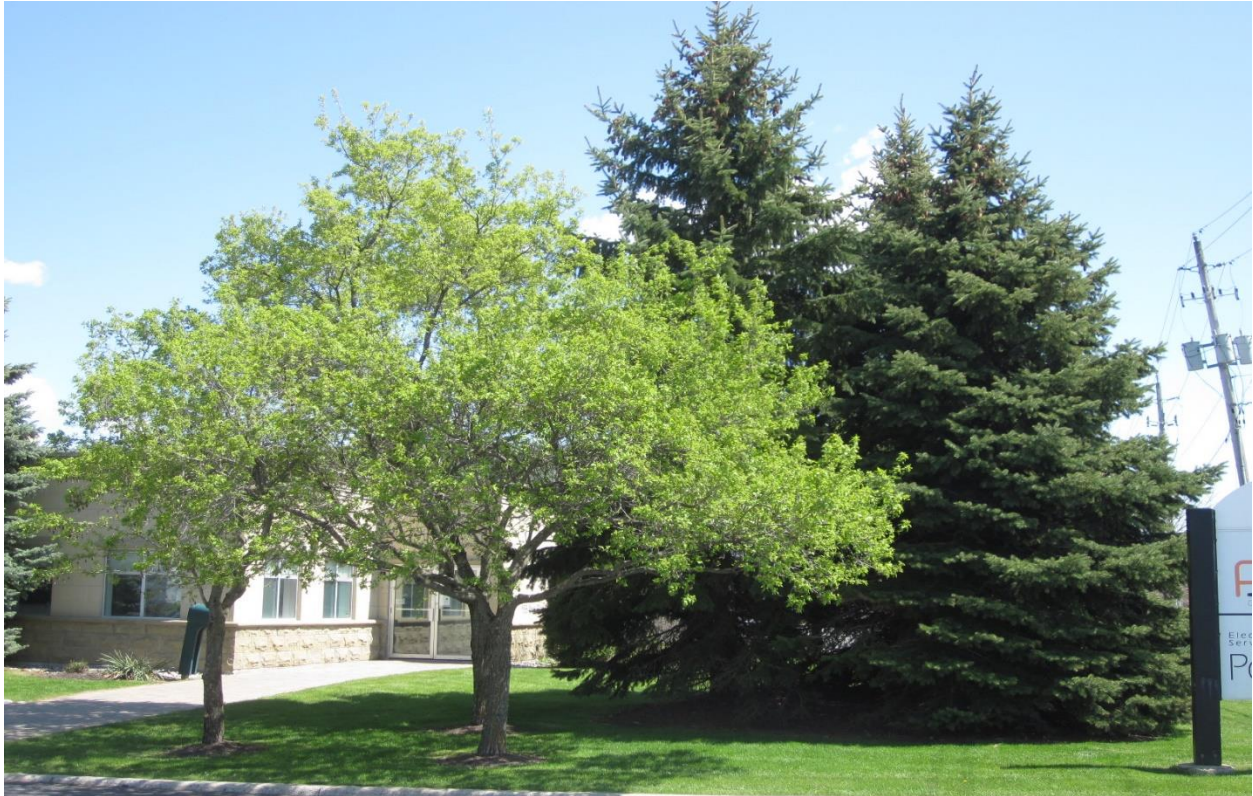
12	Amur maple	Fair	17.6	Private	Mature; 'standard' variety; crown form divergent towards southwest due to influence of trees #11 and 13; to be removed (conflicts with proposed new entranceway)
13	Amur maple	Good	20.2	Private	Mature; 'standard' variety; crown form divergent towards east due to influence of trees #11 and 12; to be removed (misshapen form and having a negative influence on nearby trees)
14	Colorado spruce	Good	26.7	Private	Mature; good crown density, growth increment and needle colour; lower crown asymmetric due to intercompetition with trees #15 and 16; to be preserved and protected

Picture 3. Trees #11-16 located at 155 Iber Road

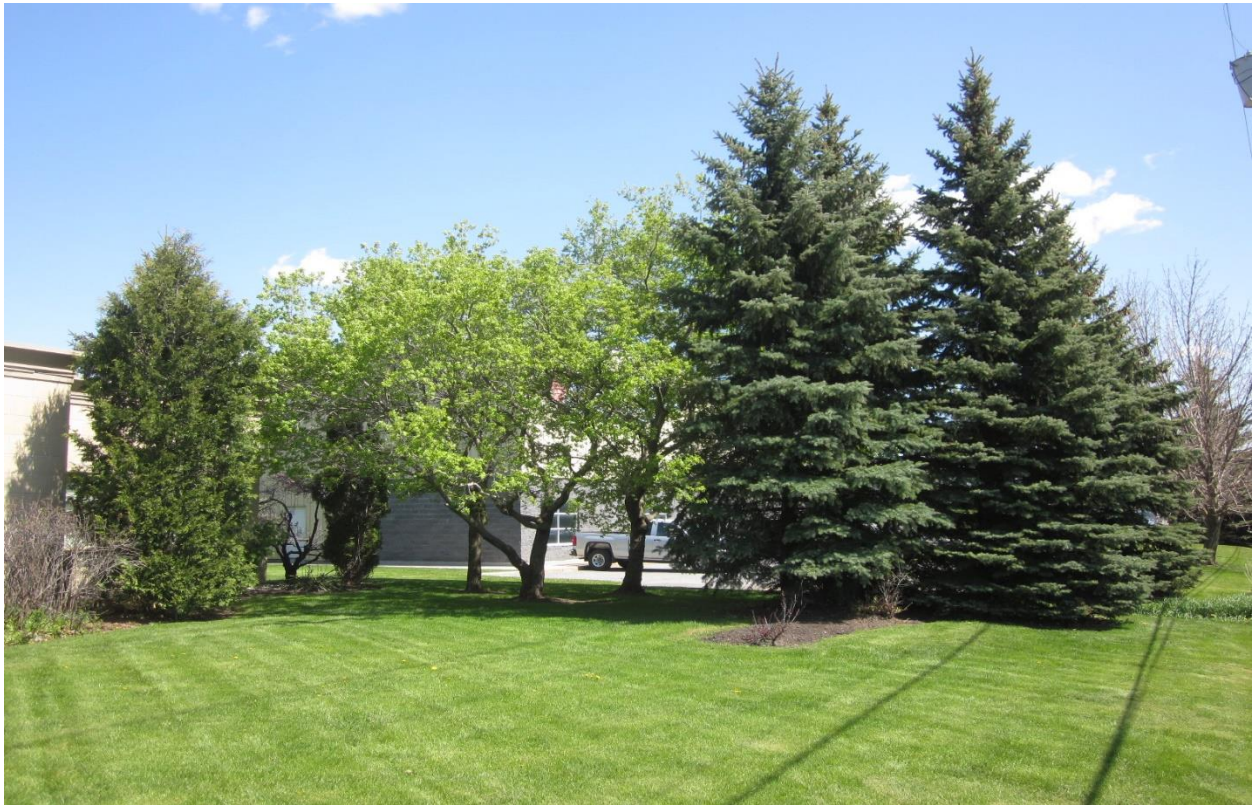
20	Colorado spruce	Good	23.9	Private	Mature; good crown density, growth increment and needle colour; lower crown thin due to combined influence of trees #18, 19 and 21; to be preserved and protected
21	Amur maple	Good	27.3	Private	Mature; 'standard' variety; generally upright form; crown asymmetric towards east; to be preserved and protected
22	Amur maple	Fair	23.1	Private	Mature; 'standard' variety; crown divergent towards north; to be preserved and protected
23	Amur maple	Fair	22.1	Private	Mature; 'standard' variety; crown divergent towards north; to be preserved and protected
24	Colorado spruce	Very good	31.3	Private	Mature; very good crown density, growth increment and needle colour; to be preserved and protected

Picture 4. Trees #18-23 (right to left) located at 155 Iber Road (cedars on left are foundation plantings below 10cm)

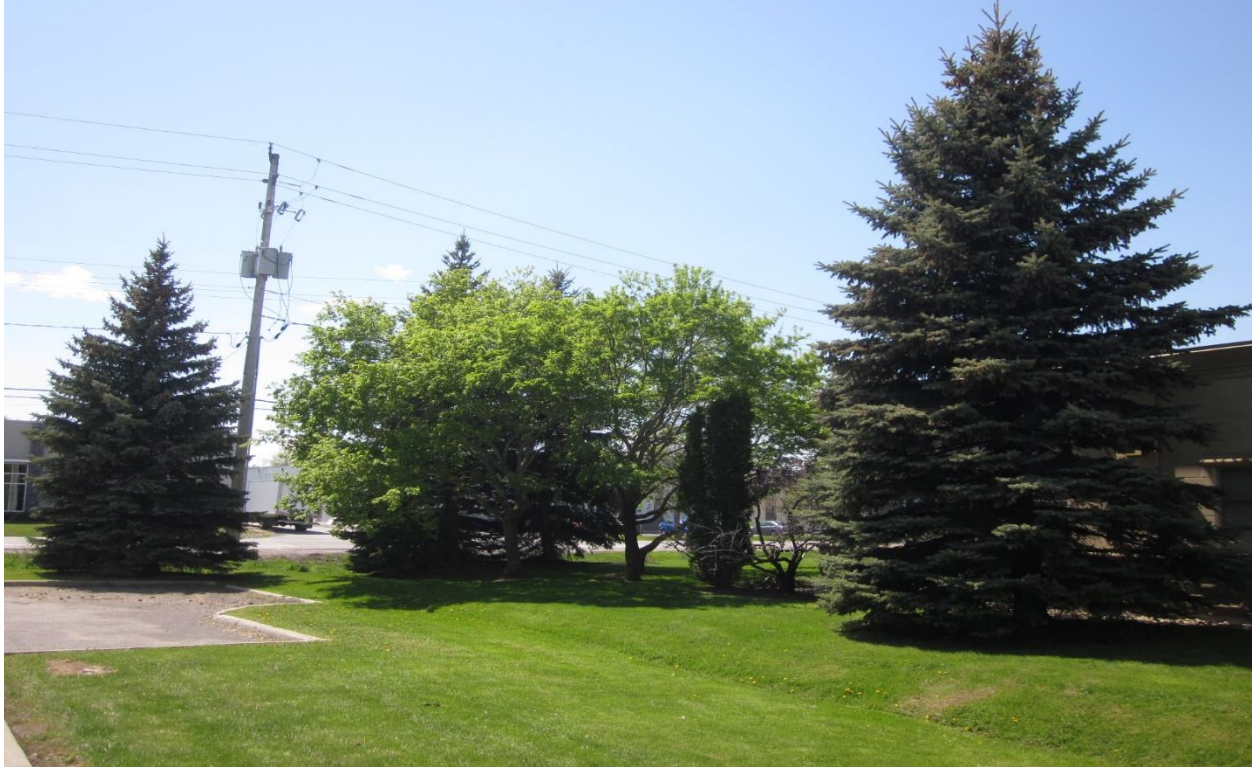
Picture 5. Trees #17-24 (left to right) located on and adjacent to 155 Iber Road

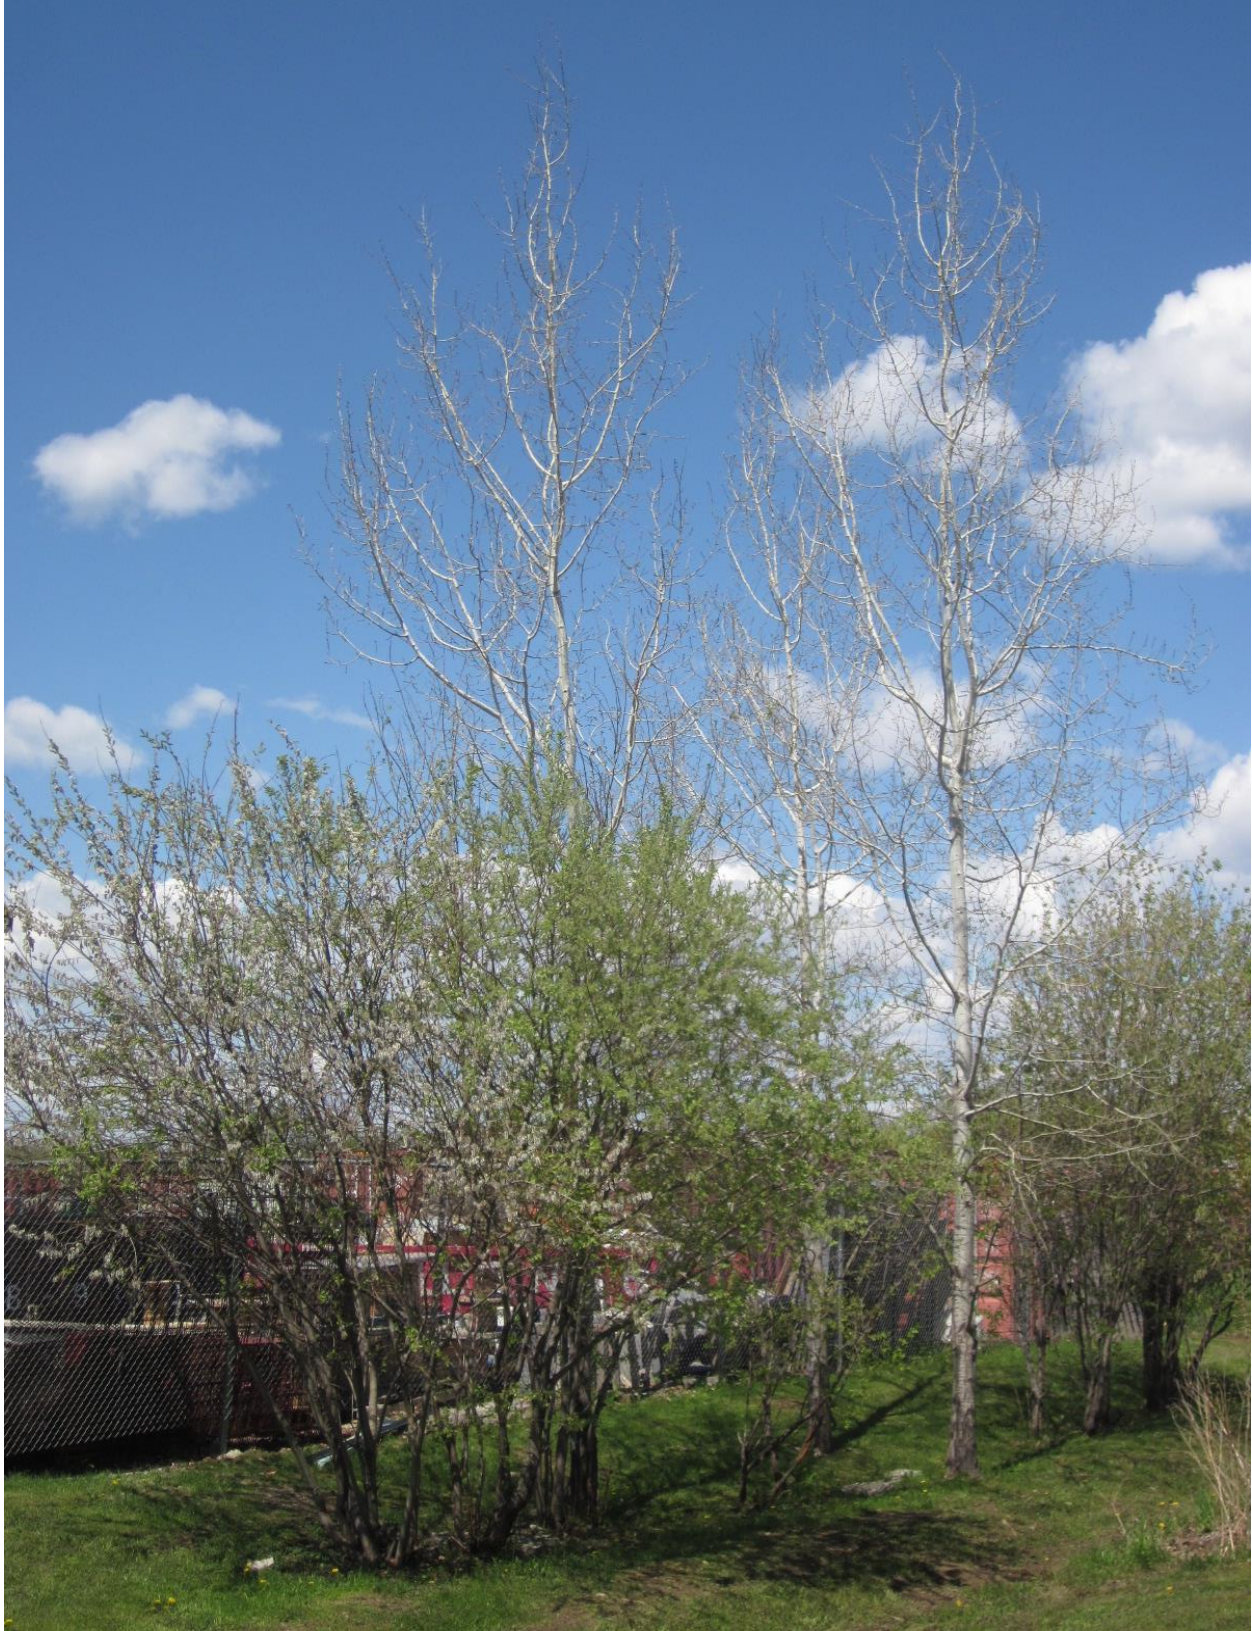
25	Trembling aspen (<i>Populus tremuloides</i>)	Fair	16.7, 21.1 & 21.2	Private	Maturing; group of three trees; 21.2cm stem with oozing wounds 2-4m from grade on north side; native species; to be preserved and protected
----	--	------	-------------------	---------	--

Picture 6. Tree grouping #25 located at 155 Iber Road
