TREE CONSERVATION
REPORT V2.0
1983 Carling Ave

Tree Conservation Report submitted as Partial
Requirements for a Site Plan Control Application

March 29, 2023

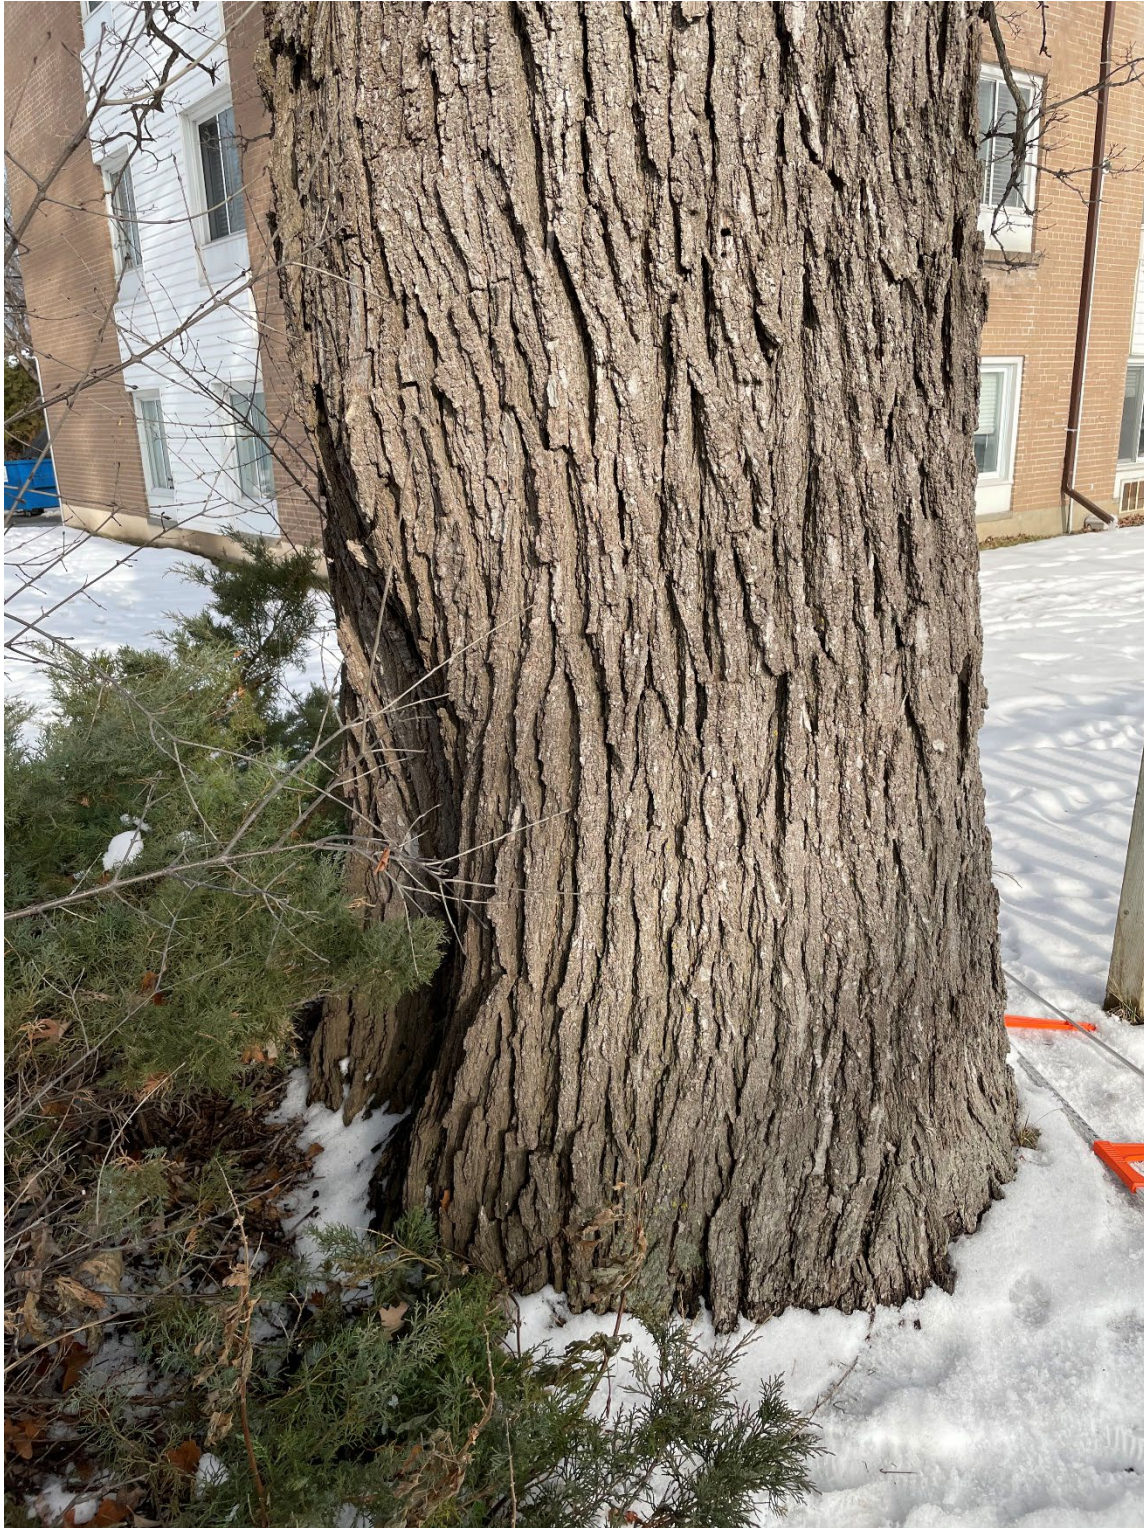
Figure 2: Wound at base of trunk along the west side

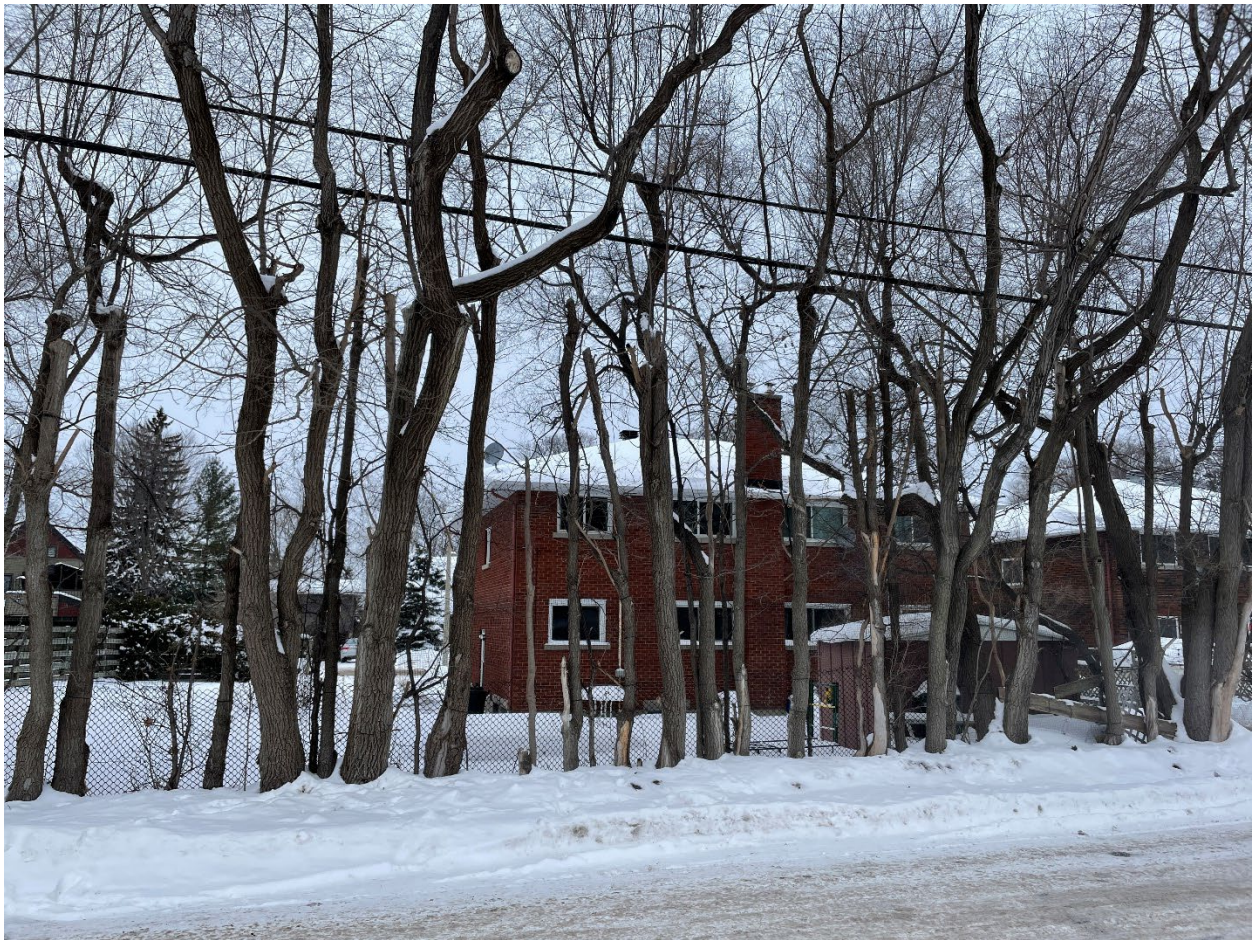
Figure 4: Trees grouping #9 - Siberian elm along northern property line under hydro – to be retained

Because the area is covered in asphalt, no tree protective fencing is required during site works. However, the following mitigation measures should be applied when replacing the asphalt and installing the subdrain:

- Avoid tearing of the roots. If the roots do tear, they should be pruned with a clean cut to increase the likelihood of sealing properly and reduce the risk of pathogens from entering the tree.
- Roots should not be left exposed and be covered with soil as quickly as possible, or temporarily with a moist, organic material such as mulch and/or burlap
