Geotechnical Investigation – Slope Stability Analysis

150 Kanata Avenue & 1200 Canadian Shield Avenue,
Kanata, Ontario

March 9, 2023

Pinchin File: 290435.003

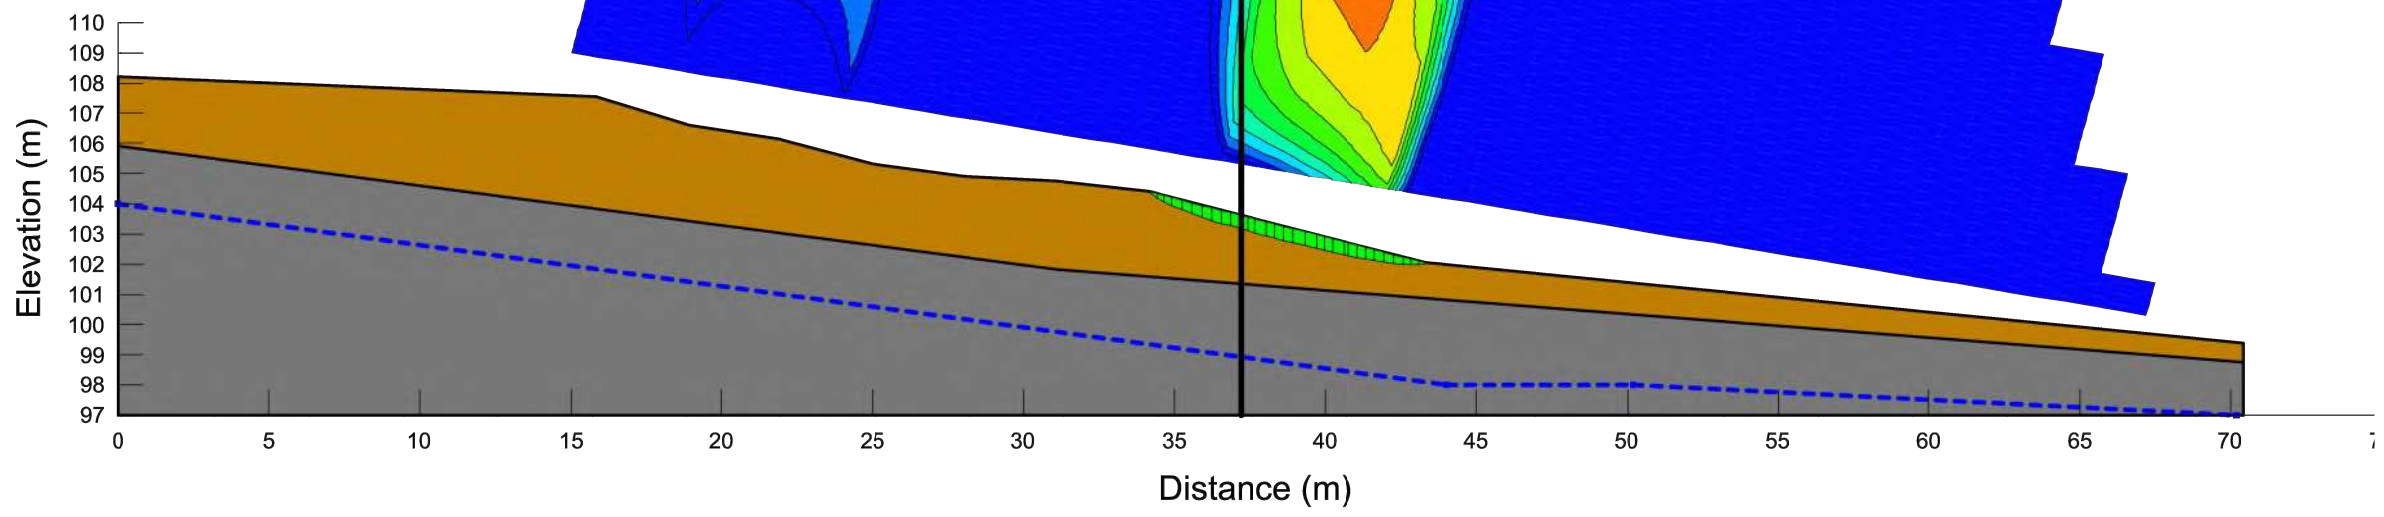
Figure 3 – Existing Cross Section Details A – A’

The results of the analysis indicate that the cross-section profiles have factors of safety against slope failure of 2.47 (existing) and 1.68 (proposed). The factors of safety are closely related to the shallowness of the slope, strength of the soil, and absence of groundwater. The results of the slope stability analysis are included on Figures 3 (existing) and 5 (proposed).

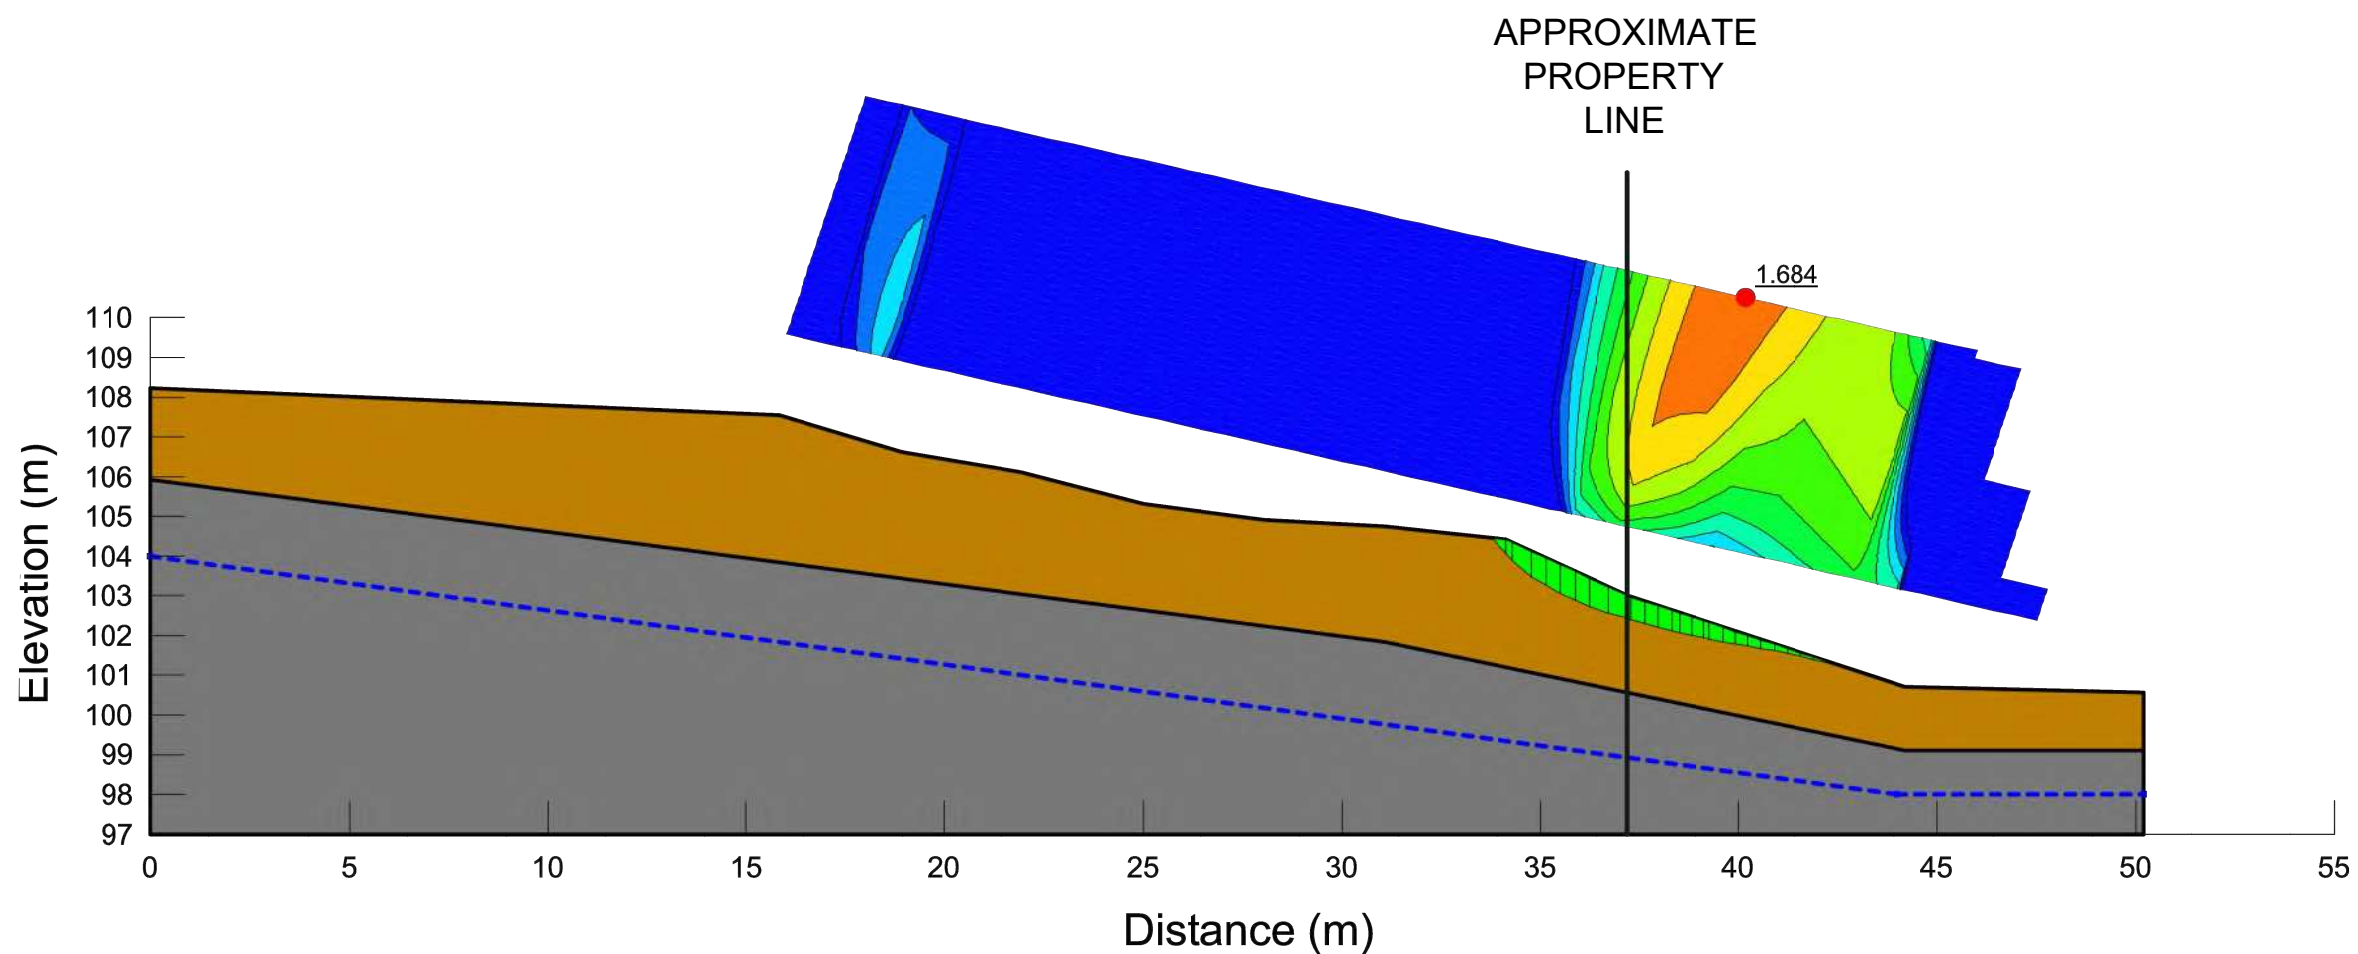
Figure 5 – Proposed Cross Section Details A – A’

Based on our analysis, the proposed slope inclination will maintain a factor of safety of greater than 1.5 after completion of the development.
