URBAN FORESTRY & FOREST MANAGEMENT CONSULTING

**RE: TREE CONSERVATION REPORT FOR 817 ROSEVIEW AVENUE, OTTAWA**

**Tree Report Plan**

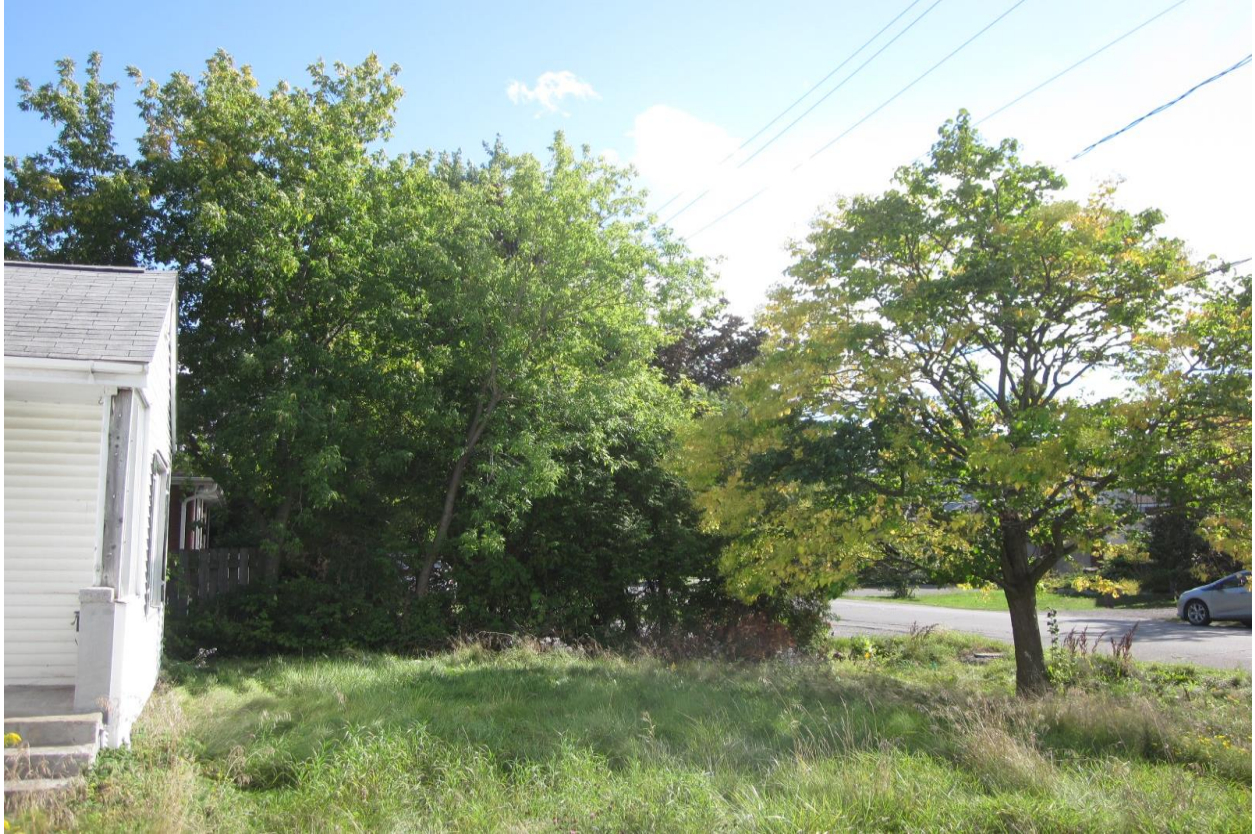
Tree #1: A Japanese tree lilac (*Syringa reticulata*) 32 cm in diameter and in good condition (broad, dense crown with good leaf size and colour). It has been pruned slightly from the overhead Hydro lines.

Tree grouping #2: A mature white cedar hedge (*Thuja occidentalis*) which appears to be shared with the neighbouring private property to the south. Two nearby single Manitoba maple (*Acer negundo*) trees, 15 and 20 cm in diameter, are in fair condition and fully on the subject property. The cedars, a native species, were planted while the Manitoba maples (a naturalized species in Eastern Ontario) both would have originated from seed.

Picture 1. Tree #1 (right) and grouping #2 at 817 Roseview Avenue

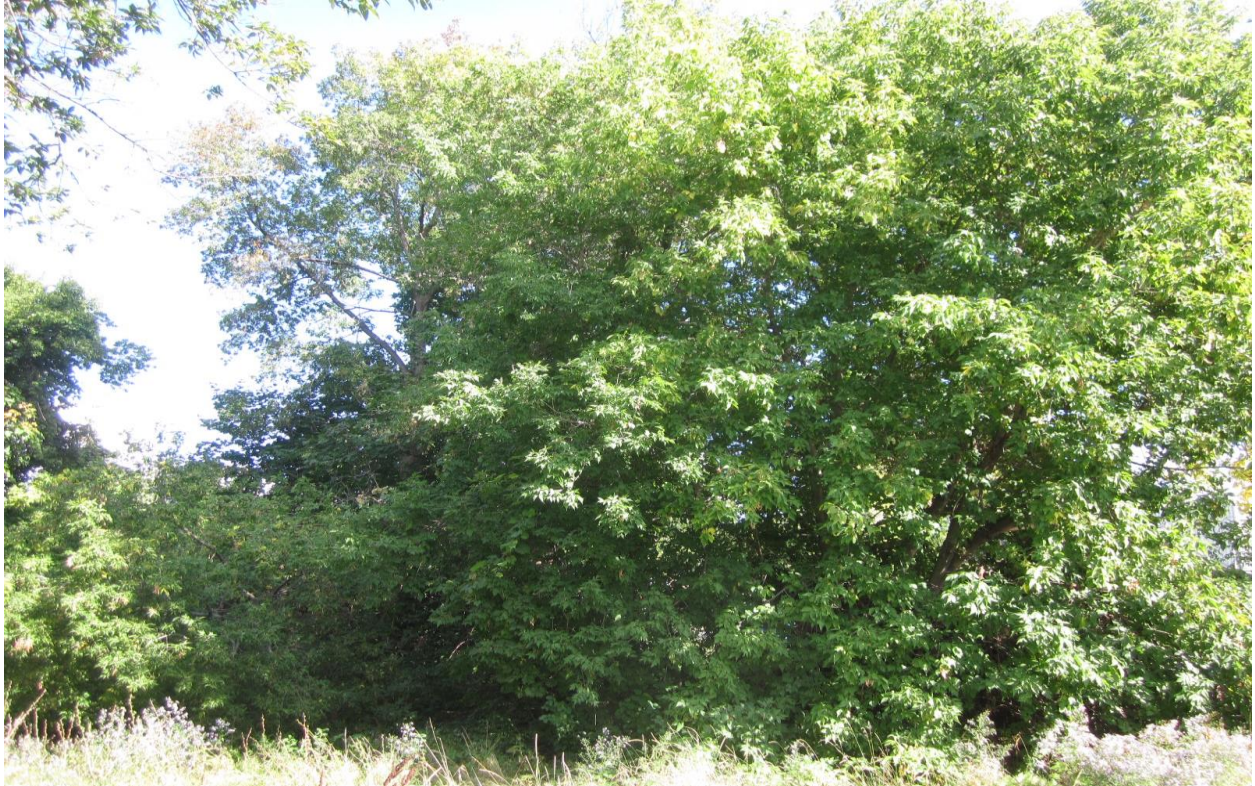
Tree grouping #4: A line of three Manitoba and two Norway maples (*Acer platanoides*). The Manitobas, all being in excess of 50 cm diameter, are mature while the Norway maples, ranging in diameter from 20-25cm, are considerably younger. Like the Manitoba maples, the Norway maples would have originated from seed. This species was introduced to North America and is considered invasive here. Importantly, several of these trees appear to be shared with the private property to the south. The neighbouring property owner's written permission is required prior to their removal.

Picture 2. Tree grouping #4 at 817 Roseview Avenue

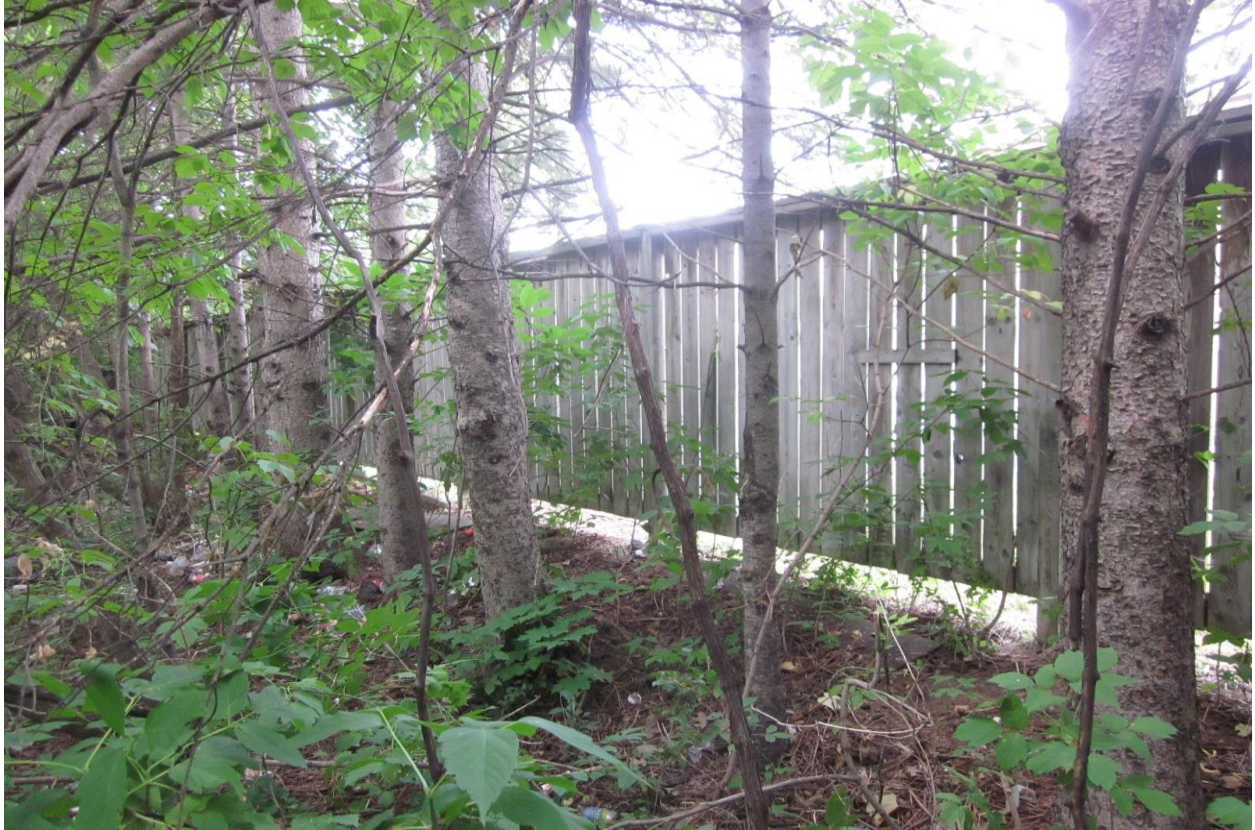
Tree grouping #5: A line of nine white spruce ranging in diameter from 12 to 36 cm. A single tree of the same species is present on the private property to the north. All would have been planted. The health of these trees has been negatively impacted by the growth of Manitoba maples in the understory and vine growth. Suppression from this competing vegetation has led to the death of two spruce and the decline of another four. The three largest spruce have grown above the competing canopy and appear to be in relative good condition – holding crowns of dense, good-coloured foliage.

Picture 3. Understory of tree grouping #5 at 817 Roseview Avenue

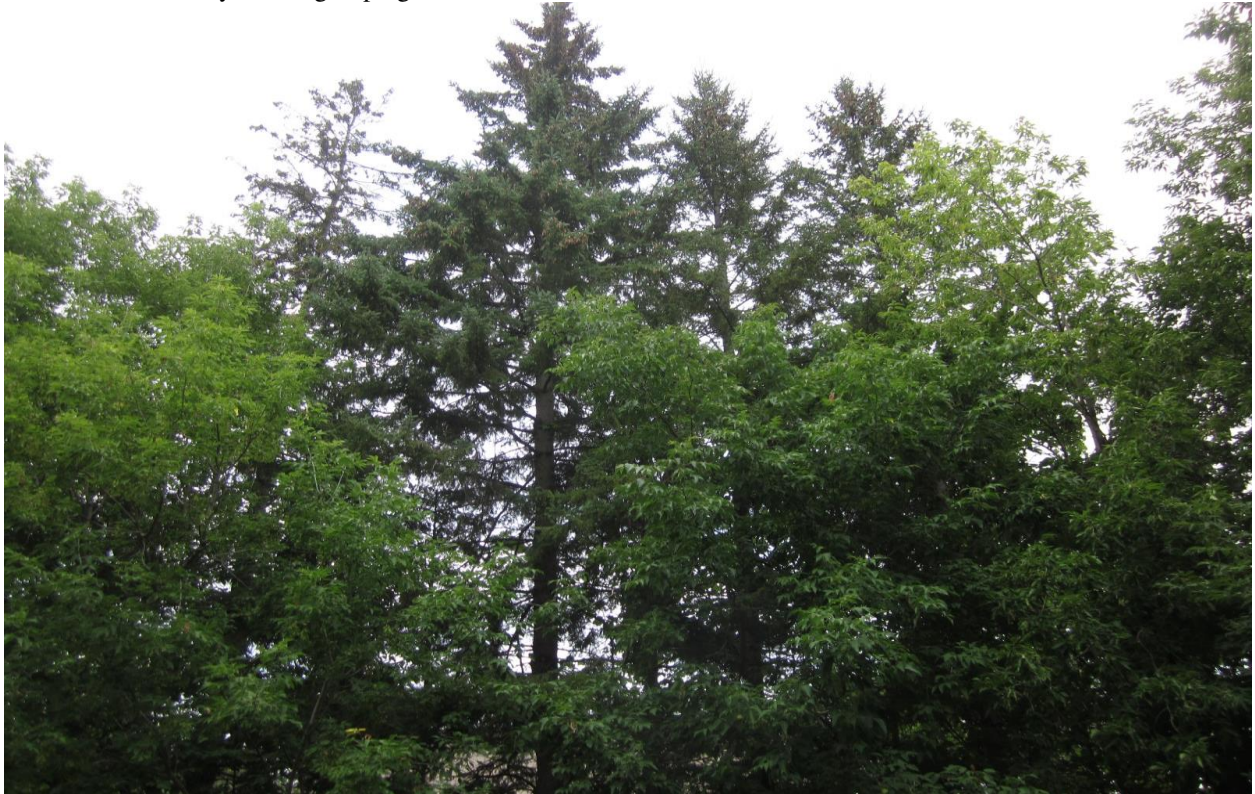
Picture 4. Overstory of tree grouping #5 at 817 Roseview Avenue
