September 30, 2021

**RE: TREE CONSERVATION REPORT FOR 249-255 RICHMOND ROAD & 372 TWEEDSMUIR AVENUE, OTTAWA**

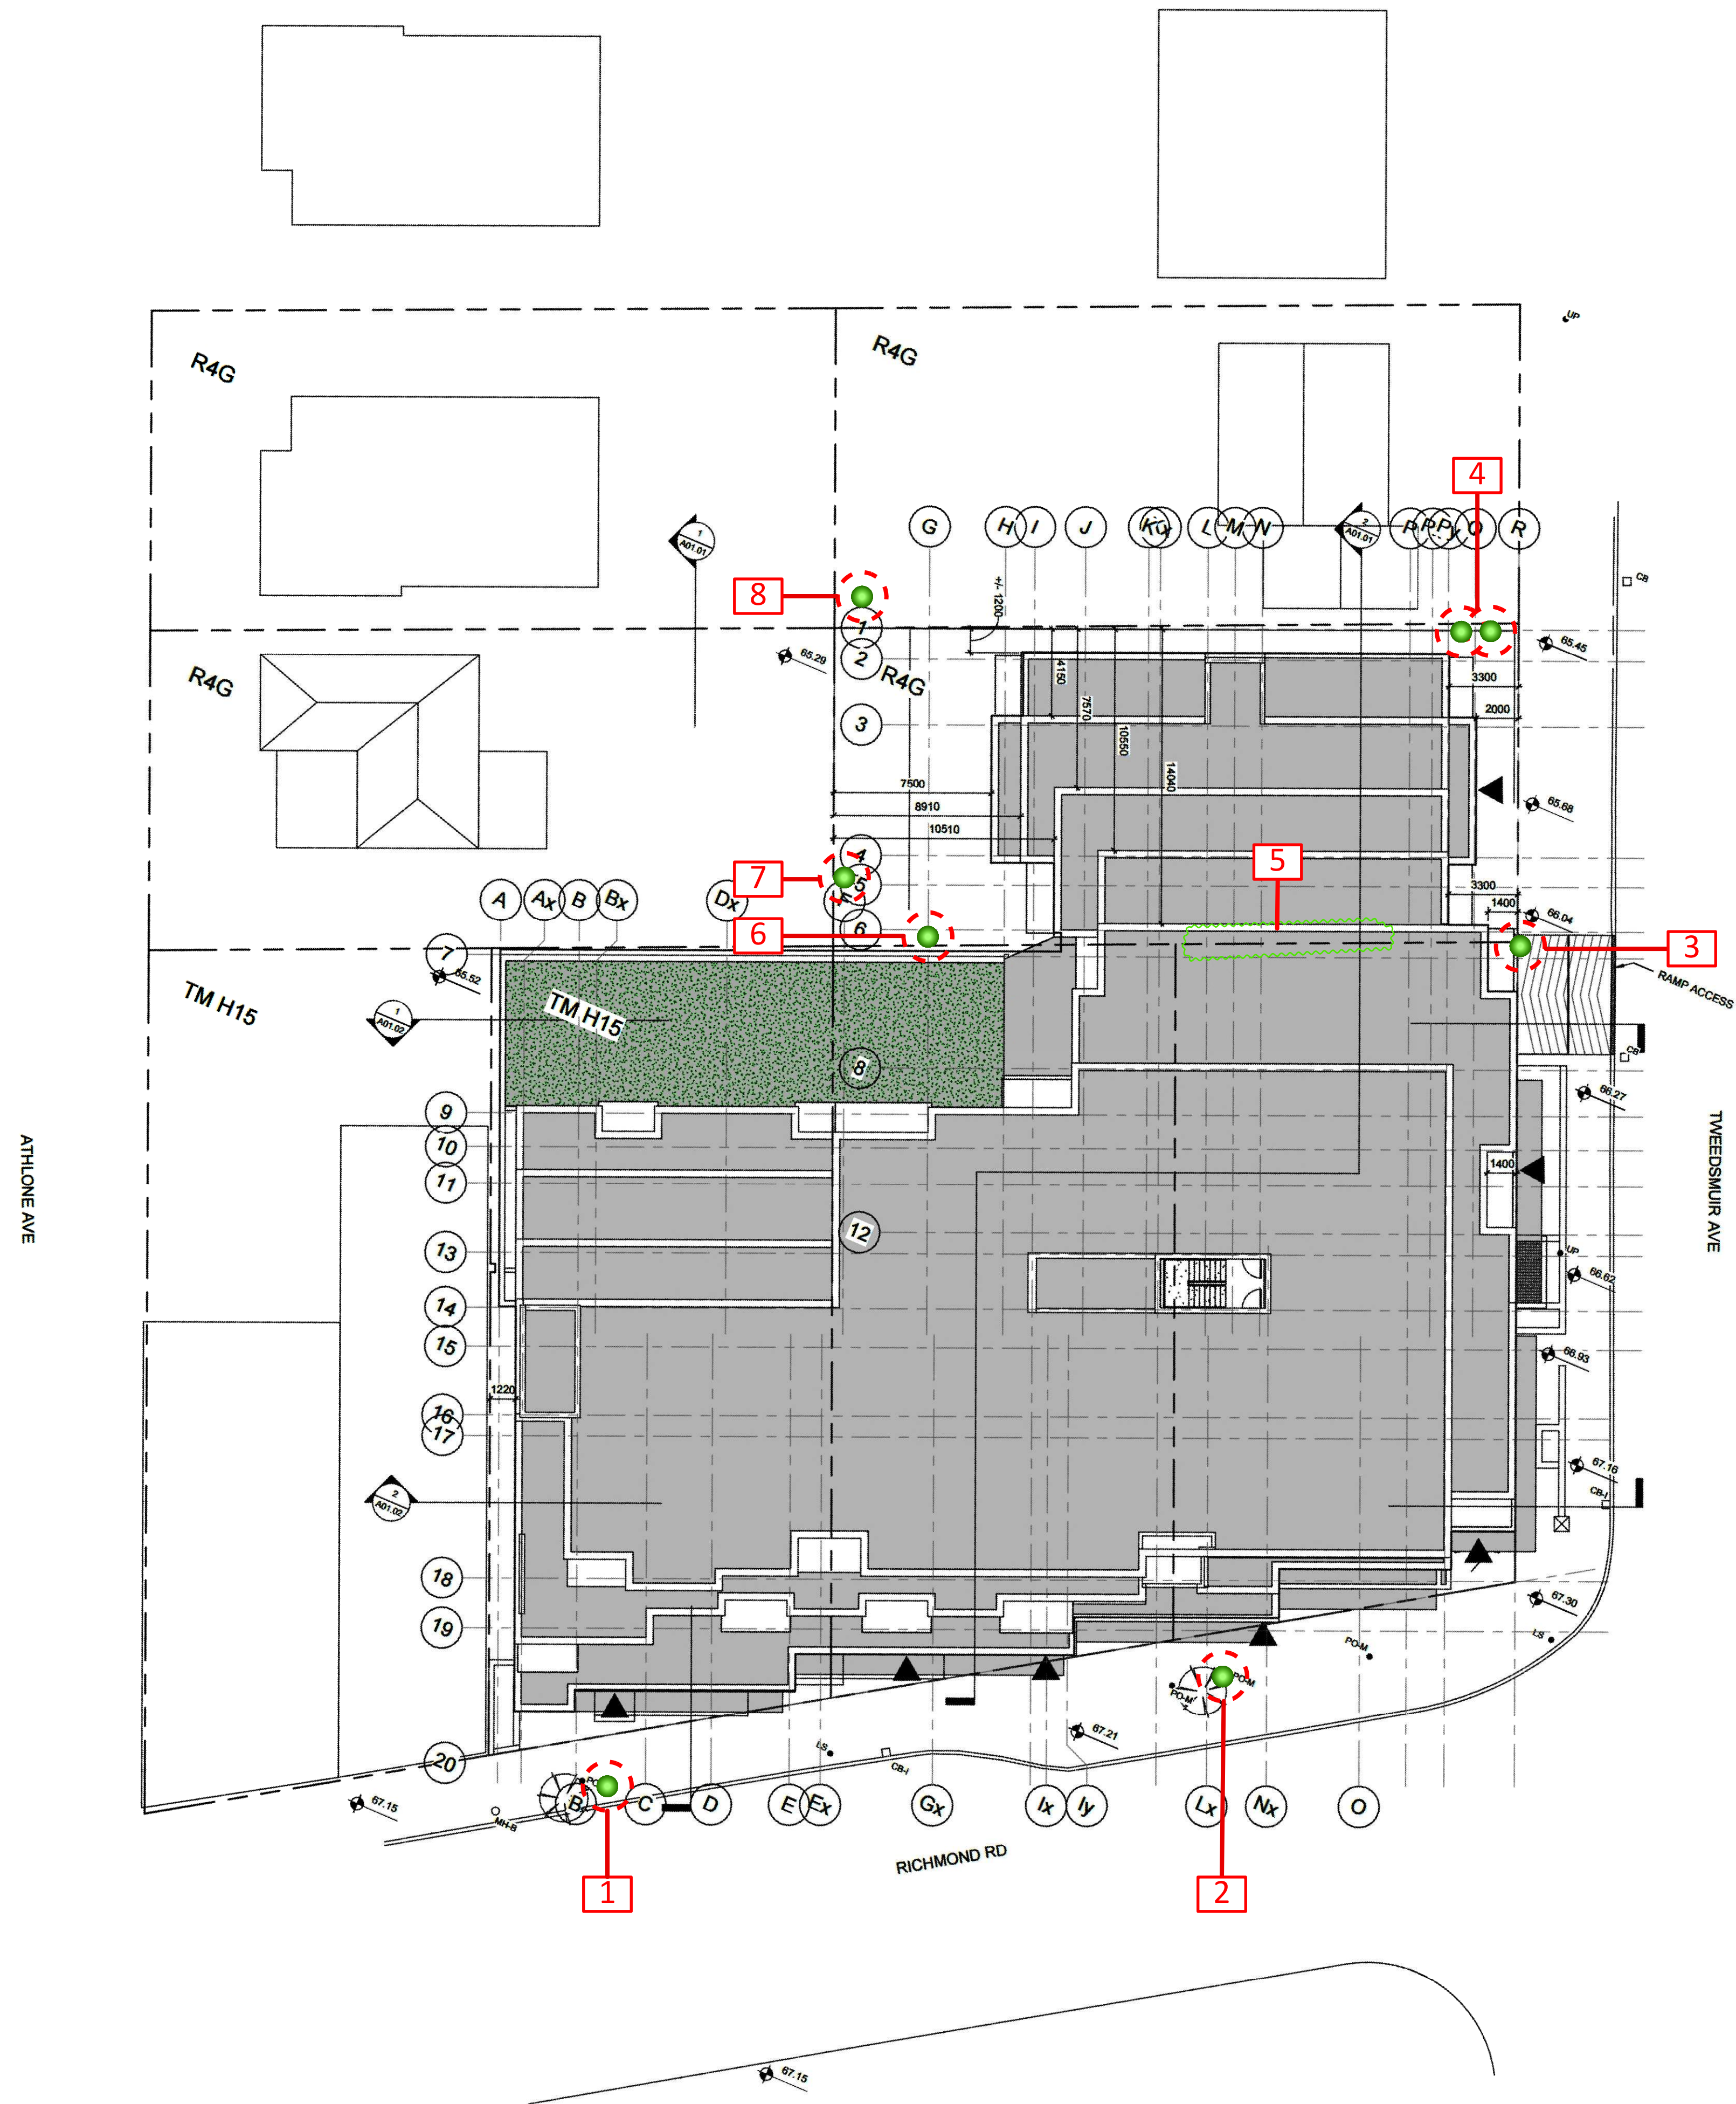
DRAWING: Tree Information Plan

Table 1 on pages 2 and 3 of this report details the species, condition, size (diameter), ownership and preservation status of the individual trees on and adjacent to the subject property. Each of these trees is referenced by the numbers plotted on the tree conservation plan included on page 3 of this report. Pictures 1 through 4 on pages 5 to 8 show selected trees on and adjacent to the subject property.

1. As per the City of Ottawa's tree protection barrier specification, erect a fence as close as possible to the CRZ of the tree(s);
2. Do not place any material or equipment within the CRZ of the tree(s);
3. Do not attach any signs, notices or posters to any tree;
4. Do not raise or lower the existing grade within the CRZ without approval;
5. Tunnel or bore instead of trenching within the CRZ of any tree;
6. Do not damage the root system, trunk or branches of any tree;
7. Ensure that exhaust fumes from all equipment are NOT directed towards any tree's canopy.

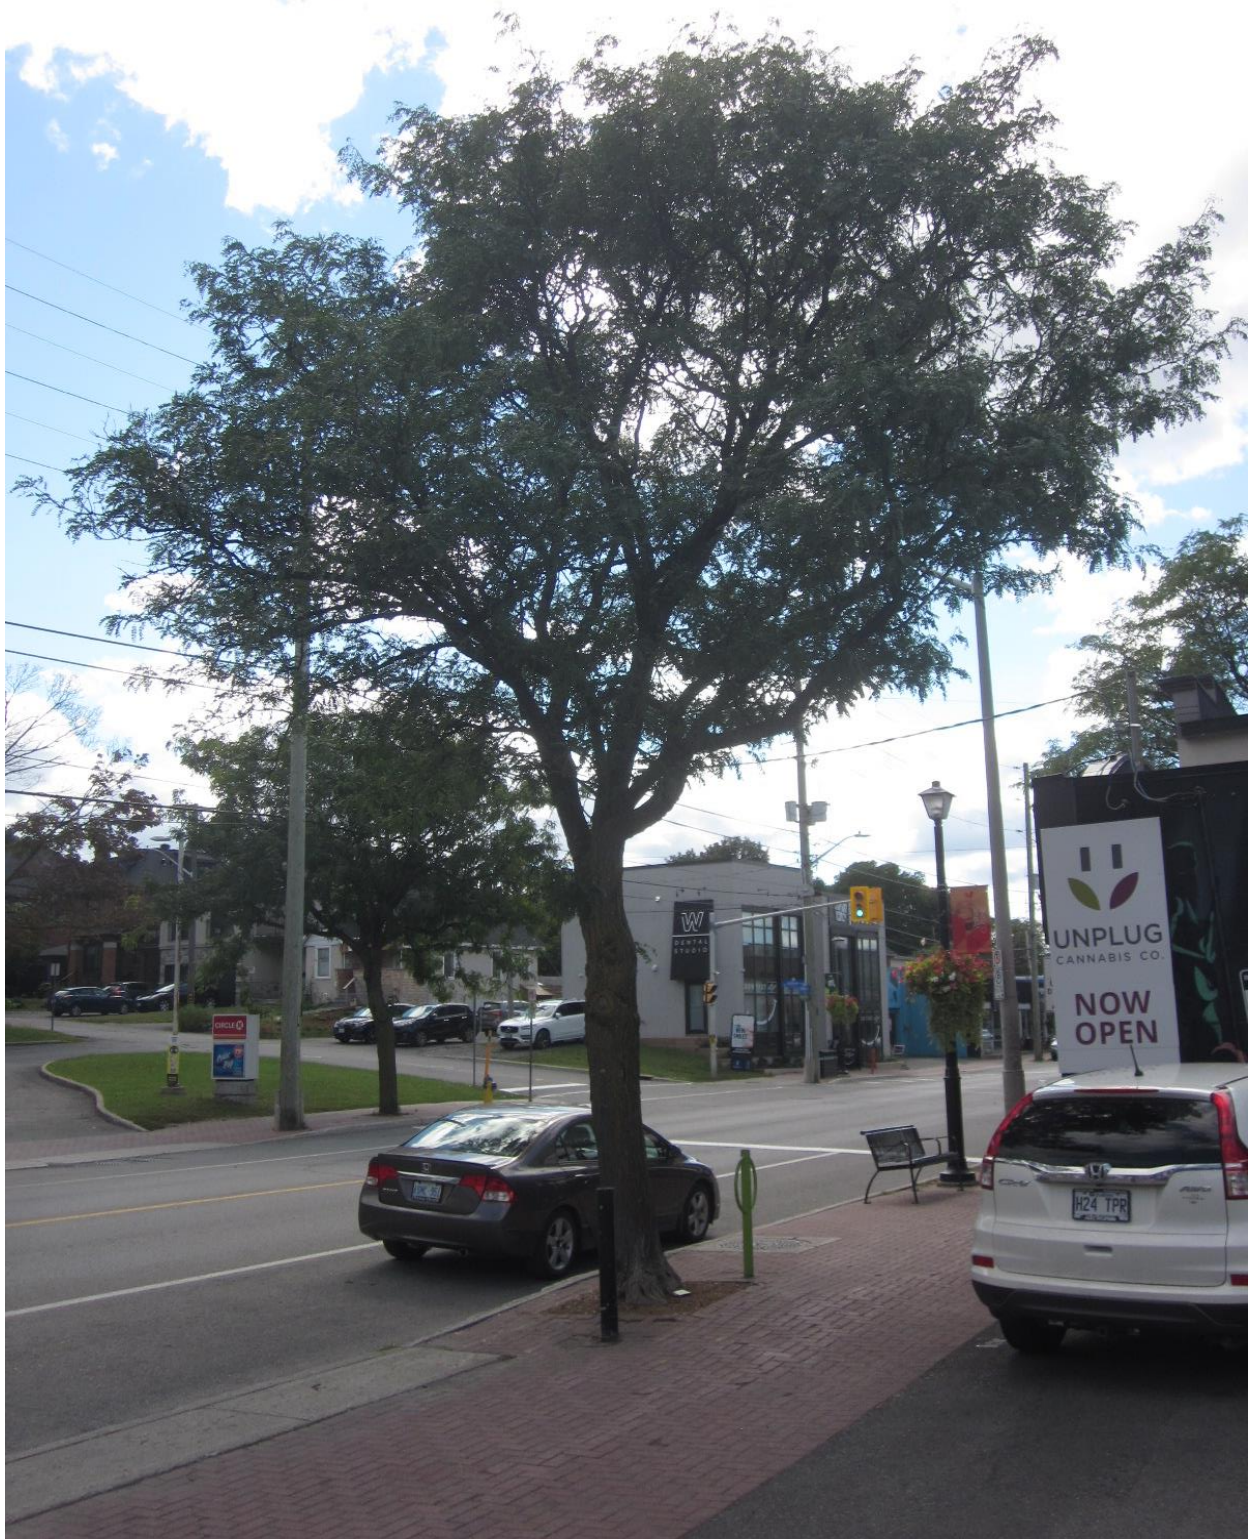
Tree No.	Tree species	Condition (VP→E)	DBH <sup>1</sup> (cm)	Owner -ship	Age class, tree condition notes & <b>preservation status</b> (to be removed or preserved and protected)
1	Honey-locust ( <i>Gleditsia triacanthos</i> )	Good	37.5	City	Mature; central lower stem with generally symmetric crown; crown raised to 4m over sidewalk; fair crown density, leaf size and colour; restricted rooting area within sidewalk; introduced species to Eastern Ontario; <b>to be preserved and protected</b>
2	Honey-locust	Good	44.6	City	Mature; central lower stem with mildly asymmetric crown towards north/northwest; crown raised to 4m over sidewalk; fair crown density, leaf size and colour; restricted rooting area within sidewalk; introduced species to Eastern Ontario; <b>to be preserved and protected</b>
3	Siberian elm ( <i>Ulmus pumila</i> )	Poor	83.3	Shared with City	Overmature; tri-stemmed at 1.5-1.75m from grade; east stem topped by Hydro at 4.5m, west stems moderately-heavily divergent towards east (over existing dwelling); introduced invasive species; <b>to be removed</b> (conflicts with construction both below and above ground)

Picture 1. Tree #1 located on city property adjacent to 249-255 Richmond Road

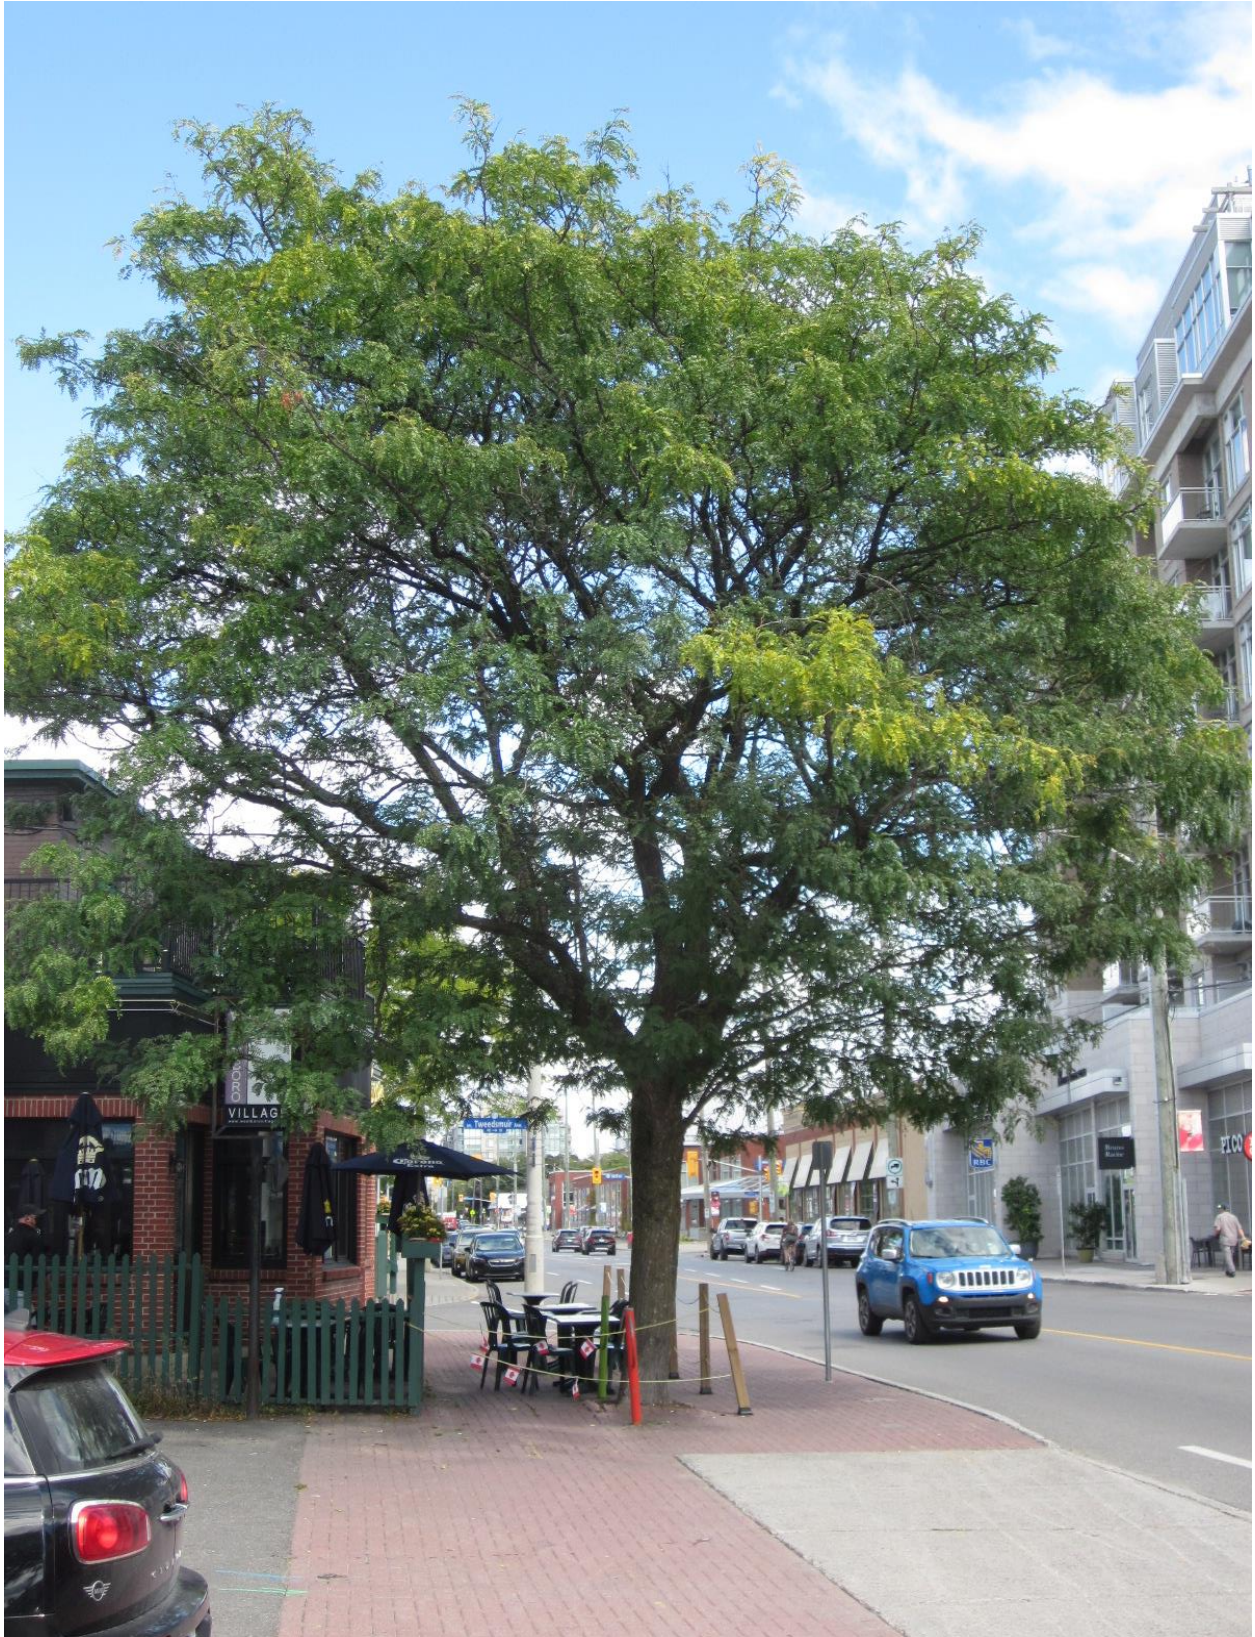
Picture 2. Tree #2 located on city property adjacent to 249-255 Richmond Road

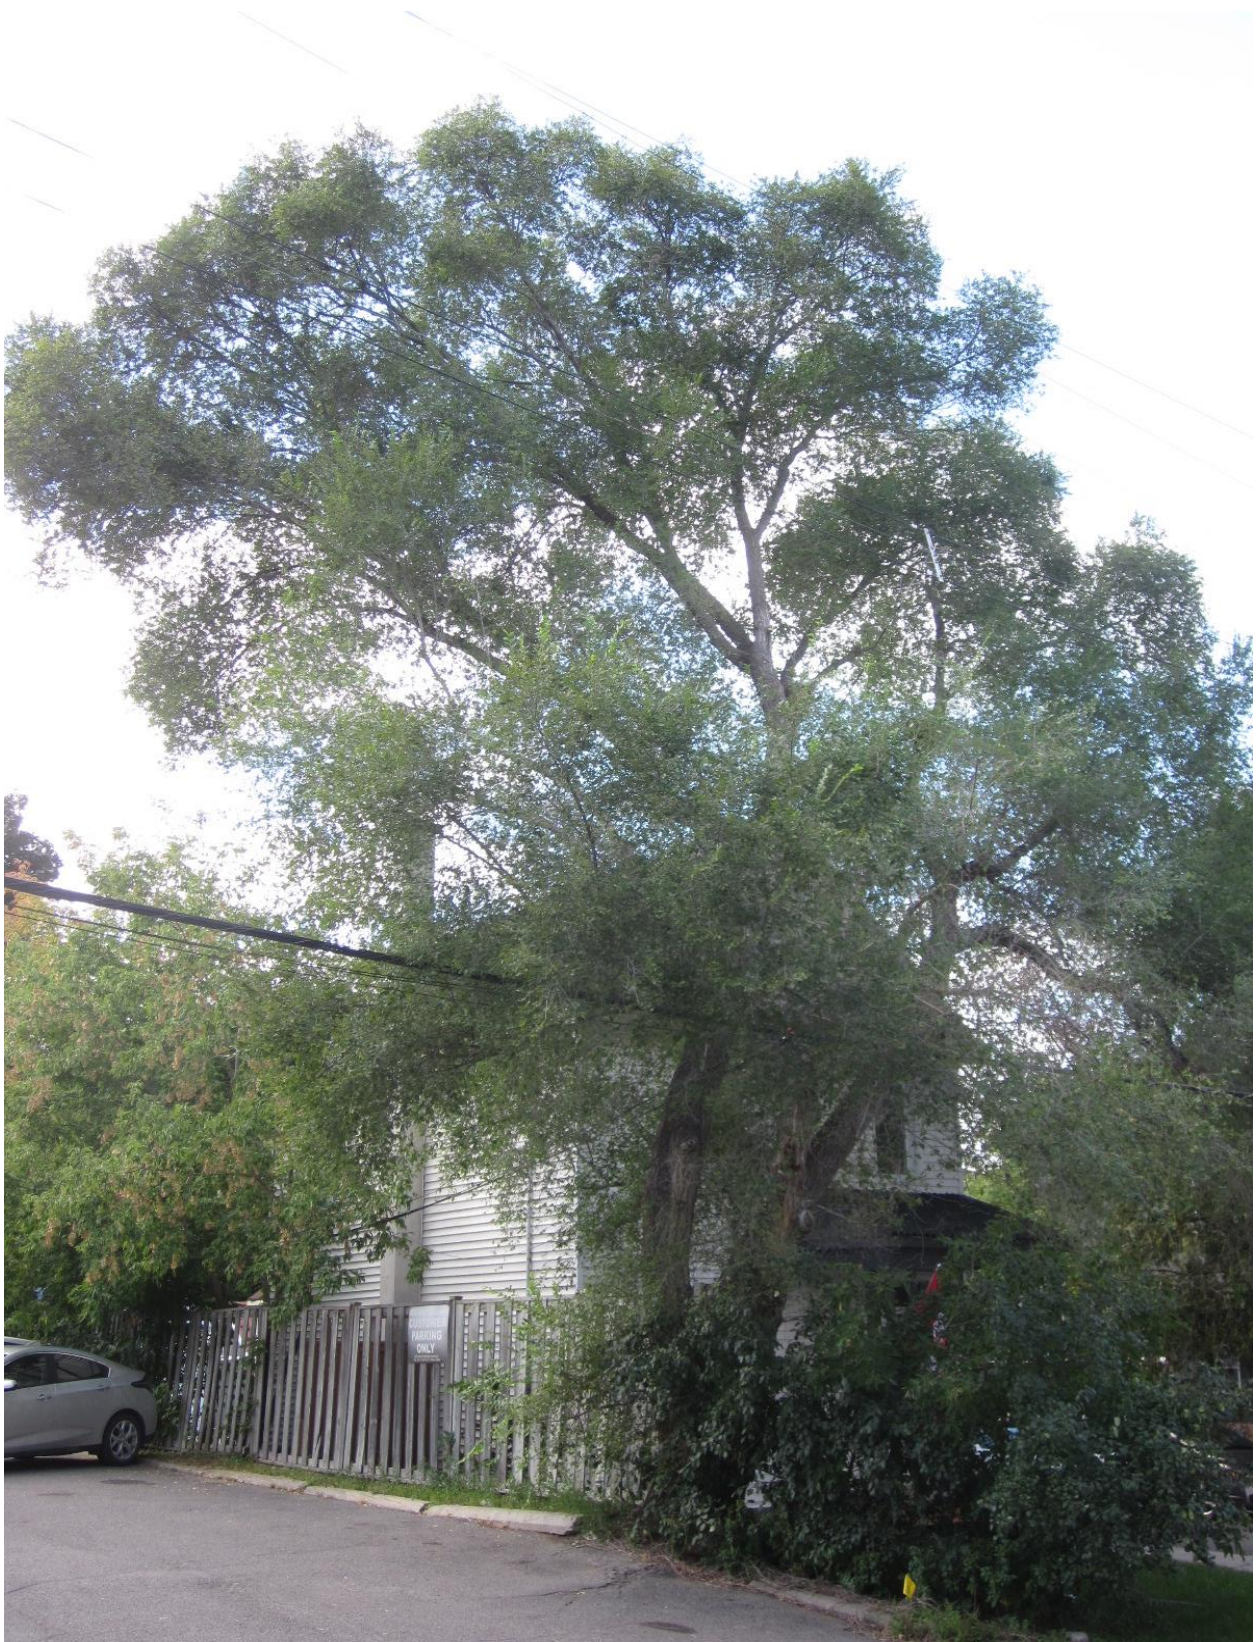
Picture 3. Tree #3 Siberian elm shared with 372 Tweedsmuir Avenue

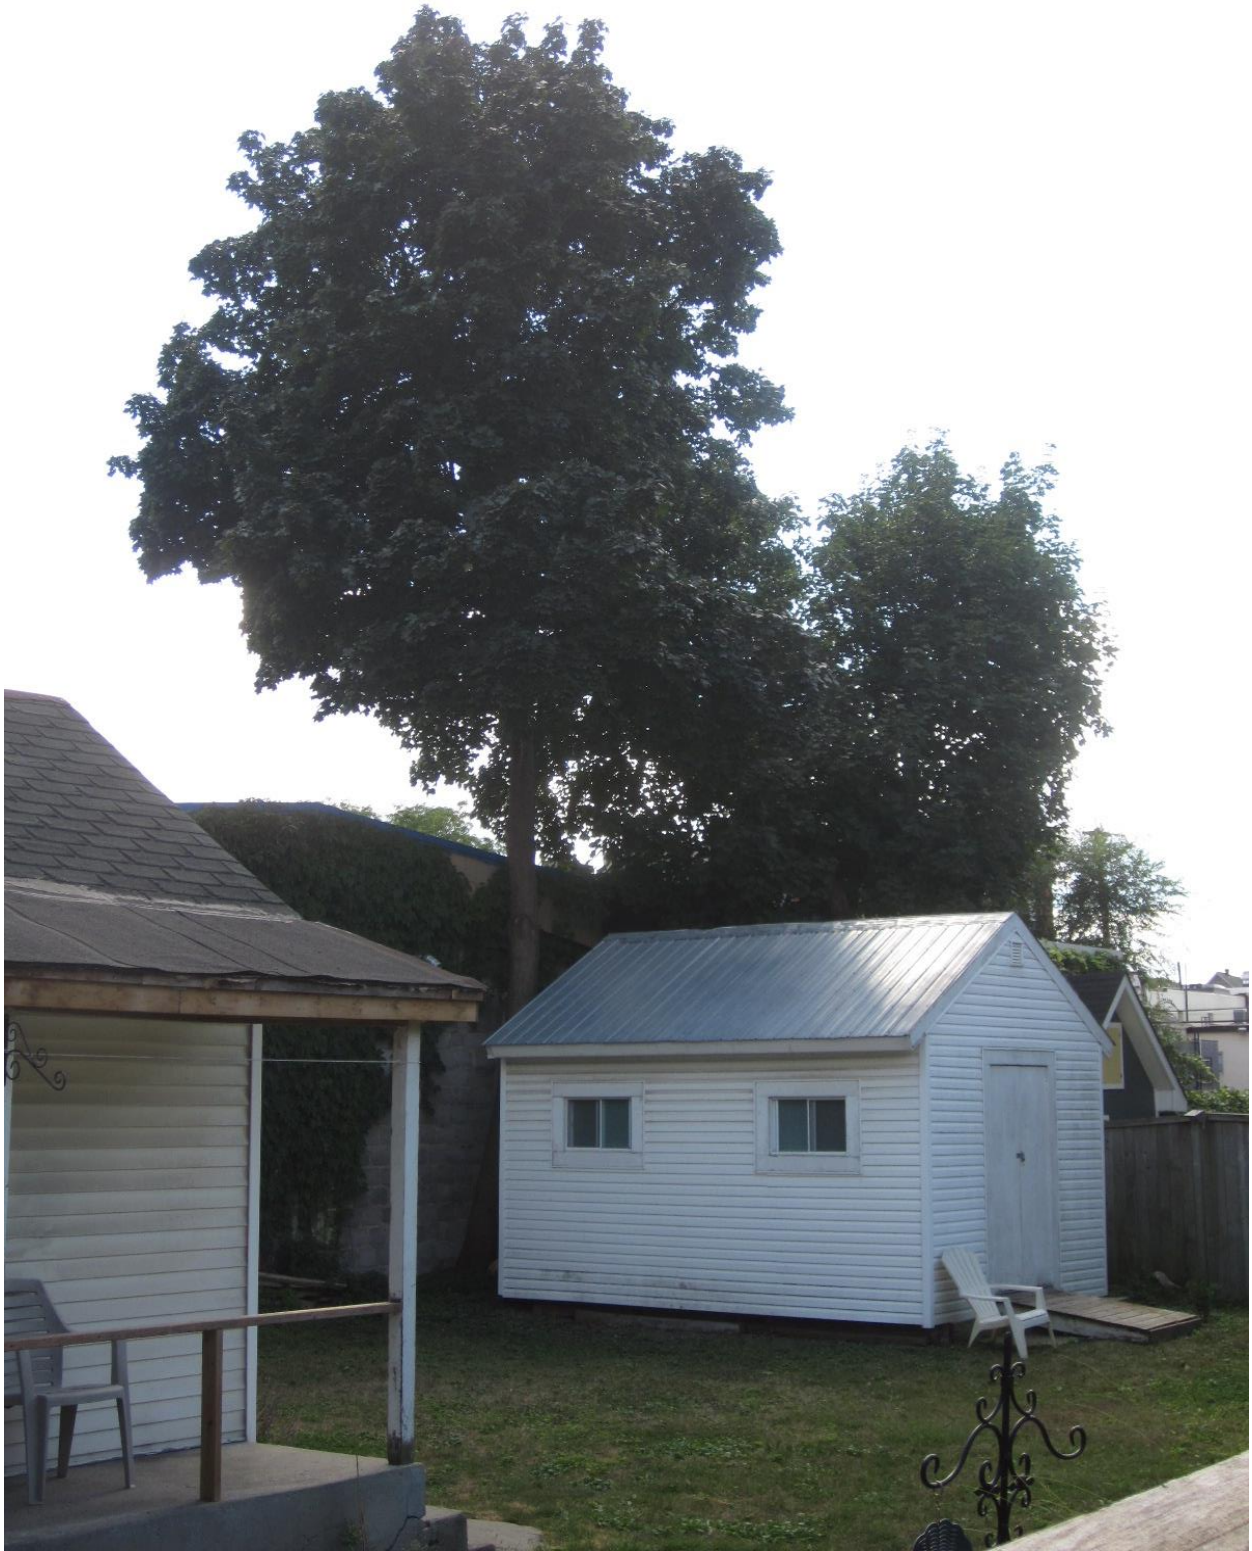
4	White cedar ( <i>Thuja occidentalis</i> )	Good	16.5 avg.	Private	Mature; nine individual stems within hedge line; good crown density, growth increment and needle colour; native species; <b>to be removed</b> (conflicts with construction)
5	Manitoba maple ( <i>Acer negundo</i> )	Fair	+/-10	Private	Maturing; four multi-stemmed trees which originated from seed; all divergent towards south (over commercial parking lot); naturalized species; <b>to be removed</b> (conflicts with construction)
6	Norway maple ( <i>Acer platanoides</i> )	Good	40.1	Private	Mature; single dominant stem for most of height; co-dominant leaders at 9.5m; lower crown asymmetric towards south and east due to influence of tree #7; introduced invasive species; <b>to be removed</b> (conflicts with construction)
7	Norway maple	Very poor	38.5	Shared	Mature; co-dominant stems at 2.5m with inclusion ridge at union; east stem broken at 5m due to eutypella canker ( <i>Eutypella parasitica</i> ), west stem previously topped at 5m – now with sweep; introduced invasive species; <b>to be removed</b> (conflicts with construction)

Picture 4. Trees #6 and 7 (left to right) located on or shared with 372 Tweedsmuir Avenue
