Tree Conservation Report for 3149 and 3169 Hawthorne Road, Ottawa, Ontario

StorageVault Inc. Owner/Applicant Toronto, Ontario

Report 22-002

Submitted March 21, 2022

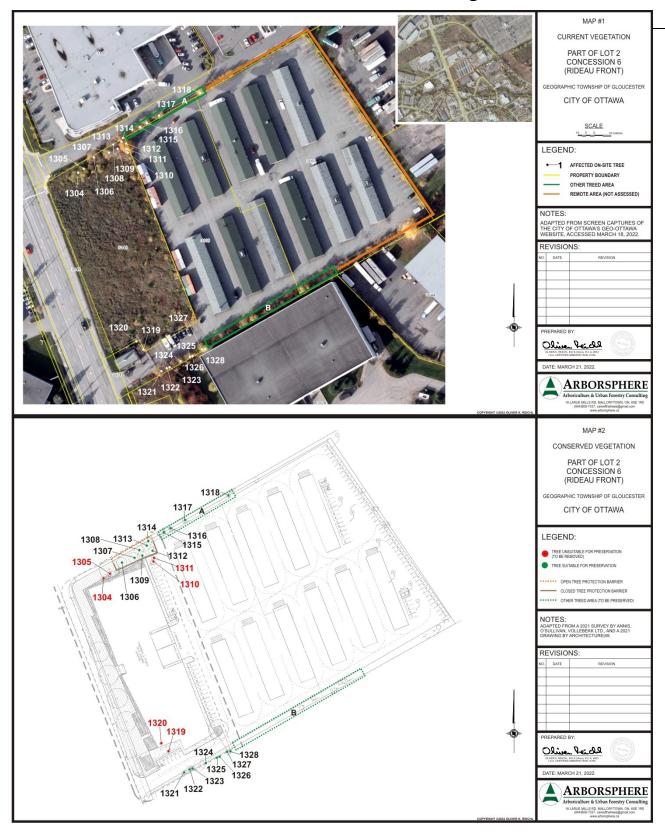
Tree Conservation Planning

Arboriculture field work was completed on March 10, 2021, resulting in an inventory of 21 affected trees. Two adjacent treed areas, adding a further 21 trees, were also noted. Tables 1 and 2 summarize my field observations and comments. Drawings in Appendix A show the locations and status of all surveyed trees.

Trees within the proposed building and parking envelopes cannot be saved. Various replacement trees have been proposed (Arch49 2021). One treed area has been identified for preservation and can be protected with open and closed CRZs. All trees along the southern boundary occur between a security fence and the property line. No construction is proposed along this boundary (Hirota 2022). Areas A and B are outside of the construction area and do not appear to need a CRZ.
