March 29, 2022

RE: TREE CONSERVATION REPORT FOR 2 ROBINSON AVENUE, OTTAWA

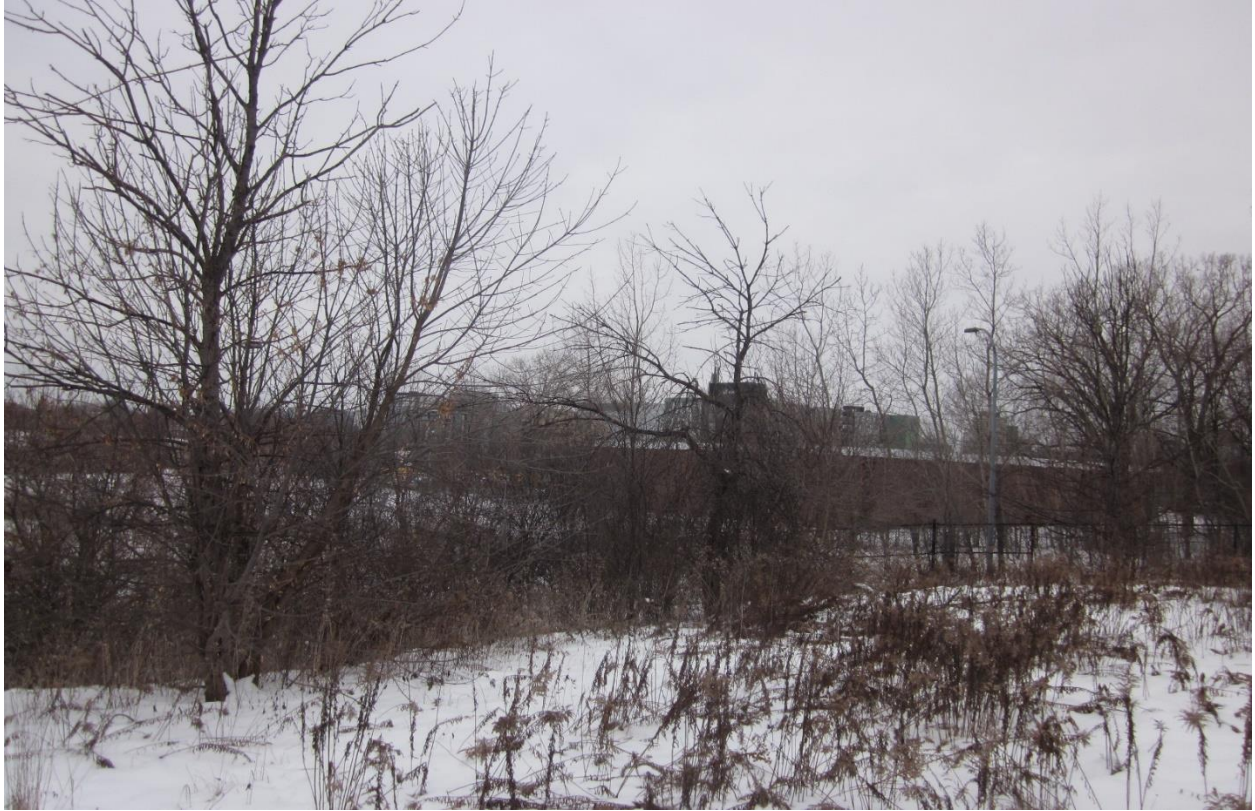
which are declining in health due to age. Other trees are suffering from biotic factors such as heavy vine growth (*Vitus* spp.), especially on edge trees, elms (*Ulmus americana*) killed by Dutch elm disease (*Ophiostoma ulmi/novo-ulmi*) and ash (*Fraxinus* spp.) killed by emerald ash borer (*Agrilus planipennis*).

Picture 1. Dead ash trees at 2 Robinson Avenue

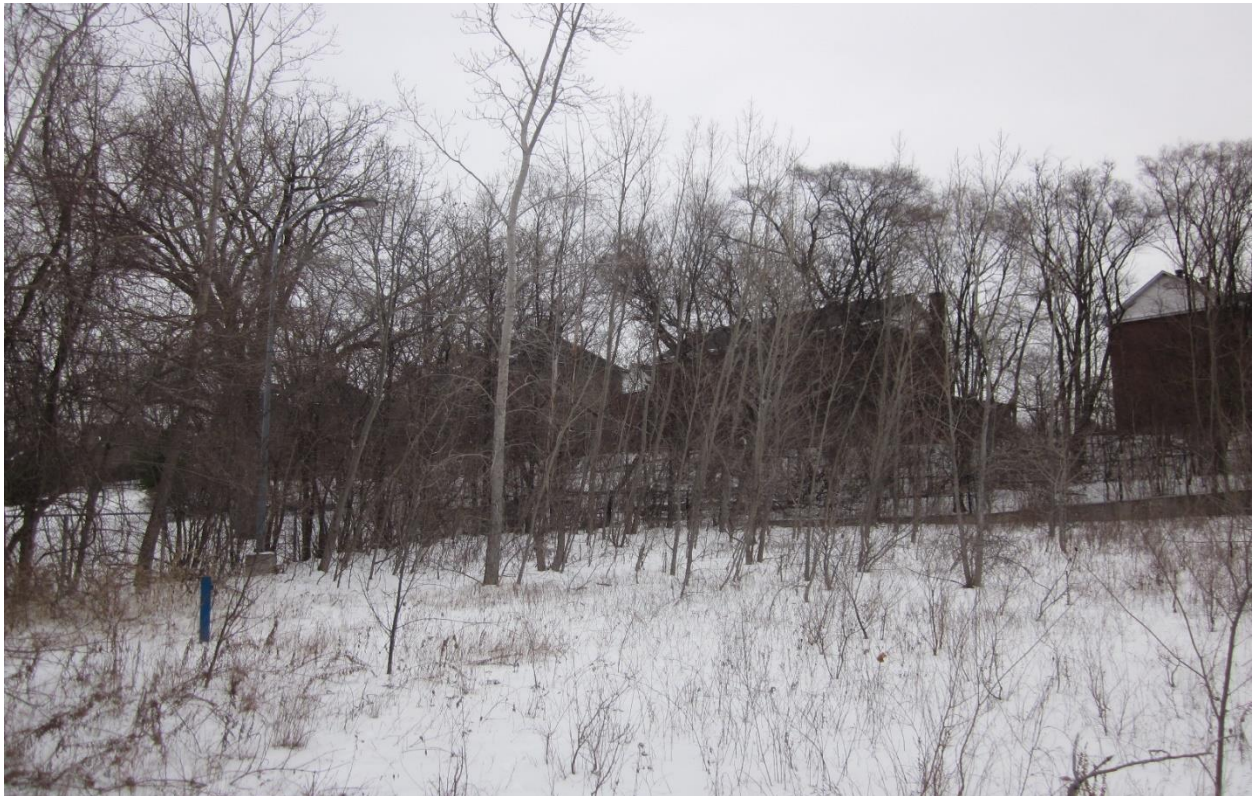
Picture 2. Poplars resulting from root sprouts at 2 Robinson Avenue

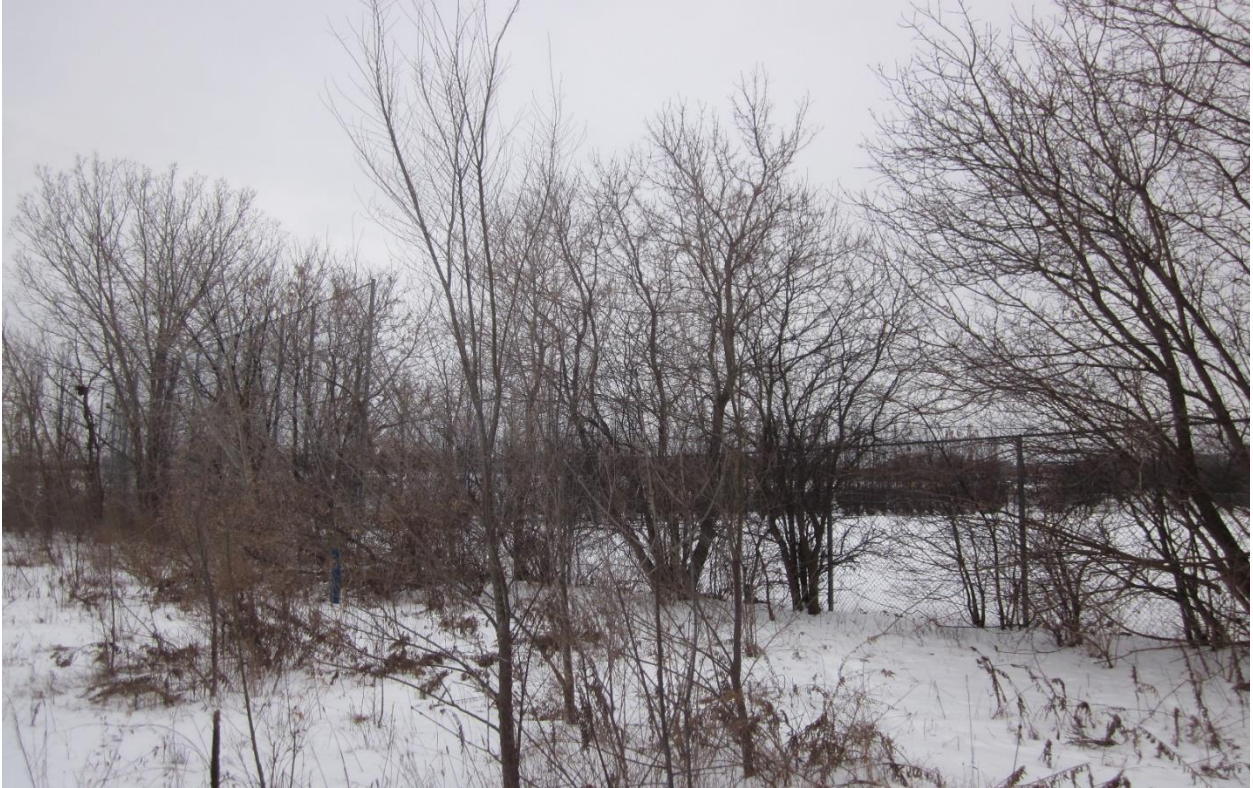
Picture 3. Seeded Siberian elms and Manitoba maples at 2 Robinson Avenue

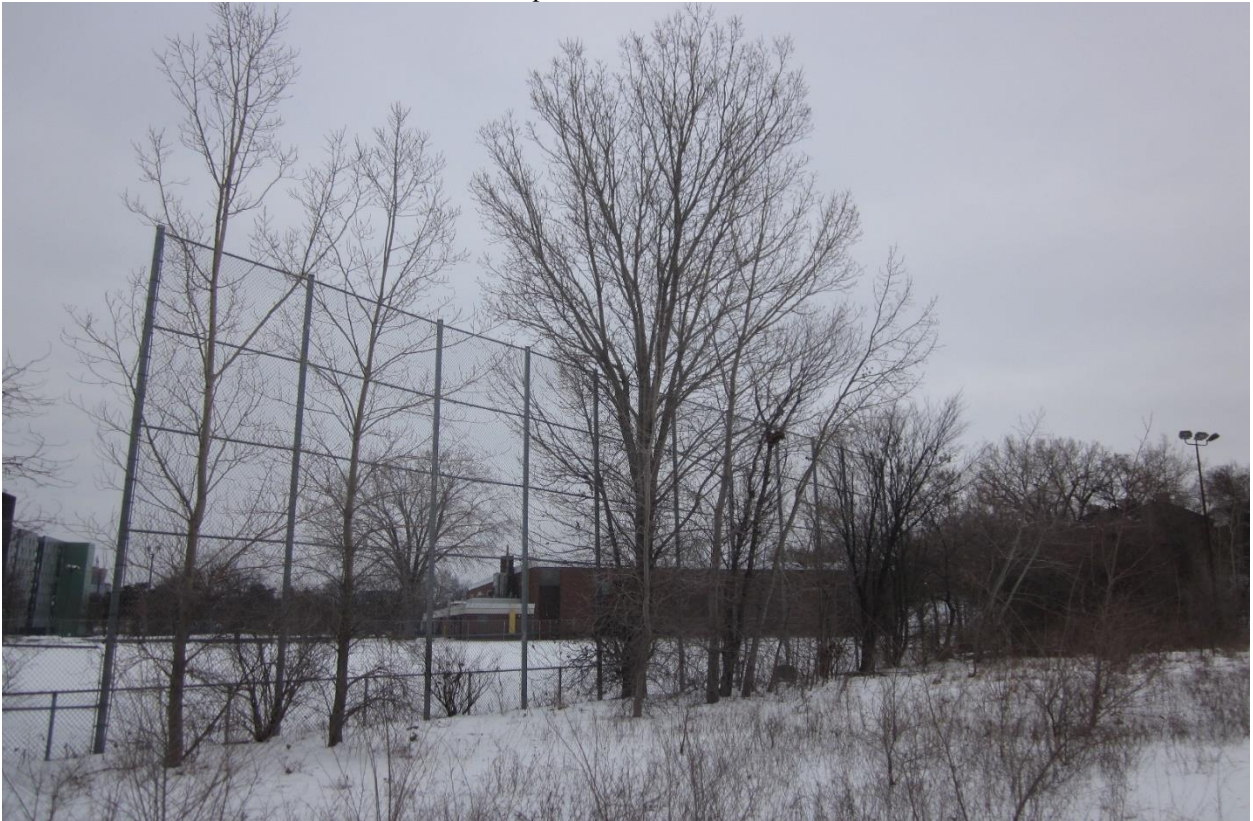
Picture 4. Poplars along western property line of 2 Robinson Avenue

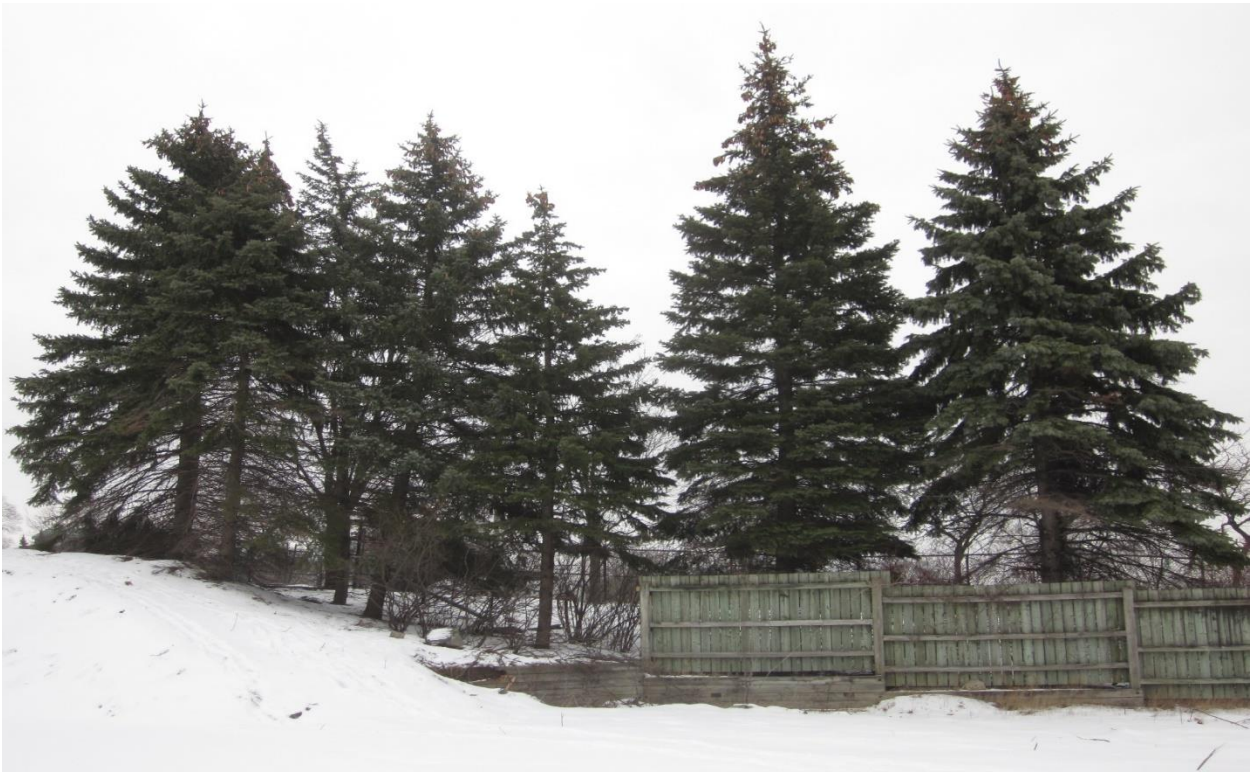
Picture 5. Planted grouping of Colorado spruce at 2 Robinson Avenue

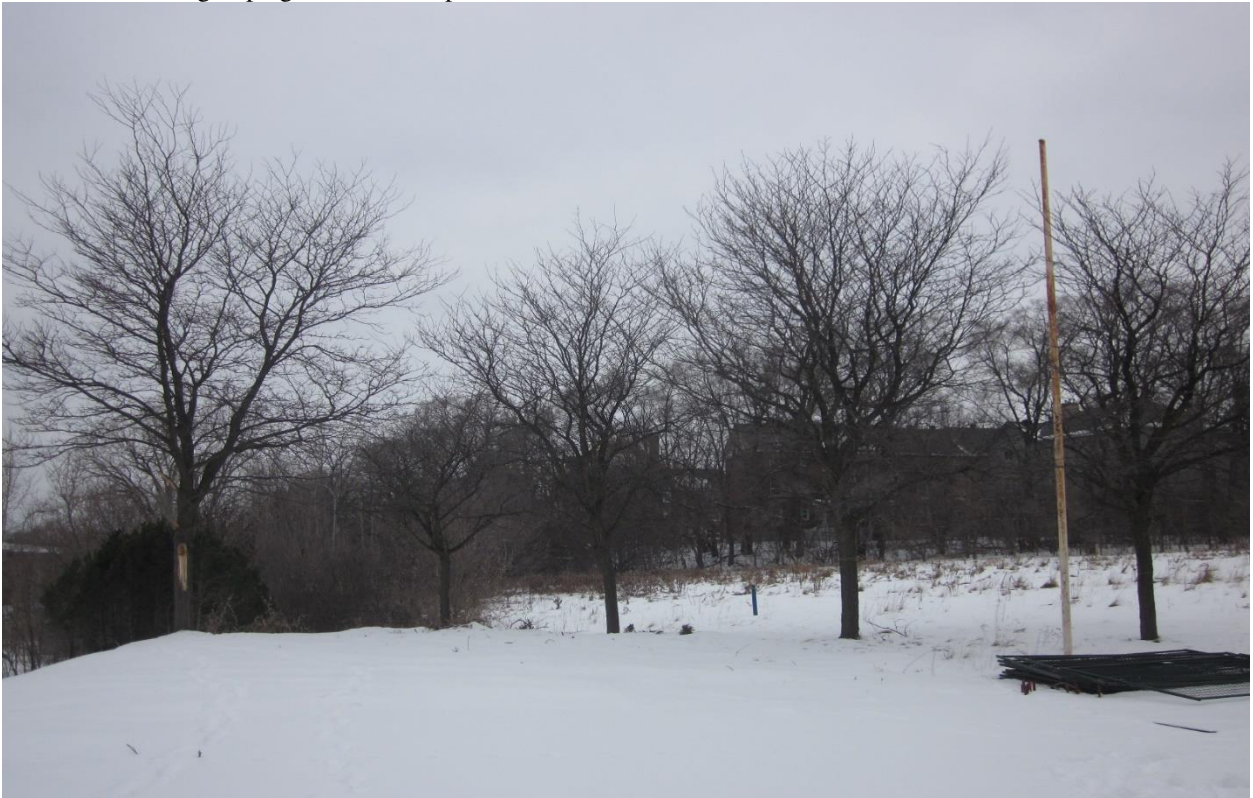
Picture 6. Line of planted honey-locust at 2 Robinson Avenue

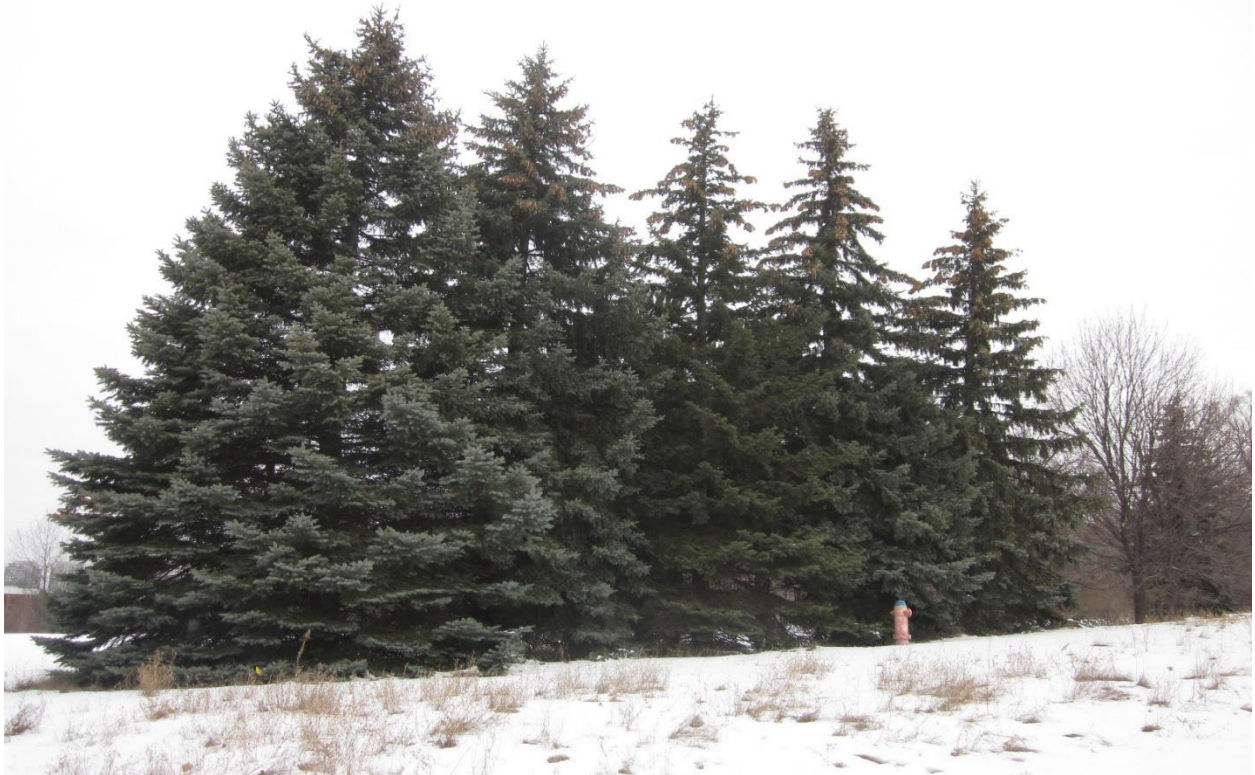
Picture 8. Planted grouping of Colorado spruce at 2 Robinson Avenue
