# TREE CONSERVATION REPORT

6001-6005 Renaud Road

Tree Conservation Report submitted as Partial  
Requirements for a Site Plan Control Application,  
August 15, 2024

# Tree Conservation Report

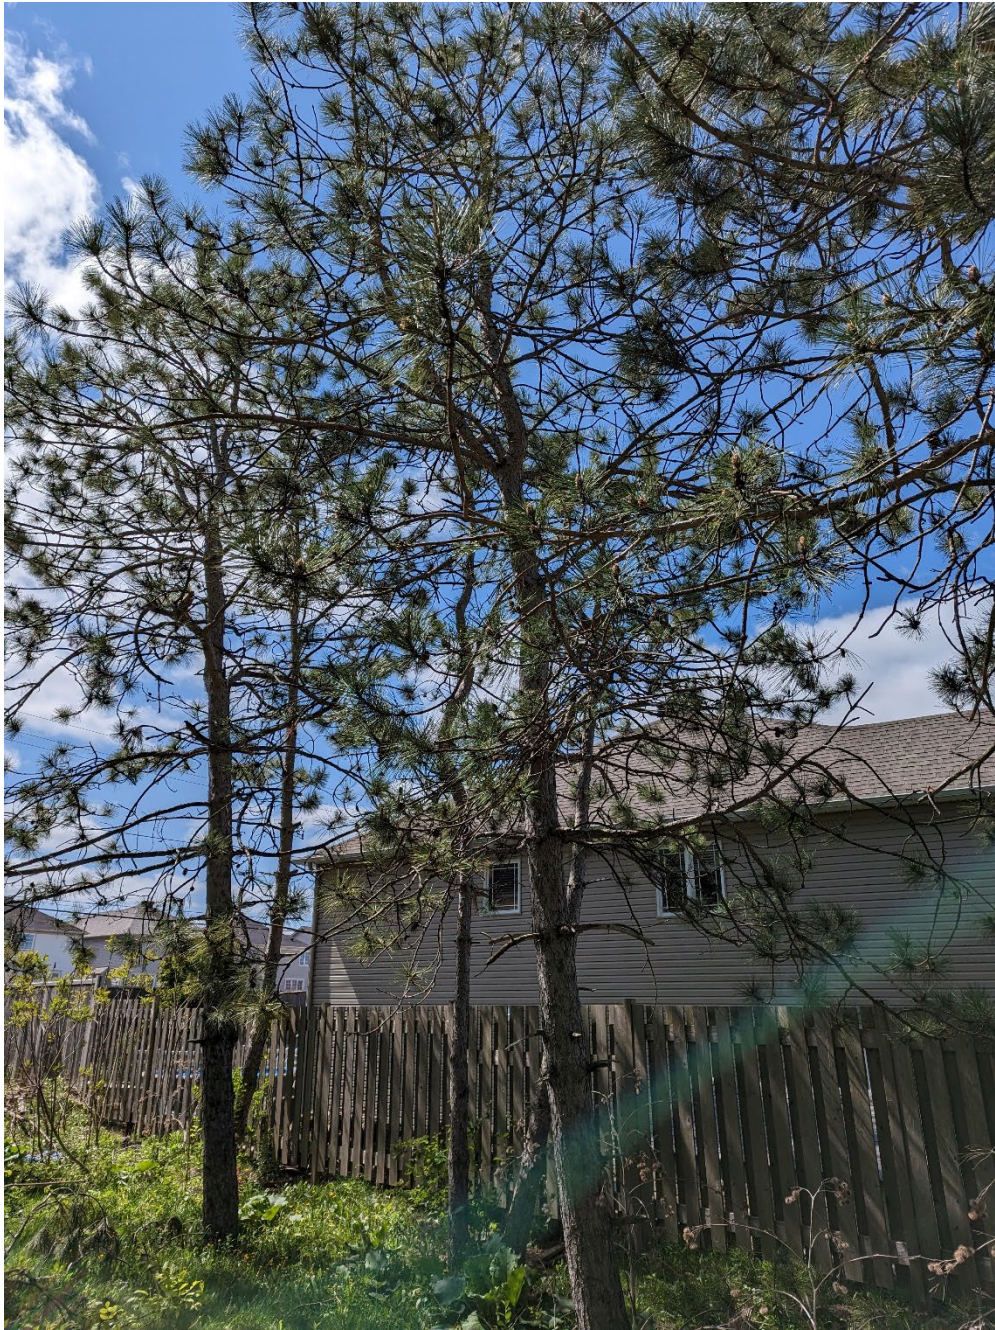
Figure 2 - (Left to Right) Trees 9-13

10	Red pine ( <i>P. resinosa</i> )	28	S.p.	Fair: thin crown	Retain and protect.
11	Red pine ( <i>P. resinosa</i> )	15	S.p.	Fair: thin crown	Retain and protect.
12	Red pine ( <i>P. resinosa</i> )	19	S.p.	Poor: thin crown; lean	Retain and protect.
13	Red pine ( <i>P. resinosa</i> )	26	S.p.	Fair: thin crown	Retain and protect.
14	Red pine ( <i>P. resinosa</i> )	31	S.p.	Fair: forked leader	Retain and protect.
15	Red pine ( <i>P. resinosa</i> )	24	S.p.	Fair	Retain and protect.
16	Red pine ( <i>P. resinosa</i> )	30	S.p.	Fair	Retain and protect.
17	Red pine ( <i>P. resinosa</i> )	17	S.p.	Fair	Retain and protect.

Upon review of the documents listed above, **Trees 9-20** should be retainable throughout construction if they are protected effectively. Tree protection as described below and shown in the map is to be installed prior to any site works.

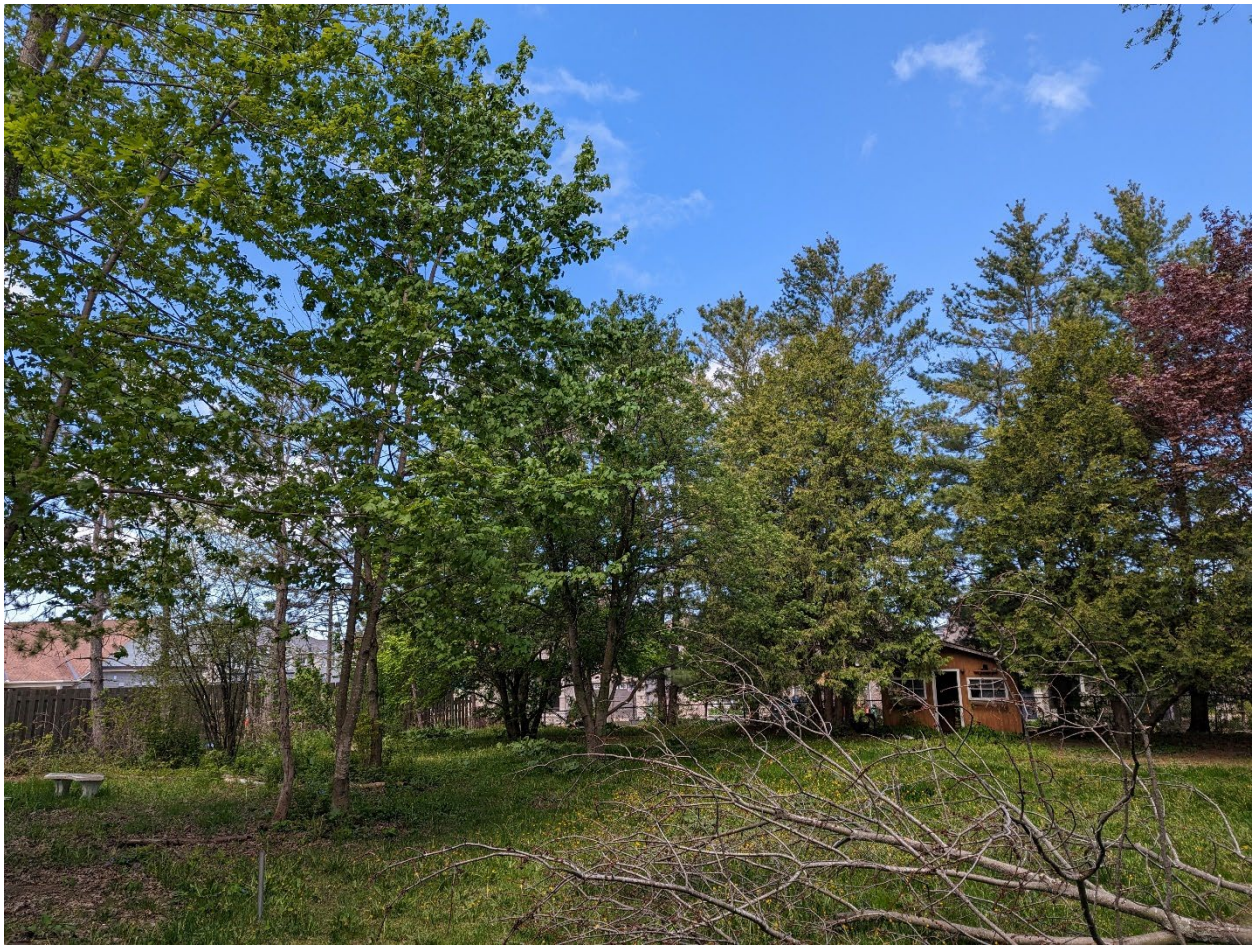
Figure 3 - Western corner of the property (Ziegler is behind the fence in the background)

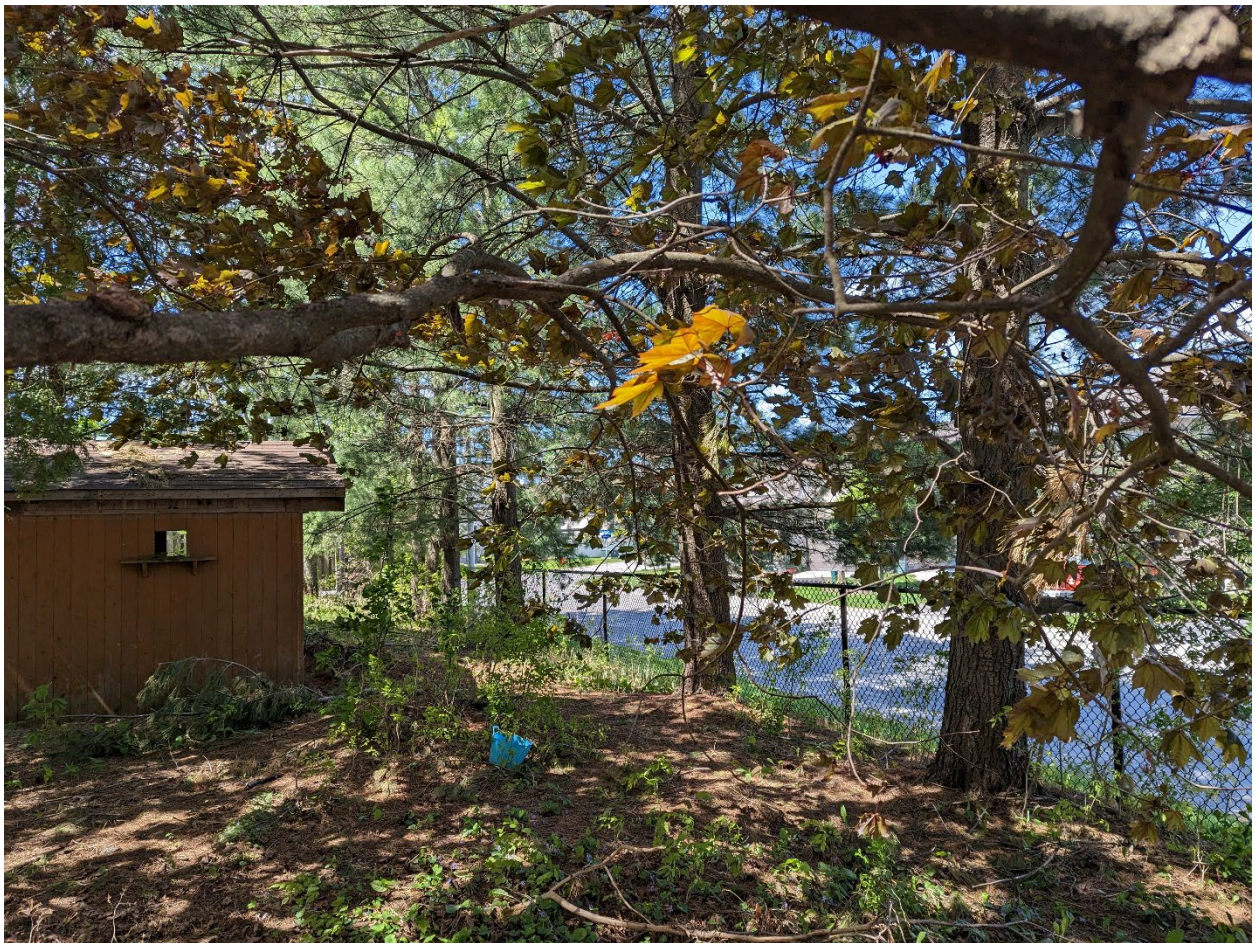
Figure 4 - White pines along the north property line

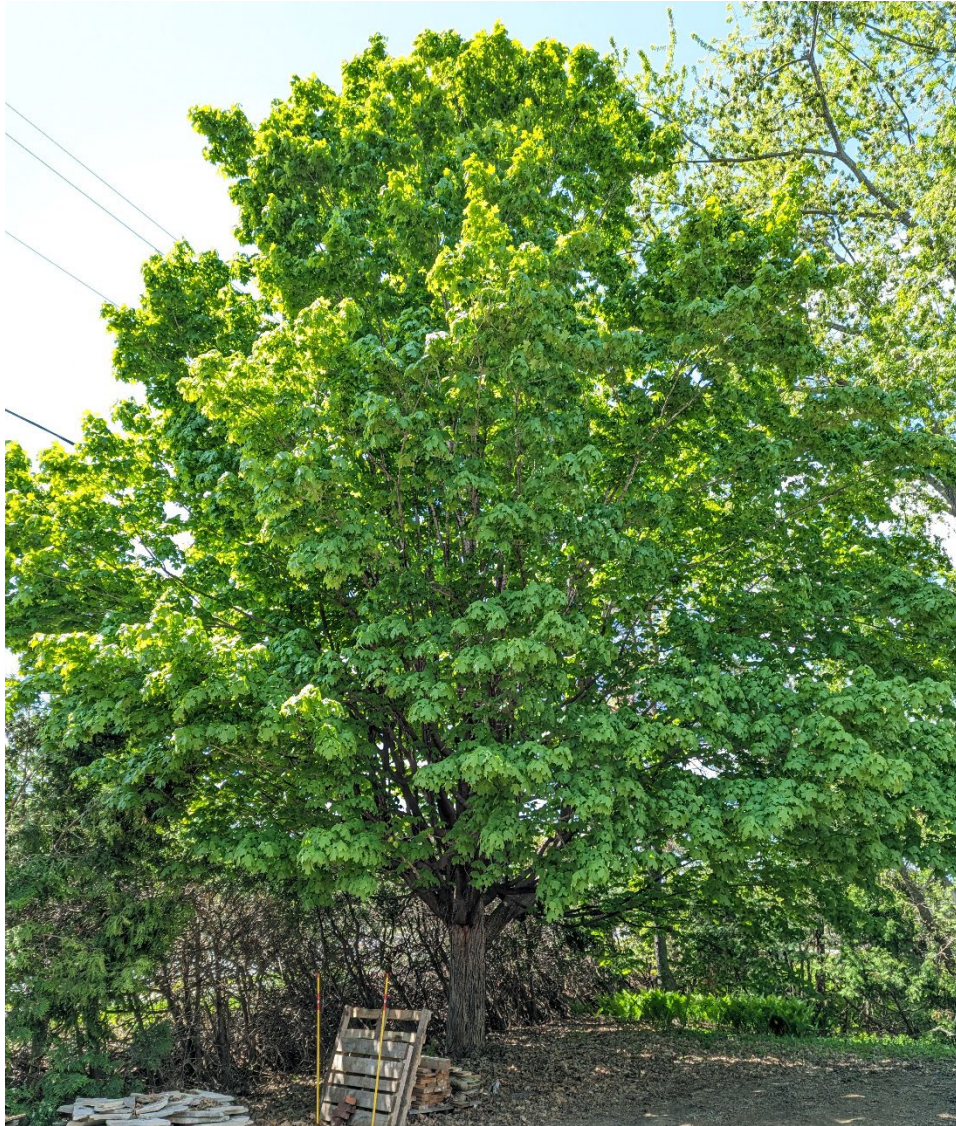
Figure 5 - Tree 37

30	Norway maple ( <i>A. platanoides</i> )	44	S.p.	Poor: canker on trunk and in crown; lean	Remove for staging.
31	Eastern white cedar ( <i>Thuja occidentalis</i> )	29, 11, 16	S.p.	Fair: tridominant stems; heavy lean on smaller stem	Remove for staging.
32	Eastern white cedar ( <i>T. occidentalis</i> )	6 stems 9-26cm	S.p.	Good/Fair	Remove for staging.
33	Tree lilac ( <i>Syringa reticulata</i> )	15, 7, 13, 19, 17	S.p.	Good/Fair	Remove for staging.
34	Mountain ash ( <i>Sorbus spp.</i> )	21, 24	S.p.	Fair: wound on trunk; sapsucker holes	Remove for staging.
35	Norway maple ( <i>A. platanoides</i> )	12, 14	S.p.	Fair: poor union – included bark	Remove.
36	Scot's pine ( <i>P. sylvestris</i> )	24, 20	S.p.	Poor: LCR <15%	Remove.
37	Sugar maple ( <i>Acer saccharum</i> )	55	S.p.	Fair: central leader is dead – has been replaced by side branches	Remove.

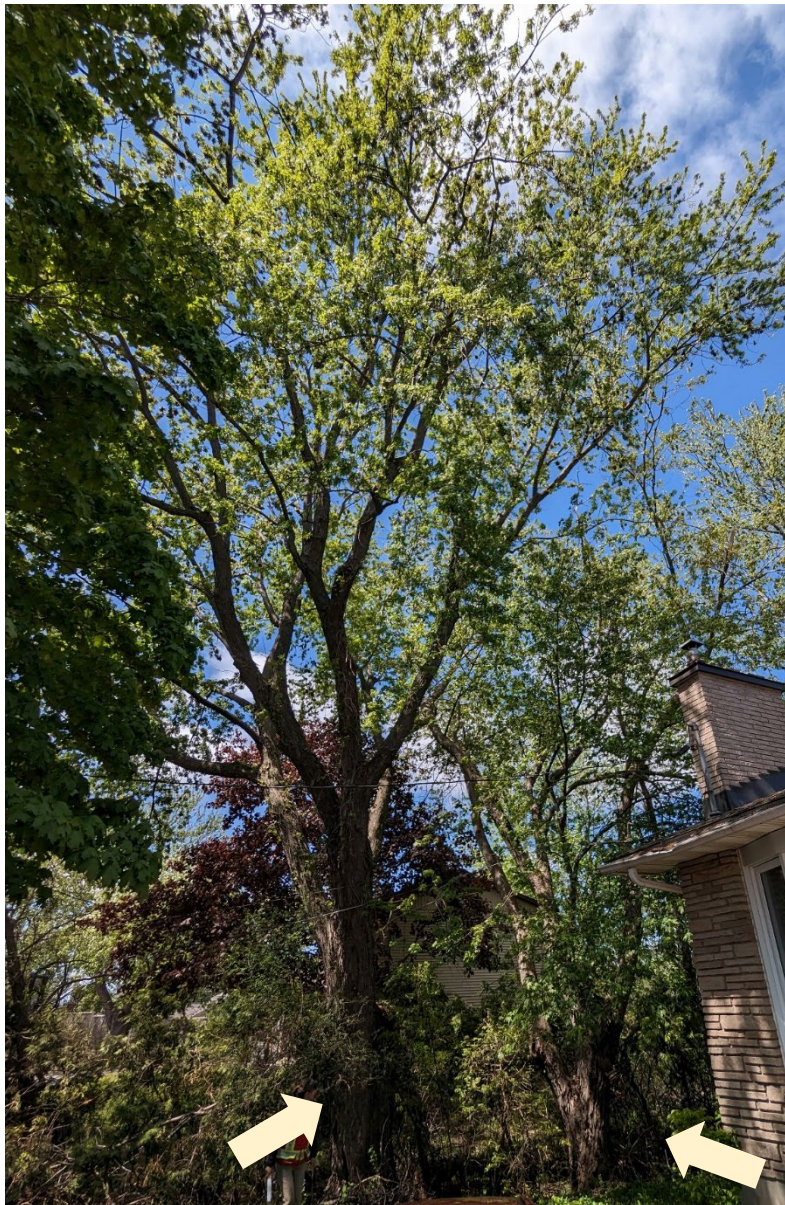
Figure 6 - (Left) Tree 38; (Right) Tree 39

38	Silver maple ( <i>A. saccharinum</i> )	110	S.p.	Fair: codominant stems with very large bulge at union; broken branches	Remove.
39	Silver maple ( <i>A. saccharinum</i> )	91	S.p.	Fair/Good: tridominant stems; cavities with decay (one >1/4 diameter, one <1/8)	Remove.
40	Silver maple ( <i>A. saccharinum</i> )	83	S.p.	Fair: large limb broken and hanging; decay at base where large stem was removed	Remove.
41	Silver maple ( <i>A. saccharinum</i> )	27, 57, 60	S.p.	Fair: three stems – smallest fusing with largest; small cavity at base	Remove for staging.
42	Scot's pine ( <i>P. sylvestris</i> )	35	S.p.	Fair: suppressed	Remove for staging.
43	Scot's pine ( <i>P. sylvestris</i> )	32	S.p.	Fair/Poor: thin crown	Remove for staging.
44	Scot's pine ( <i>P. sylvestris</i> )	35	S.p.	Fair/Good	Remove for staging.
45	Red pine ( <i>P. resinosa</i> )	33	S.p.	Good/Fair: slight lean with possible girdling root	Remove for staging.

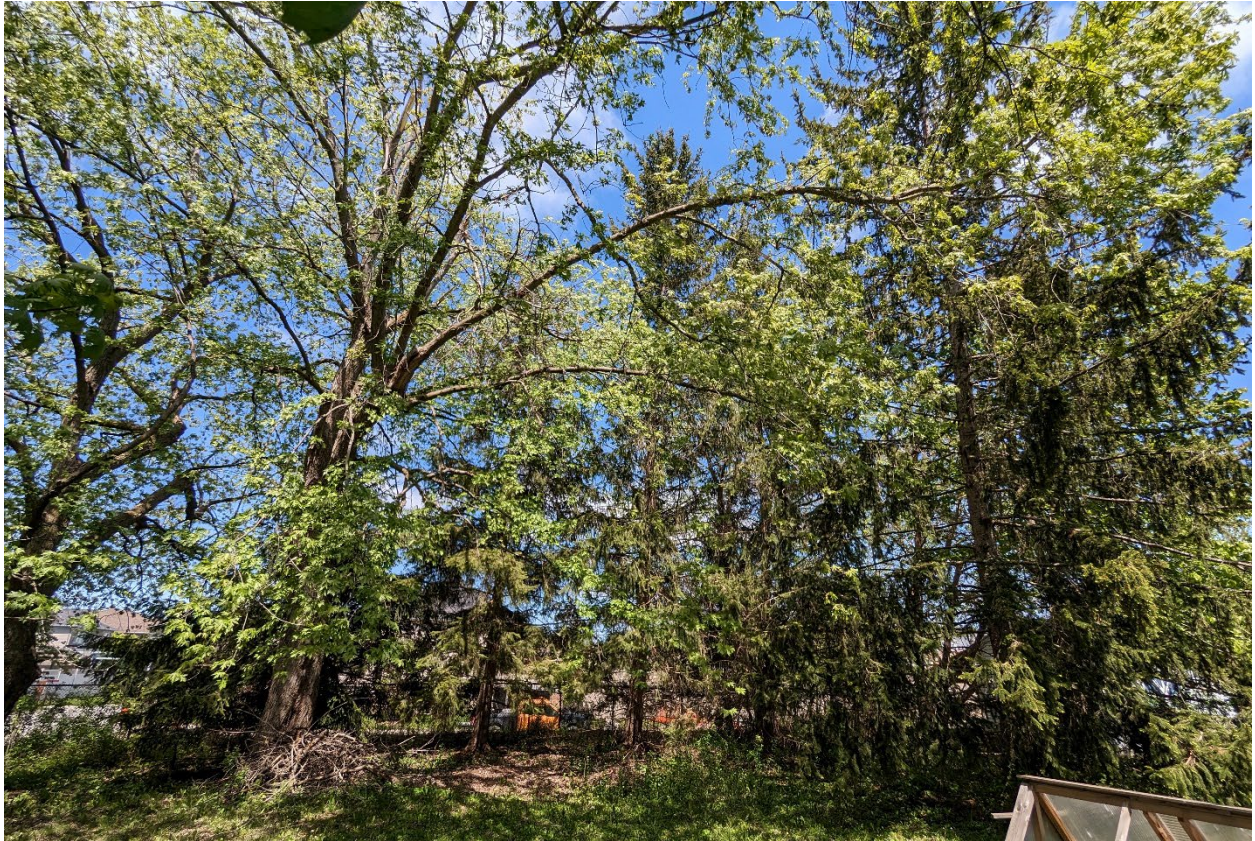
Figure 8 - Northwestern corner of the property

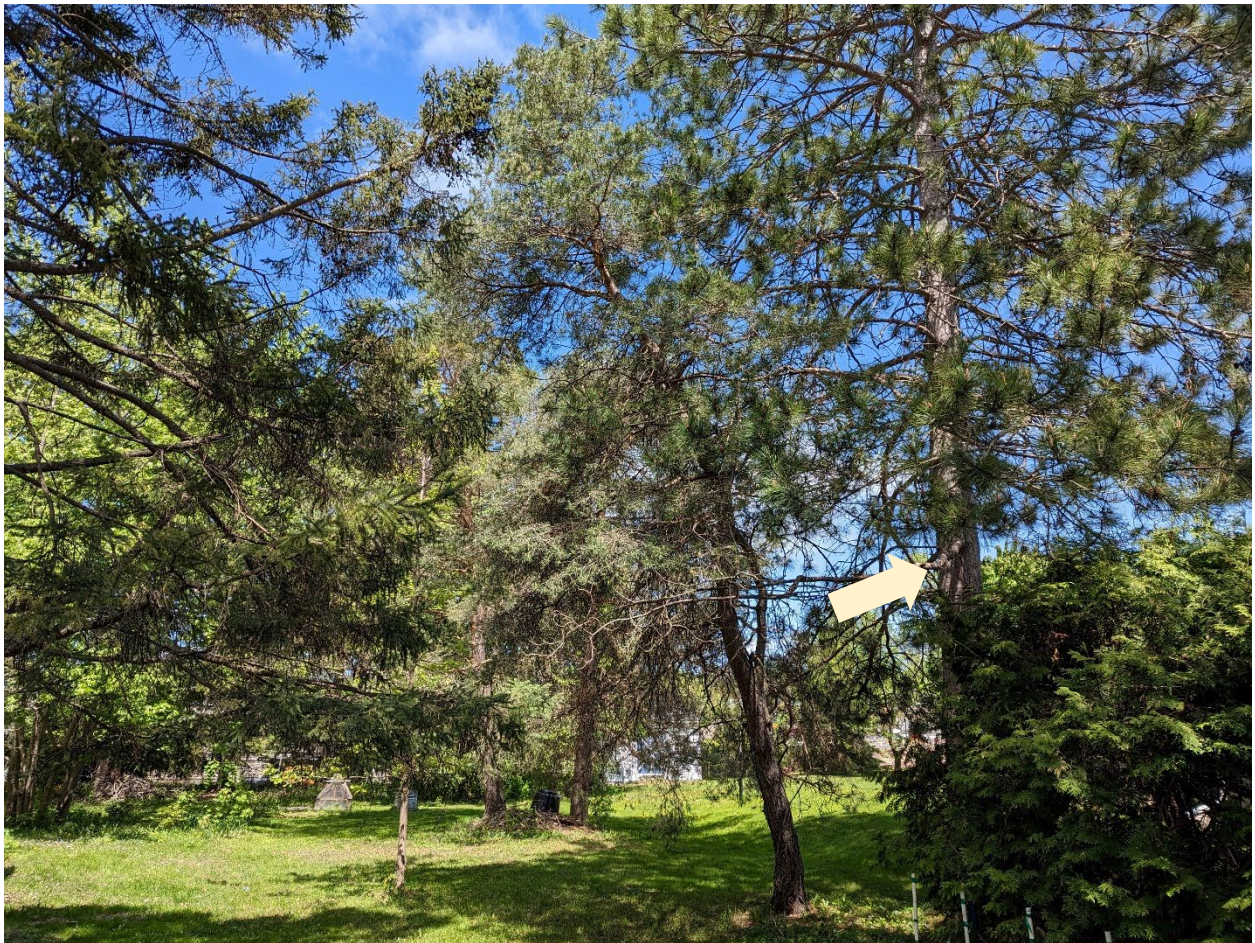
Figure 9 - Looking along the western property line. Tree 66 indicated with arrow

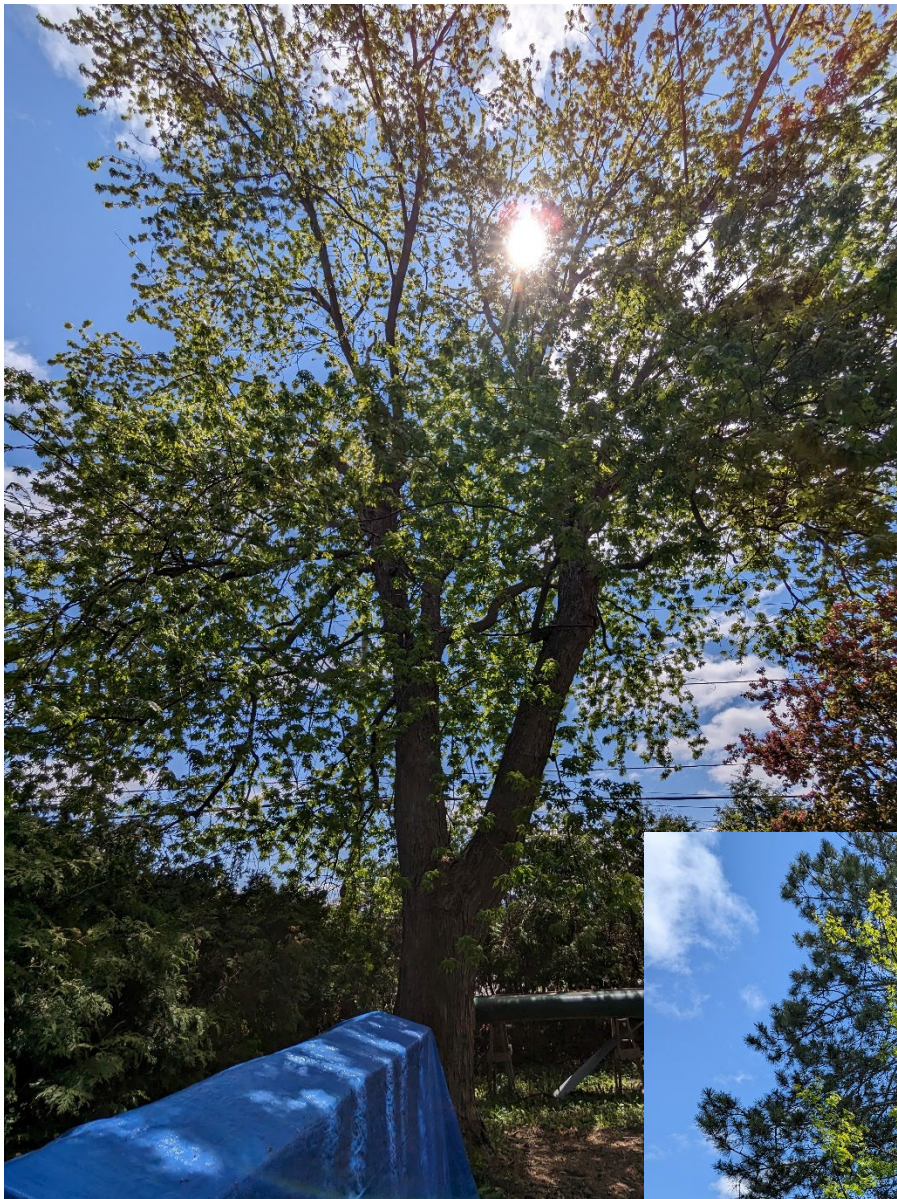
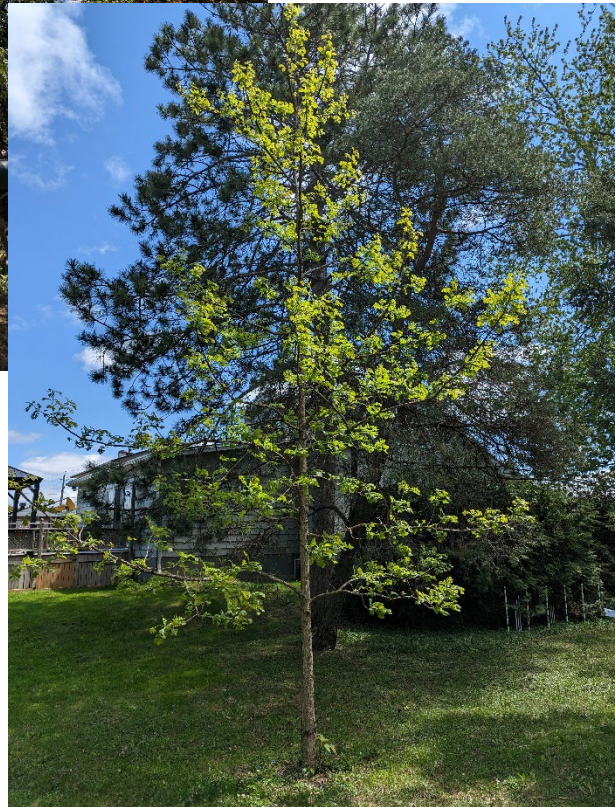
Figure 10 - (Above) Tree 68 (Right) Tree 64

67	White spruce ( <i>Picea glauca</i> )	31	S.p.	Fair/Poor: significant dieback in crown	Remove.
68	Silver maple ( <i>A. saccharinum</i> )	91	S.p.	Good	Remove.
