TREE CONSERVATION REPORT

6001-6005 Renaud Road

Tree Conservation Report submitted as Partial
Requirements for a Site Plan Control Application, June
12, 2023

Date of Report: June 12, 2023

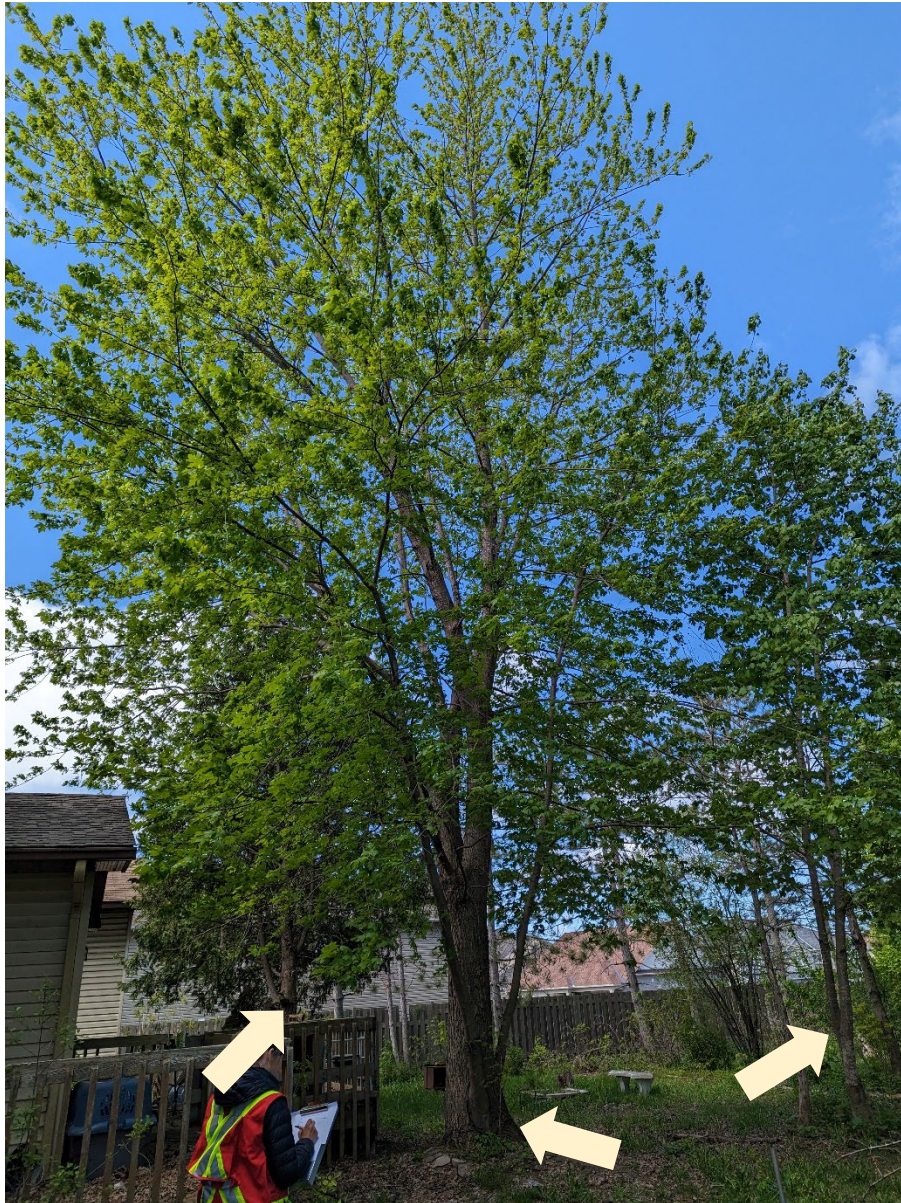
Figure 1 - (Left to Right) Trees 7, 6 & 35

Tree ¹	Species	DBH (cm)	Ownership ^{2,3}	Condition	Action
1	Silver maple (<i>Acer saccharinum</i>)	80	Subject property (S.p.)	Fair: epicormic shoots	Remove
2	Crabapple (<i>Malus spp.</i>)	31	S.p.	Fair/Good: mechanical injury on trunk; sapsucker holes	Remove
3	Norway maple (<i>Acer platanoides</i>)	38	S.p.	Good/Fair: possible canker on trunk	Remove
4 ⁴	Scot's pine (<i>Pinus sylvestris</i>)	29	S.p.	Fair/Good: shaded by Tree 38	Remove
5 ⁴	Scot's pine (<i>Pinus sylvestris</i>)	21	S.p.	Fair: suppressed	Remove
6	Silver maple (<i>A. saccharinum</i>)	12, 14, 56	S.p.	Good/Fair: codominant stems; sprouts from trunk becoming stems	Remove
7	Eastern white cedar (<i>Thuja occidentalis</i>)	29	S.p.	Fair	Remove
8 ³	Silver maple (<i>A. saccharinum</i>)	23	S.p.	Good/Fair: codominant stems; slight lean	Remove
9	Red pine (<i>Pinus resinosa</i>)	21	S.p.	Fair: thin crown	Retain and protect; limit excavation for new home

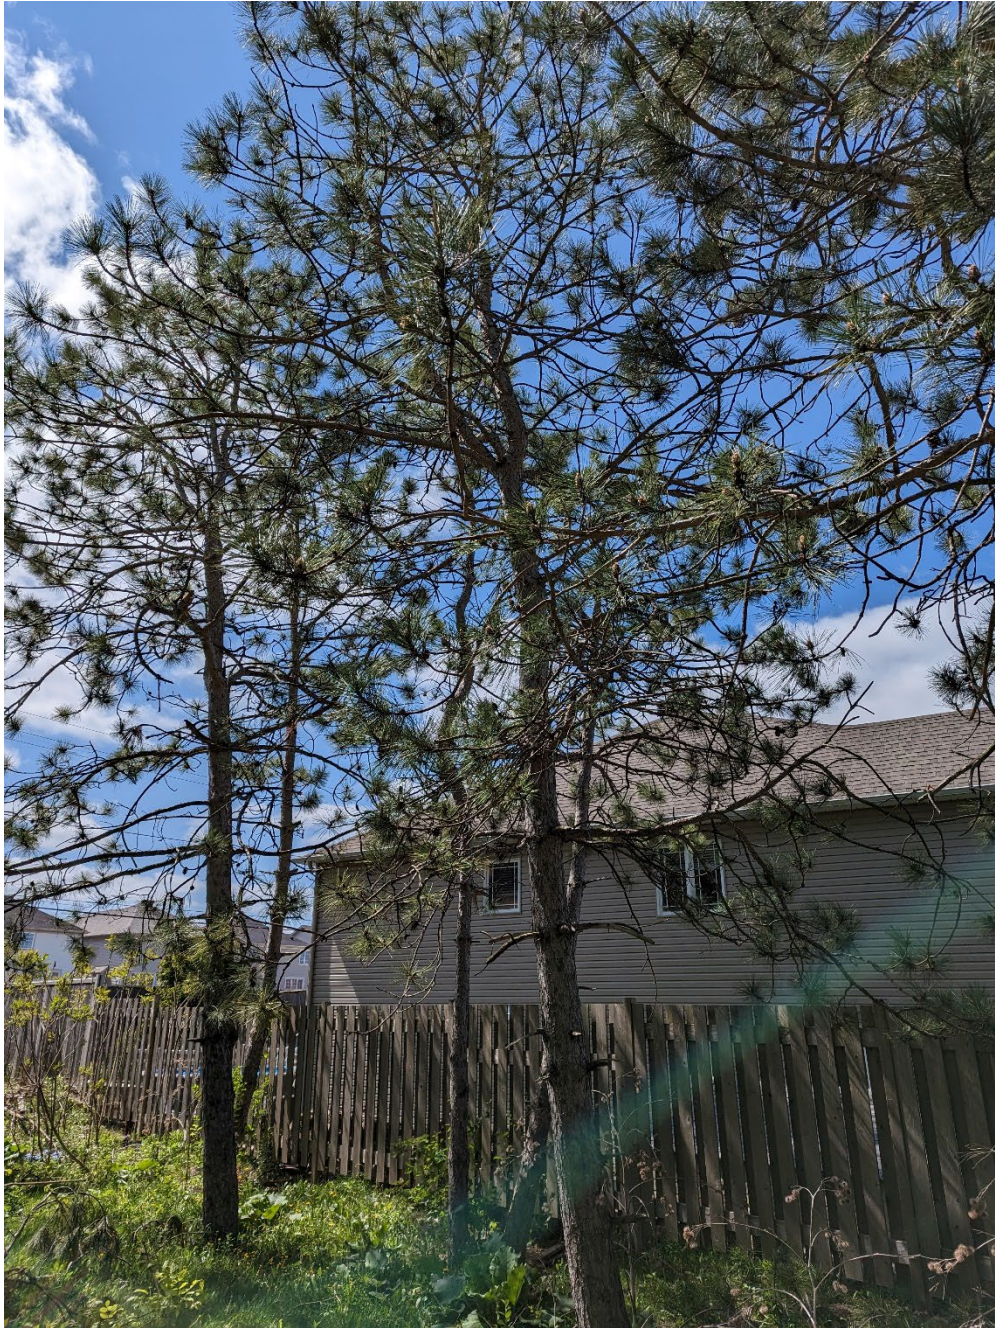
Figure 2 - (Left to Right) Trees 9-13

Trees 9-20 are established red pines. **Tree 20** conflicts with the proposed driveway, but most of the remaining trees can likely be effectively preserved. **Tree 16** is only approximately 1.5m away from the proposed building, and therefore it is expected that the excavation would need to come very close to the trunk. It is for this reason that removal is recommended of Tree 16. For the remainder of the trees in this group (i.e. **Trees 9-15, 17-19**), fencing is to be erected as described below and excavation for the adjacent building should be reduced as much as possible to reduce impact to these trees.

10	Red pine (<i>P. resinosa</i>)	28	S.p.	Fair: thin crown	Retain and protect; limit excavation for new home
11	Red pine (<i>P. resinosa</i>)	15	S.p.	Fair: thin crown	Retain and protect; limit excavation for new home
12	Red pine (<i>P. resinosa</i>)	19	S.p.	Poor: thin crown; lean	Retain and protect; limit excavation for new home
13	Red pine (<i>P. resinosa</i>)	26	S.p.	Fair: thin crown	Retain and protect; limit excavation for new home
14	Red pine (<i>P. resinosa</i>)	31	S.p.	Fair: forked leader	Retain and protect; limit excavation for

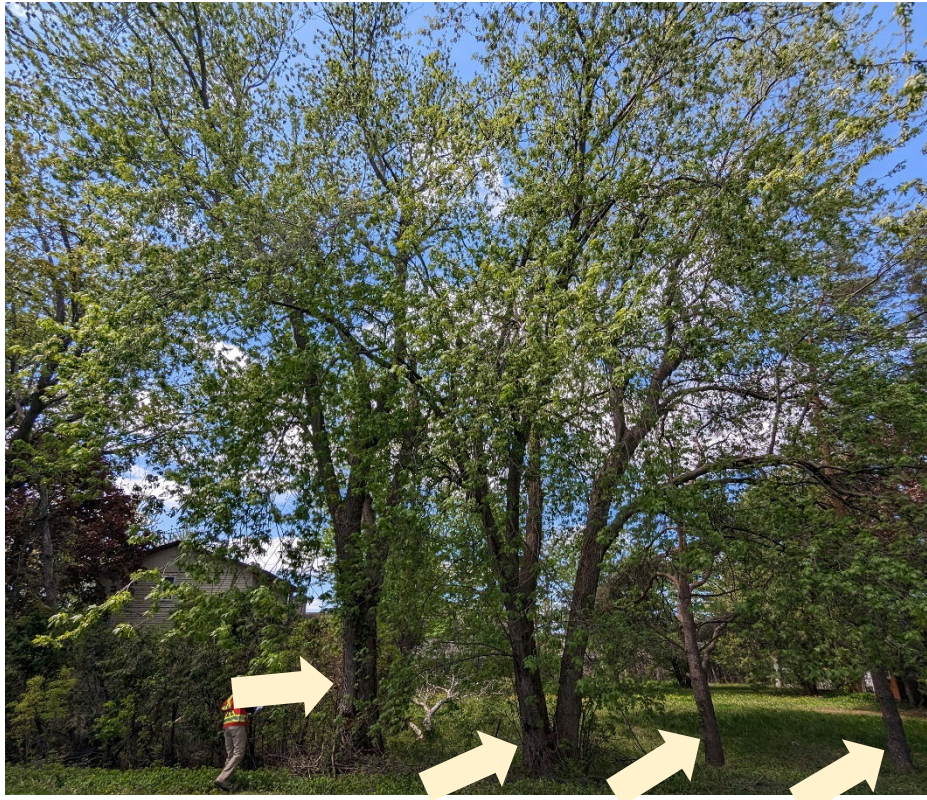
Figure 7 - (Left to Right) Trees 40-43

Initially, options were explored to retain some of the trees at the centre of the property such as 40 and 41, but due to sensitive marine clay soils on the site and the City of Ottawa Tree Planting in Sensitive Marine Clay Soils (2017 Guidelines), these large trees are not retainable.

26cm			
33	Tree lilac (<i>Syringa reticulata</i>)	15, 7, 13, 19, 17	S.p.	Good/Fair	Remove
34	Mountain ash (<i>Sorbus spp.</i>)	21, 24	S.p.	Fair: wound on trunk; sapsucker holes	Remove
35	Norway maple (<i>A. platanooides</i>)	12, 14	S.p.	Fair: poor union – included bark	Remove
36	Scot's pine (<i>P. sylvestris</i>)	24, 20	S.p.	Poor: LCR <15%	Remove
37	Sugar maple (<i>Acer saccharum</i>)	55	S.p.	Fair: central leader is dead – has been replaced by side branches	Remove
38	Silver maple (<i>A. saccharinum</i>)	110	S.p.	Fair: codominant stems with very large bulge at union; broken branches	Remove
39	Silver maple (<i>A. saccharinum</i>)	91	S.p.	Fair/Good: tridominant stems; cavities with decay (one >1/4 diameter, one <1/8)	Remove
40	Silver maple (<i>A. saccharinum</i>)	83	S.p.	Fair: large limb broken and hanging; decay at base where large stem was removed	Remove
41	Silver maple (<i>A. saccharinum</i>)	27, 57, 60	S.p.	Fair: three stems – smallest fusing with largest; small cavity at base	Remove

42	Scot's pine (<i>P. sylvestris</i>)	35	S.p.	Fair: suppressed	Remove
43	Scot's pine (<i>P. sylvestris</i>)	32	S.p.	Fair/Poor: thin crown	Remove
44	Scot's pine (<i>P. sylvestris</i>)	35	S.p.	Fair/Good	Remove
45	Red pine (<i>P. resinosa</i>)	33	S.p.	Good/Fair: slight lean with possible girdling root	Remove
46	Scot's pine (<i>P. sylvestris</i>)	25	S.p.	Good	Remove
47 ³	Scot's pine (<i>P. sylvestris</i>)	23	S.p.	Fair: suppressed	Remove
48	Scot's pine (<i>P. sylvestris</i>)	33	S.p.	Fair: crooks	Remove
49	Scot's pine (<i>P. sylvestris</i>)	37	S.p.	Fair: sapsucker	Remove

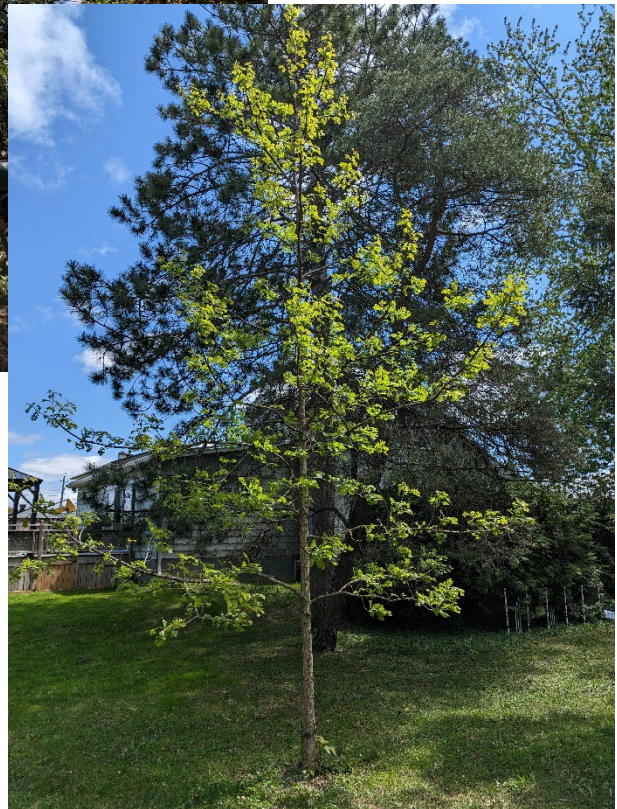
Figure 10 - (Above) Tree 68 (Right) Tree 64

60	Basswood (<i>Tilia americana</i>)	52	S.p.	Fair: hollow trunk with sprouts	Remove
61	Scot's pine (<i>P. sylvestris</i>)	42	S.p.	Fair/Good	Remove
62	Scot's pine (<i>P. sylvestris</i>)	33	S.p.	Fair	Remove
63	Silver maple (<i>A. saccharinum</i>)	8 stems 6-23cm	S.p.	Fair: growing as clump	Remove
64	Bur oak (<i>Quercus macrocarpa</i>)	9	S.p.	Good	Remove
65	Scot's pine (<i>P. sylvestris</i>)	26	S.p.	Fair: lean and crooks	Remove
66	Red pine (<i>P.</i>	49	S.p.	Good	Remove

<i>resinosa</i>)				
67	White spruce (<i>Picea glauca</i>)	31	S.p.	Fair/Poor: significant dieback in crown	Remove
68	Silver maple (<i>A.</i> <i>saccharinum</i>)	91	S.p.	Good	Remove
