TREE CONSERVATION REPORT

6001-6005 Renaud Road

Tree Conservation Report submitted as Partial
Requirements for a Site Plan Control Application, April
4, 2024

Tree Conservation Report

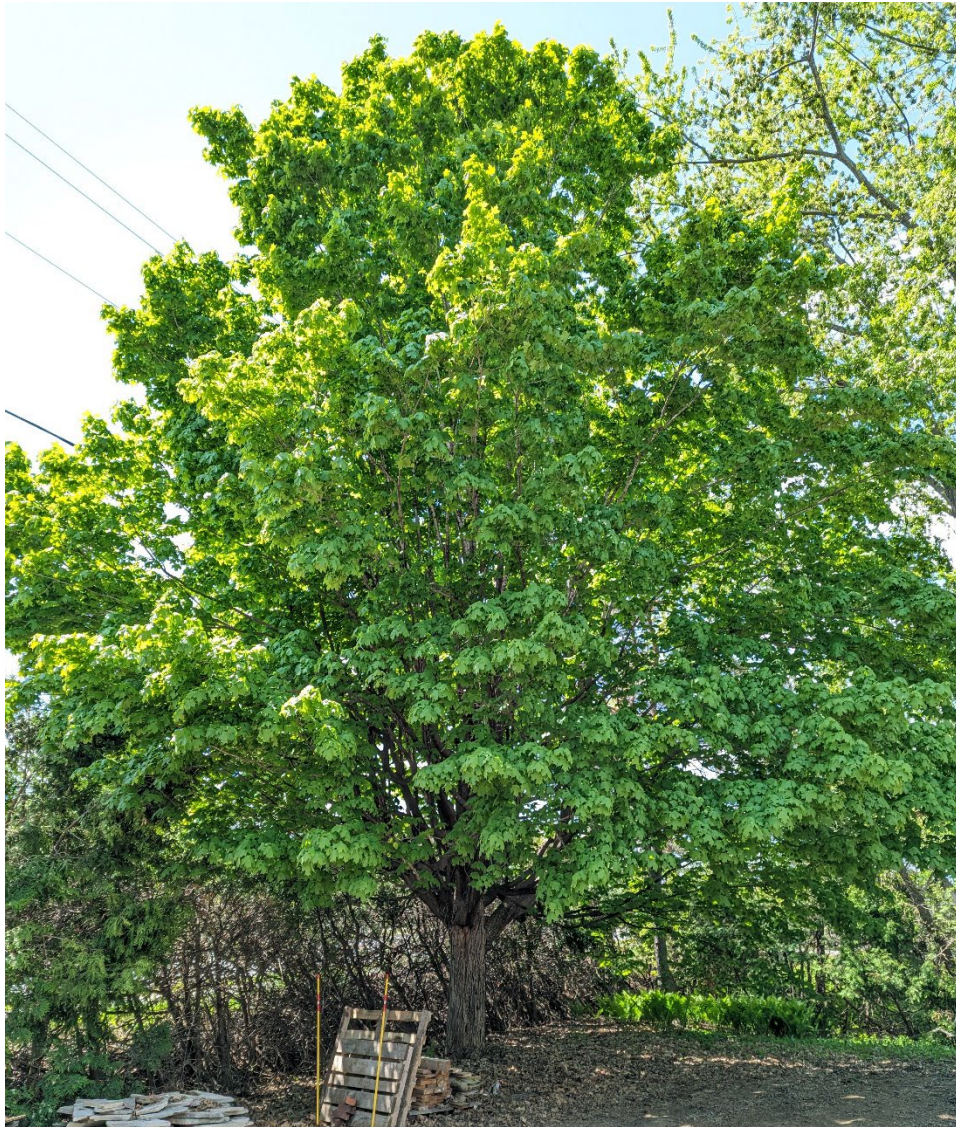
Figure 5 - Tree 37

36	Scot's pine (<i>P. sylvestris</i>)	24, 20	S.p.	Poor: LCR <15%	Remove
37	Sugar maple	55	S.p.	Fair: central leader is	Remove

(<i>Acer saccharum</i>)			dead – has been replaced by side branches	
38	Silver maple (<i>A. saccharinum</i>)	110	S.p.	Fair: codominant stems with very large bulge at union; broken branches	Remove
39	Silver maple (<i>A. saccharinum</i>)	91	S.p.	Fair/Good: tridominant stems; cavities with decay (one >1/4 diameter, one <1/8)	Remove
40	Silver maple (<i>A. saccharinum</i>)	83	S.p.	Fair: large limb broken and hanging; decay at base where large stem was removed	Remove
41	Silver maple (<i>A. saccharinum</i>)	27, 57, 60	S.p.	Fair: three stems – smallest fusing with largest; small cavity at base	Remove
42	Scot's pine (<i>P. sylvestris</i>)	35	S.p.	Fair: suppressed	Retain and protect for this phase
43	Scot's pine (<i>P. sylvestris</i>)	32	S.p.	Fair/Poor: thin crown	Retain and protect for this phase
44	Scot's pine (<i>P. sylvestris</i>)	35	S.p.	Fair/Good	Retain and protect for this phase
45	Red pine (<i>P. resinosa</i>)	33	S.p.	Good/Fair: slight lean with possible girdling root	Retain and protect for this phase

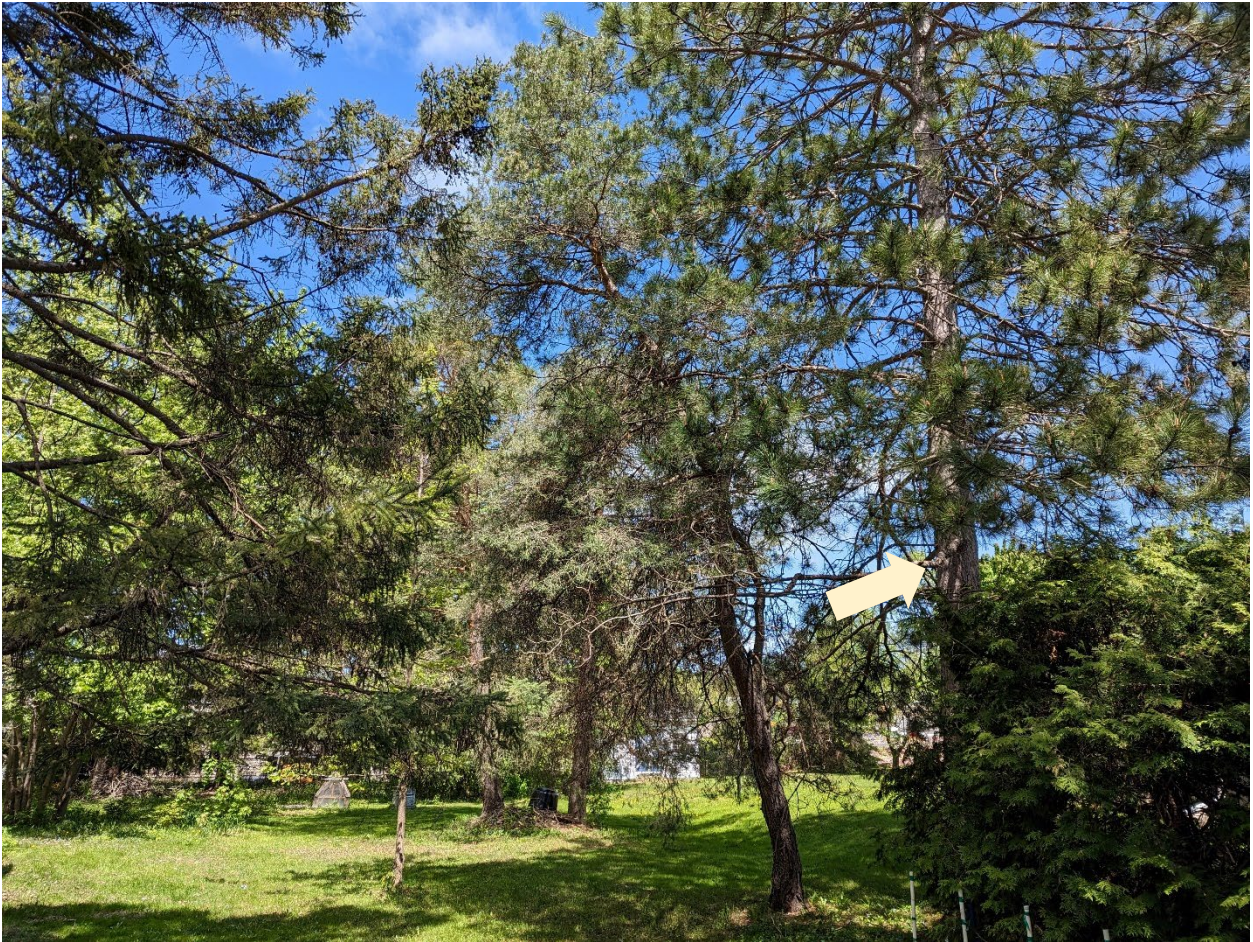
Figure 9 - Looking along the western property line. Tree 66 indicated with arrow

66	Red pine (<i>P. resinosa</i>)	49	S.p.	Good	Remove
67	White spruce (<i>Picea glauca</i>)	31	S.p.	Fair/Poor: significant dieback in crown	Remove
68	Silver maple (<i>A. saccharinum</i>)	91	S.p.	Good	Remove
