**TREE CONSERVATION
REPORT V3.0
1940 Carling Avenue**

Tree Conservation Report submitted as Partial
Requirements for a Site Plan Control Application,
February 15, 2023

Address: 1940 Carling Ave

Date: February 15, 2023

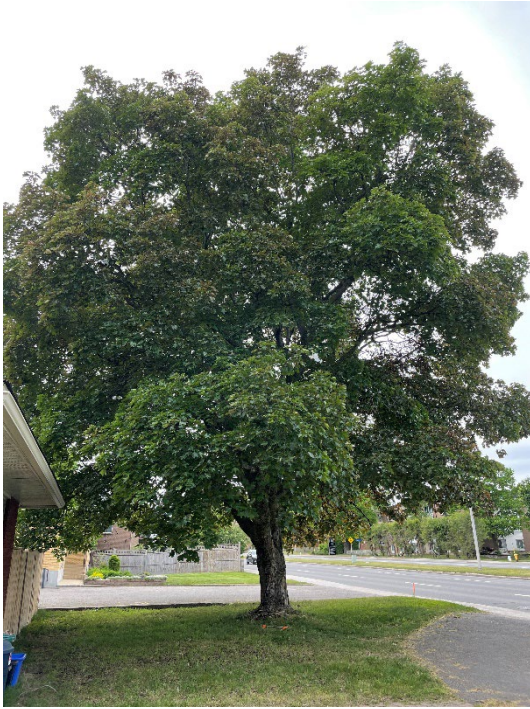
Tree ¹	Species	Diameter at breast height (dbh)	Ownership ^{2,3}	Condition	Action
1	Norway maple (<i>Acer platanoides</i>)	77 cm	Private	Fair/poor; multiple spiral frost cracks on trunk, significant deadwood	Remove; within proposed building footprint
2	Norway maple (<i>Acer platanoides</i>)	75 cm (estimate)	Private	Poor; earlier loss of other codominant trunk, 1 m long branch attachment wound, significant crown dieback	Remove based on health and within building footprint
3	Austrian pine (<i>Pinus nigra</i>)	31 cm	Private	Good	Remove; within less than a metre of proposed excavation
4	American elm (<i>Ulmus americana</i>)	34 cm	Private	Good	Remove; within zone of excavation
5	Manitoba maple (<i>Acer negundo</i>)	30 cm	Private (within easement)	Fair; heavy lean due to pruning for hydro access	Remove; on edge of excavation zone
6 ⁴	Manitoba maple (<i>Acer negundo</i>)	25 cm (estimate)	Private (within easement)	Fair; heavy lean due to pruning for hydro access	Remove; on edge of excavation zone

Figure 1: Tree 1, Norway maple to be removed

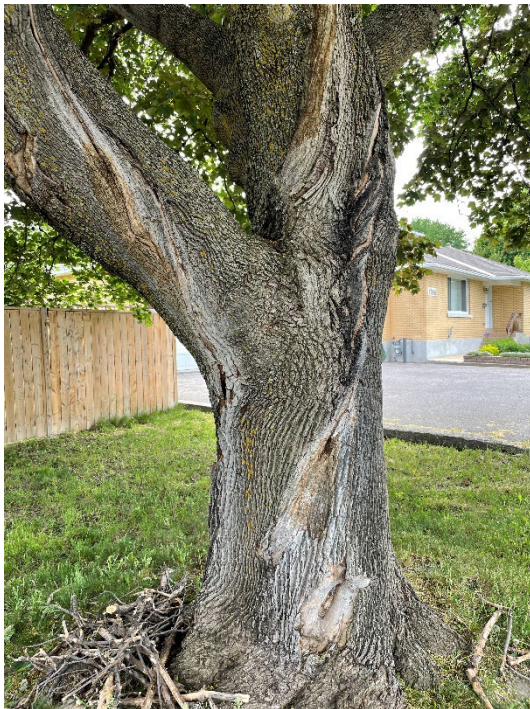
Figure 2: Close up of spiral cracking on tree 1

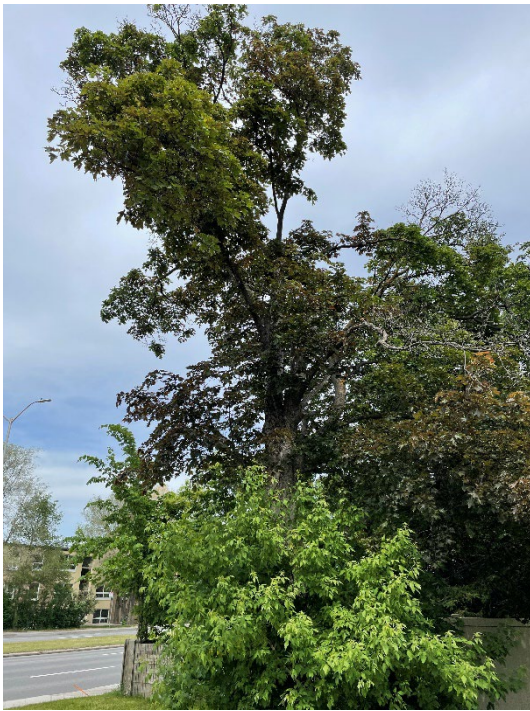
Figure 3: Tree 2, Norway maple to be removed

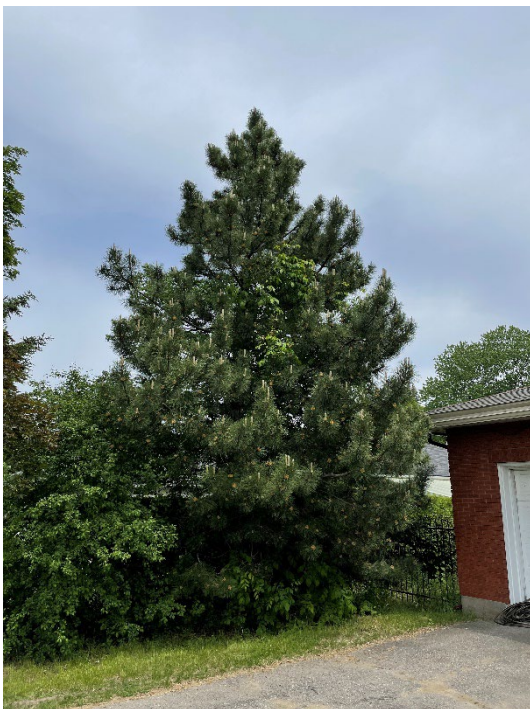
Figure 4: Tree 3, Austrian pine to be removed

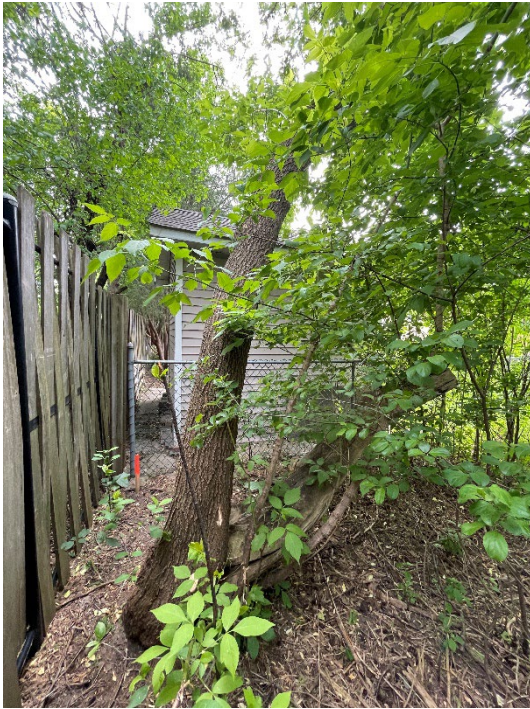
Figure 5: Tree 5, Manitoba maple to be removed

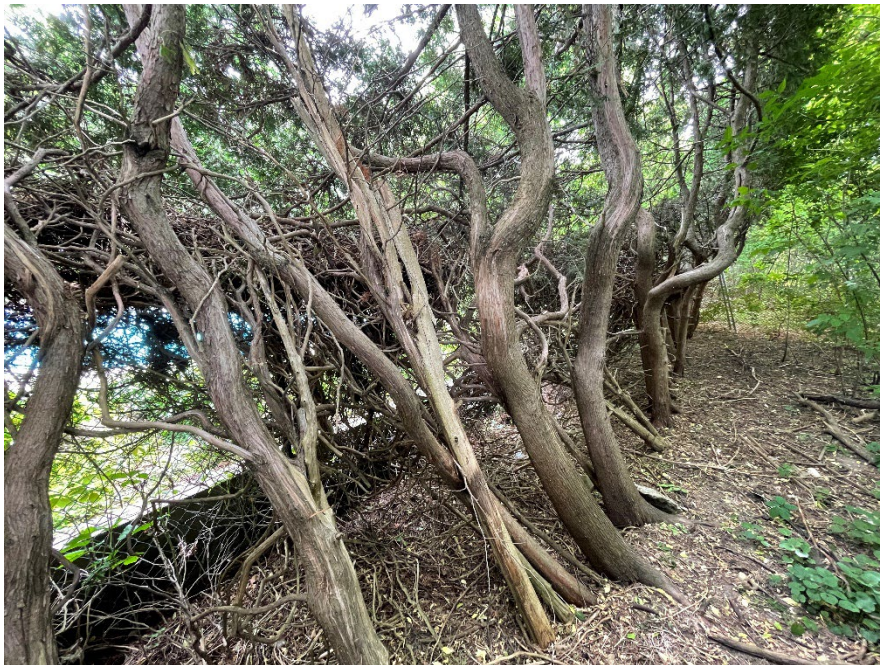
8	Siberian elm (<i>Ulmus pumila</i>)	24, 15 cm	Private	Fair; low vigour and leaf area, crown dieback	Remove; within excavation zone
9	Eastern white cedar hedge (<i>Thuja occidentalis</i>)	10-24 cm, 15-20 stems	Adjacent property at 824 Dunlevie	Fair/good; little foliage on the northern edge, but full foliage along the southern edge	Retain and protect
10	Norway spruce (<i>Picea abies</i>)	20 cm (estimate)	Adjacent property at 824 Dunlevie	Poor; topped through hydro pruning	Retain and protect; grade increase (of approx. 60cm) on subject property may have impact on roots
11	Norway spruce (<i>Picea abies</i>)	40 cm (estimate)	Adjacent property at 824 Dunlevie	Fair; topped through hydro pruning	Retain and protect; grade increase (of approx. 60cm) on subject property may have impact on roots
12	Manitoba maple (<i>Acer negundo</i>)	50 cm (estimate)	Adjacent property at 824 Dunlevie	Fair; significant pruning for hydro clearance	Retain, overhanging branches will need to be pruned back to avoid conflict with new building; grade increase (of approx. 60cm) on subject property may have impact on roots

Figure 6: Cedar hedges on adjacent property to be retained

Although this area within the easement will have a grade increase, it is still important to protect the existing soil during site works to avoid additional damage through compaction, and any pruning for clearance should be completed by a Certified Arborist. Prior to any site works, protective fencing should be installed around the cedar hedges as indicated in the attached Tree Information Map and maintained until all construction on site has been completed as per the **City of Ottawa Tree Protection Specifications (March 2021)**. Within the fenced area, the following tree protection guidelines should be applied:

In addition to the above protection measures, the roots will be severed ahead of time for the retained trees 10-12 by an arborist to avoid any tearing during the excavation.

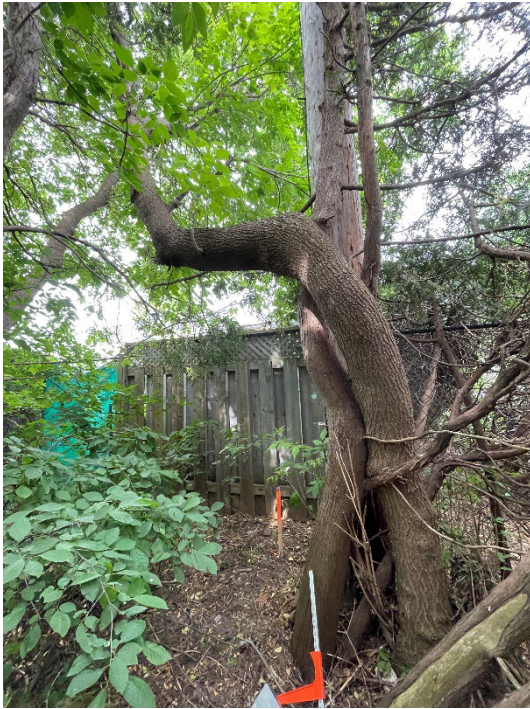
Figure 5: Tree 6, Manitoba maple to be removed

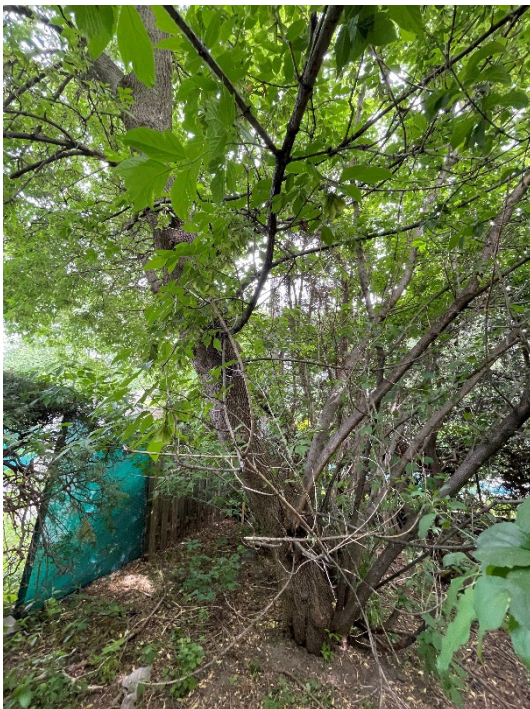
7	Manitoba maple (<i>Acer negundo</i>)	25 cm	Private	Fair; significant sprouting at base of tree	Remove; within excavation zone

Figure 6: Tree 7, Manitoba maple to be removed

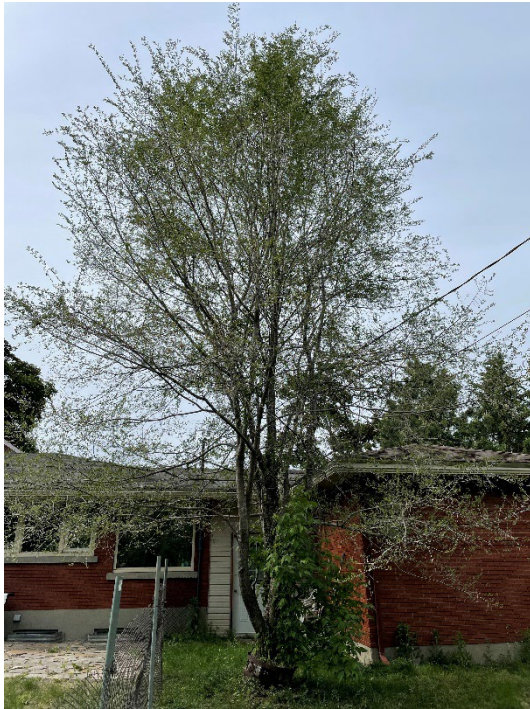
Figure 7: Tree 8, Siberian elm to be removed

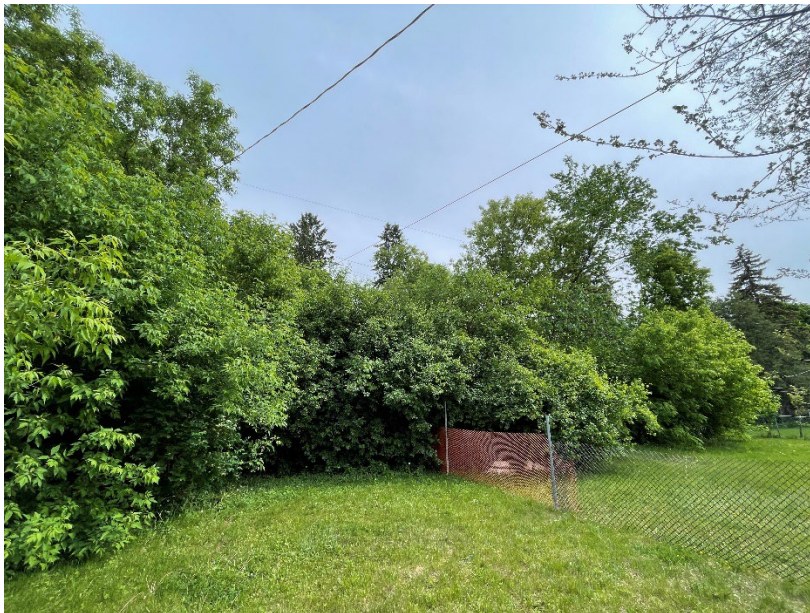
Figure 8: Photo showing vegetation along back made of up Manitoba maple and buckthorn
