TREE CONSERVATION REPORT

1940 Carling Avenue

Tree Conservation Report submitted as Partial
Requirements for a Site Plan Control Application,
September 19, 2021

Dendron Forestry Services

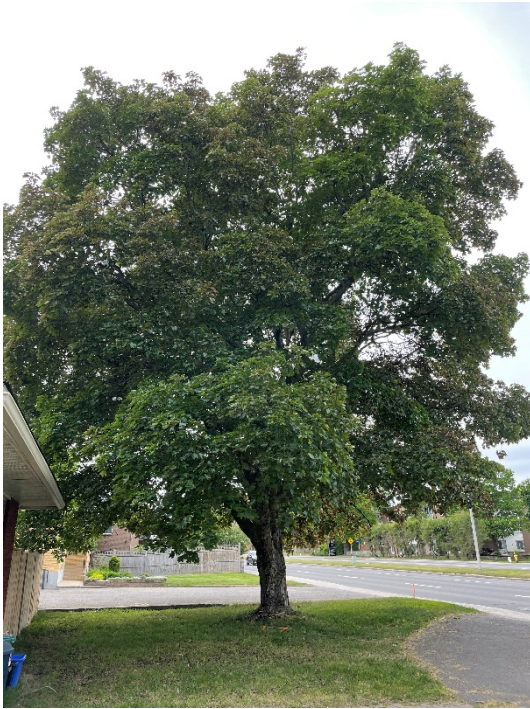
Figure 1: Tree 1, Norway maple to be removed

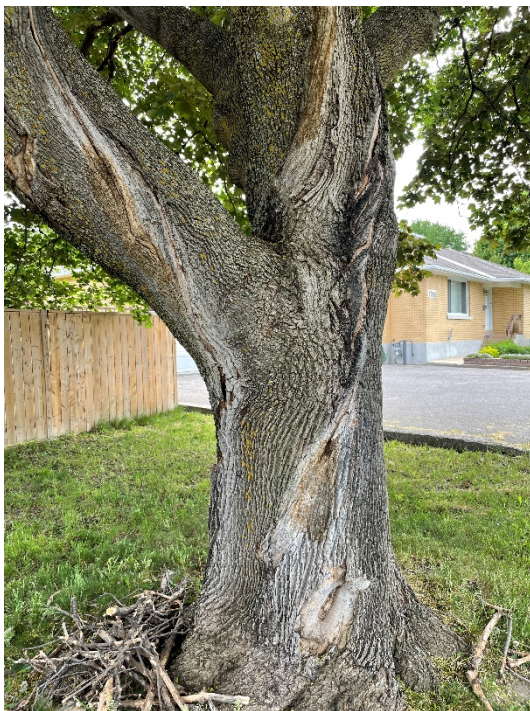
Figure 2: Close up of spiral cracking on tree 1

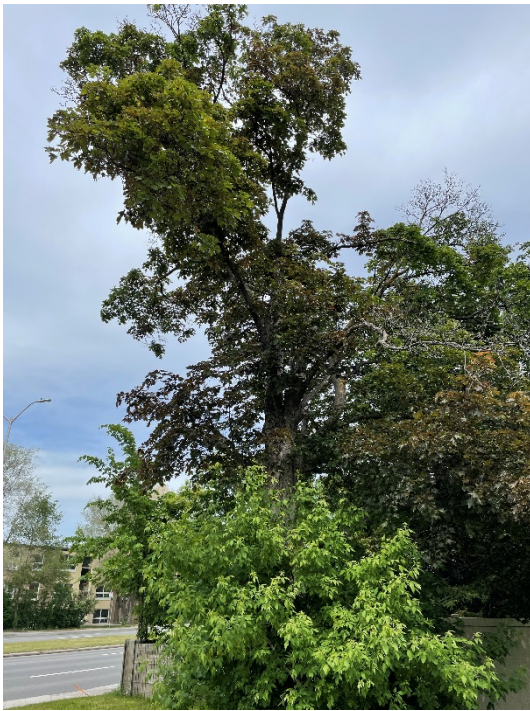
Figure 3: Tree 2, Norway maple to be removed

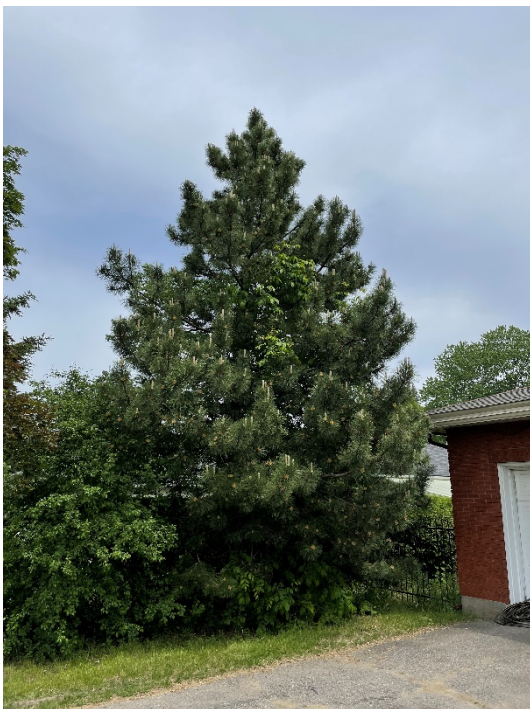
Figure 4: Tree 3, Austrian pine to be removed

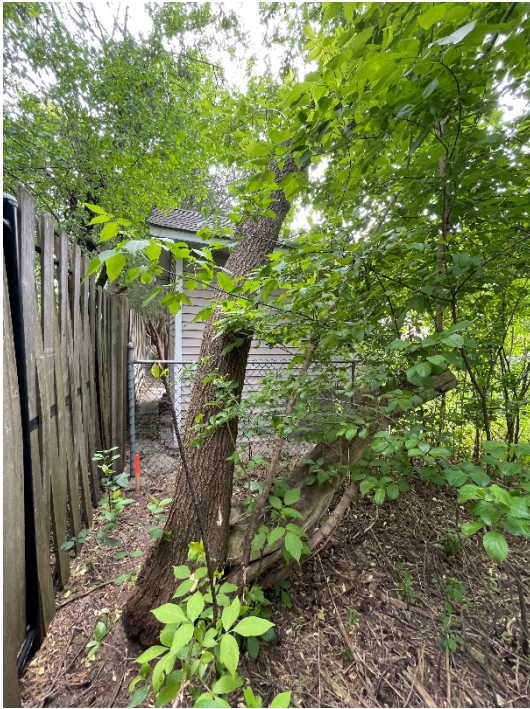
Figure 5: Tree 5, Manitoba maple to be removed

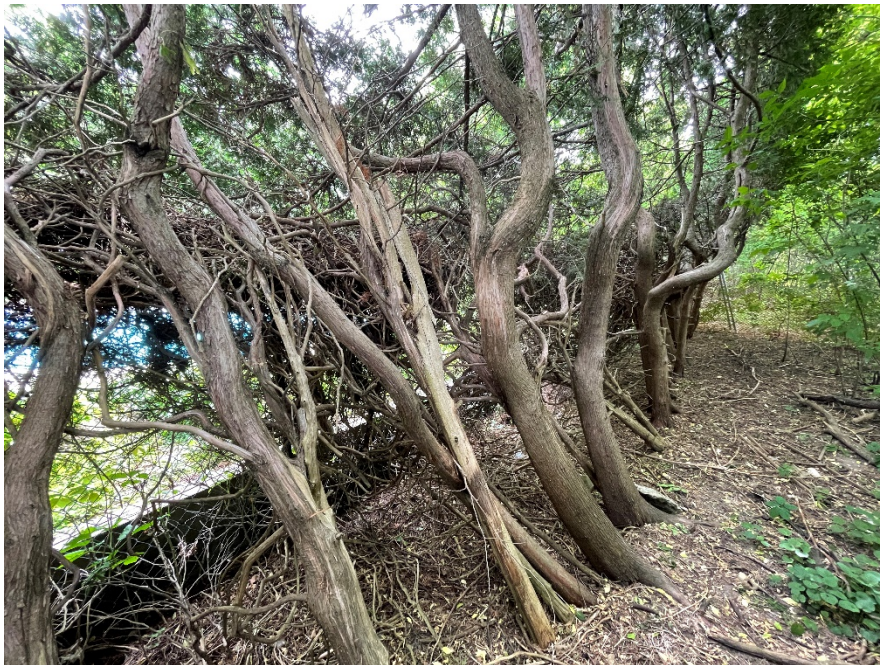
Figure 6: Cedar hedges on adjacent property to be retained

Prior to any site works, protective fencing should be installed around the cedar hedges as indicated in the attached Tree Information Map and maintained until all construction on site has been completed as per the **City of Ottawa Tree Protection Specifications (March 2021)**. Within the fenced area, the following tree protection guidelines should be applied:

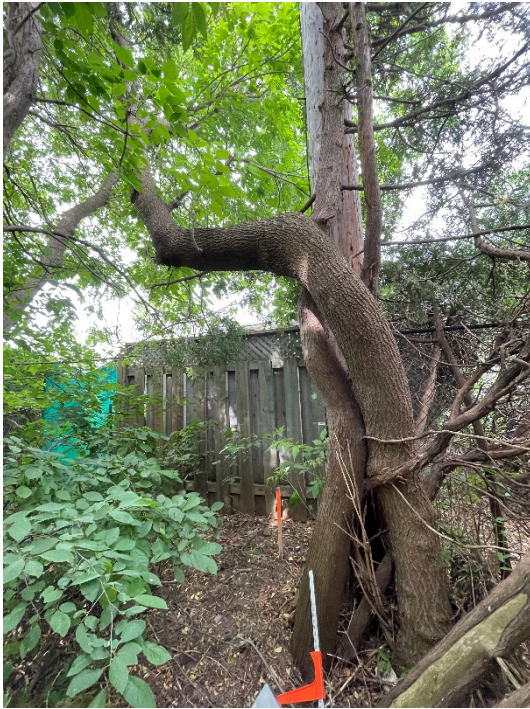
Figure 5: Tree 6, Manitoba maple to be removed

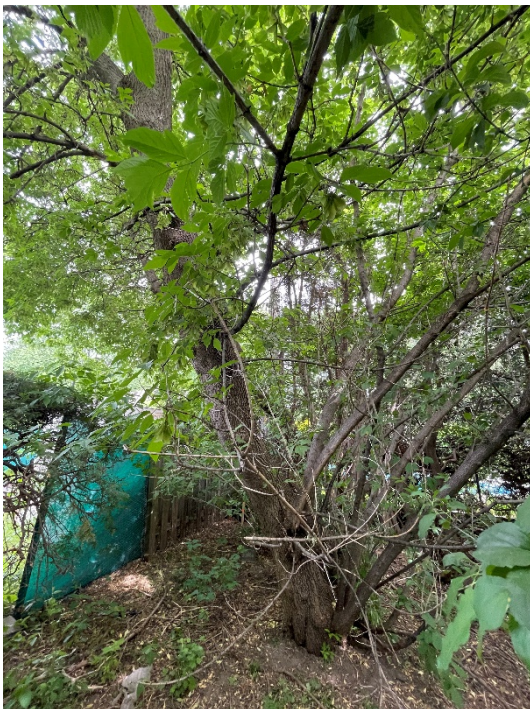
7	Manitoba maple (<i>Acer negundo</i>)	25 cm	Private	Fair; significant sprouting at base of tree	Remove; within excavation zone
8	Siberian elm (<i>Ulmus pumila</i>)	24, 15 cm	Private	Fair; low vigour and leaf area, crown dieback	Remove; within excavation zone
9	Eastern white cedar hedge (<i>Thuja occidentalis</i>)	10-24 cm, 15-20 stems	Adjacent property at 824 Dunlevie	Fair	Retain and protect
10	Norway spruce (<i>Picea abies</i>)	20 cm (estimate)	Adjacent property at 824 Dunlevie	Poor; topped through hydro pruning	Retain and protect
11	Norway spruce (<i>Picea abies</i>)	40 cm (estimate)	Adjacent property at 824 Dunlevie	Fair; topped through hydro pruning	Retain and protect
12	Manitoba maple (<i>Acer negundo</i>)	50 cm (estimate)	Adjacent property at 824 Dunlevie	Fair; significant pruning for hydro clearance	Retain, overhanging branches will need to be pruned back to avoid conflict with new building

Figure 6: Tree 7, Manitoba maple to be removed

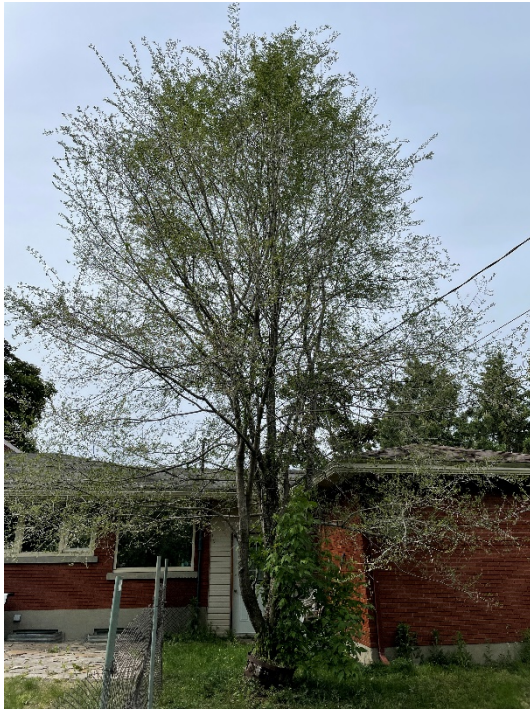
Figure 7: Tree 8, Siberian elm to be removed

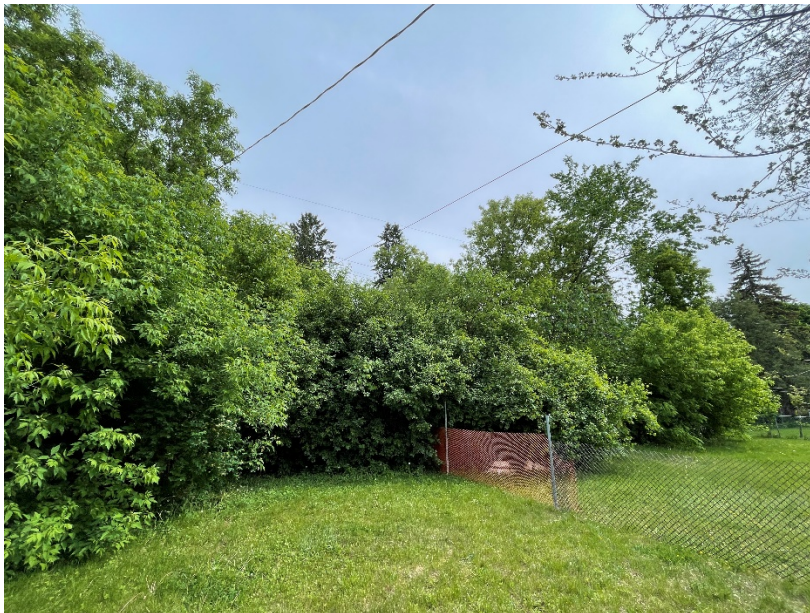
Figure 8: Photo showing vegetation along back made of up Manitoba maple and buckthorn

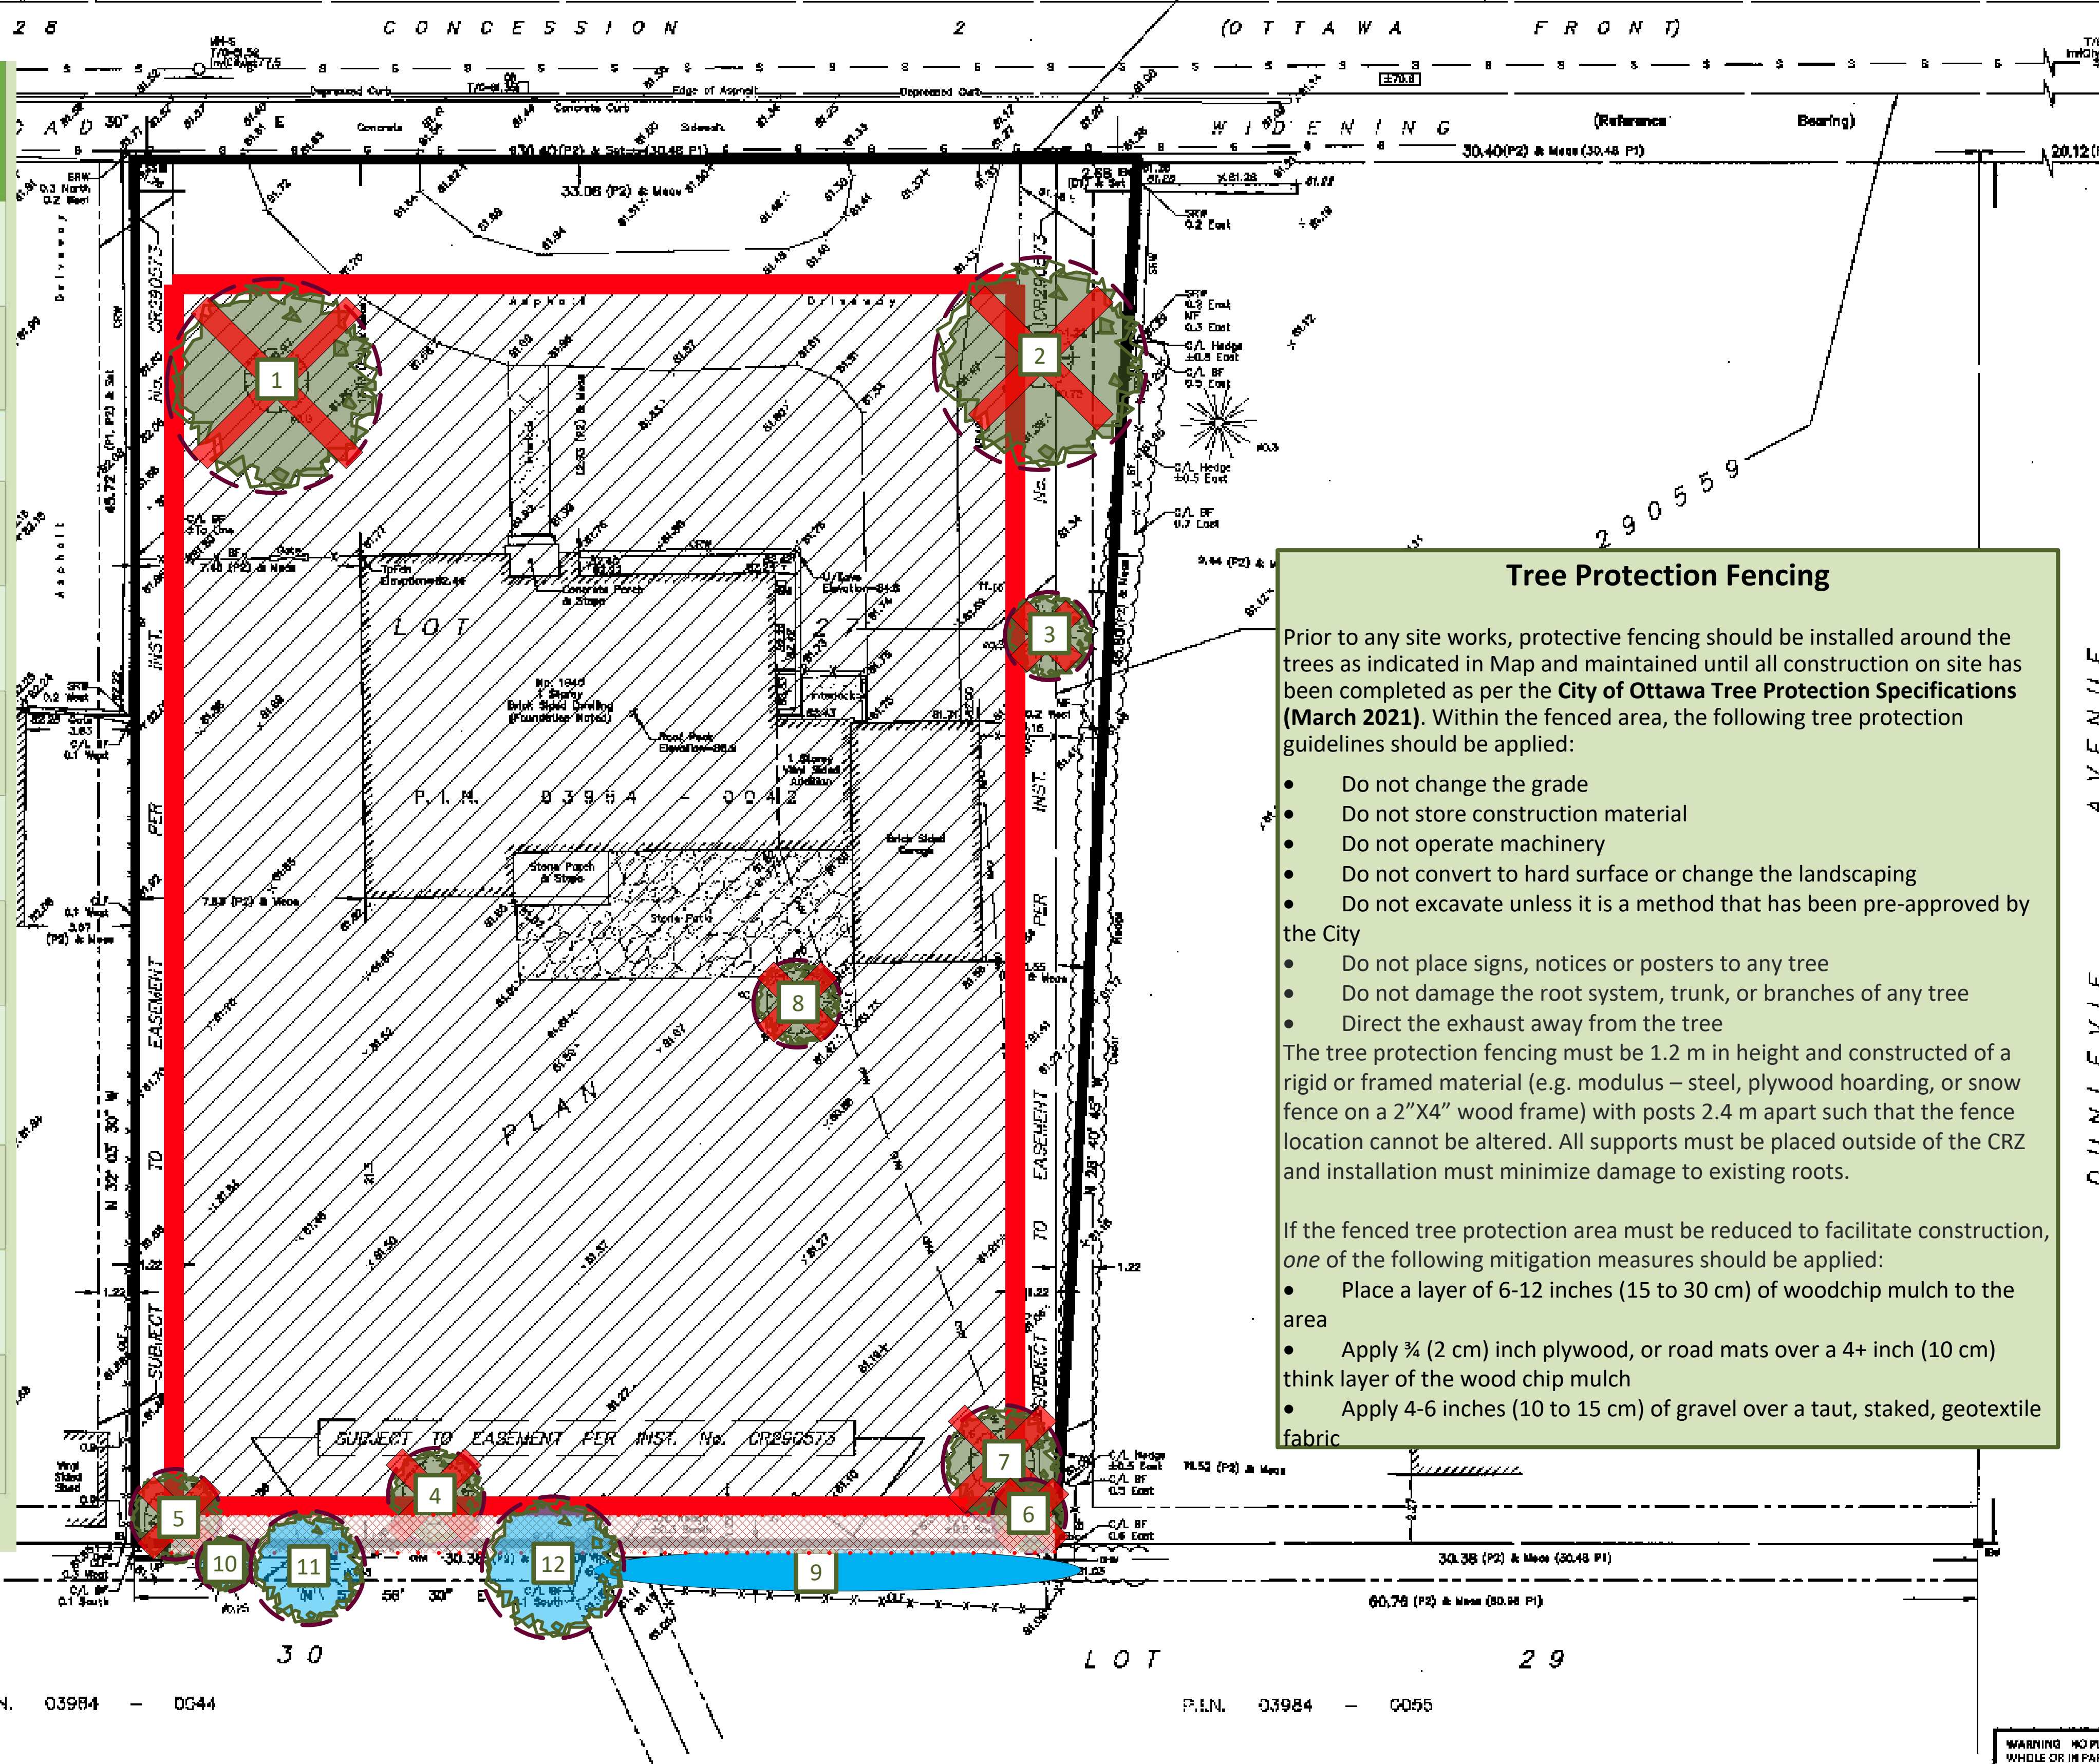
Tree Conservation Report – 1940 Carling
 Existing Conditions and Proposed Development
 Tree layer prepared by Dendron Forestry Services
 Version 1.0, September 19, 2021
 For more information, please contact info@dendronforestry.ca

The Existing Conditions and Proposed Development map shows the zone of excavation for the proposed development with the thick red line. All the trees on this property are located either within this zone of excavation or so close to it such that severing of the roots will make the tree(s) unstable. The only vegetation that is retainable on the property may be some buckthorn shrubs along the back fence line, although buckthorn is a non-native, highly invasive shrub, and retention of this species is not recommended. There are also some trees (10-12) and the cedar hedge on the adjacent property at 824 Dunlevie that may be impacted by the excavation. Tree protection measures for these trees are provided below.

Prior to any site works, protective fencing should be installed around the trees as indicated in Map and maintained until all construction on site has been completed as per the **City of Ottawa Tree Protection Specifications (March 2021)**. Within the fenced area, the following tree protection guidelines should be applied:

The tree protection fencing must be 1.2 m in height and constructed of a rigid or framed material (e.g. modulus – steel, plywood hoarding, or snow fence on a 2"X4" wood frame) with posts 2.4 m apart such that the fence location cannot be altered. All supports must be placed outside of the CRZ and installation must minimize damage to existing roots.

- Place a layer of 6-12 inches (15 to 30 cm) of woodchip mulch to the area
- Apply ¾ (2 cm) inch plywood, or road mats over a 4+ inch (10 cm) thick layer of the wood chip mulch
- Apply 4-6 inches (10 to 15 cm) of gravel over a taut, staked, geotextile fabric
