TREE CONSERVATION REPORT V2.0

1940 Carling Avenue

Tree Conservation Report submitted as Partial
Requirements for a Site Plan Control Application,
July 8, 2022

Dendron Forestry Services

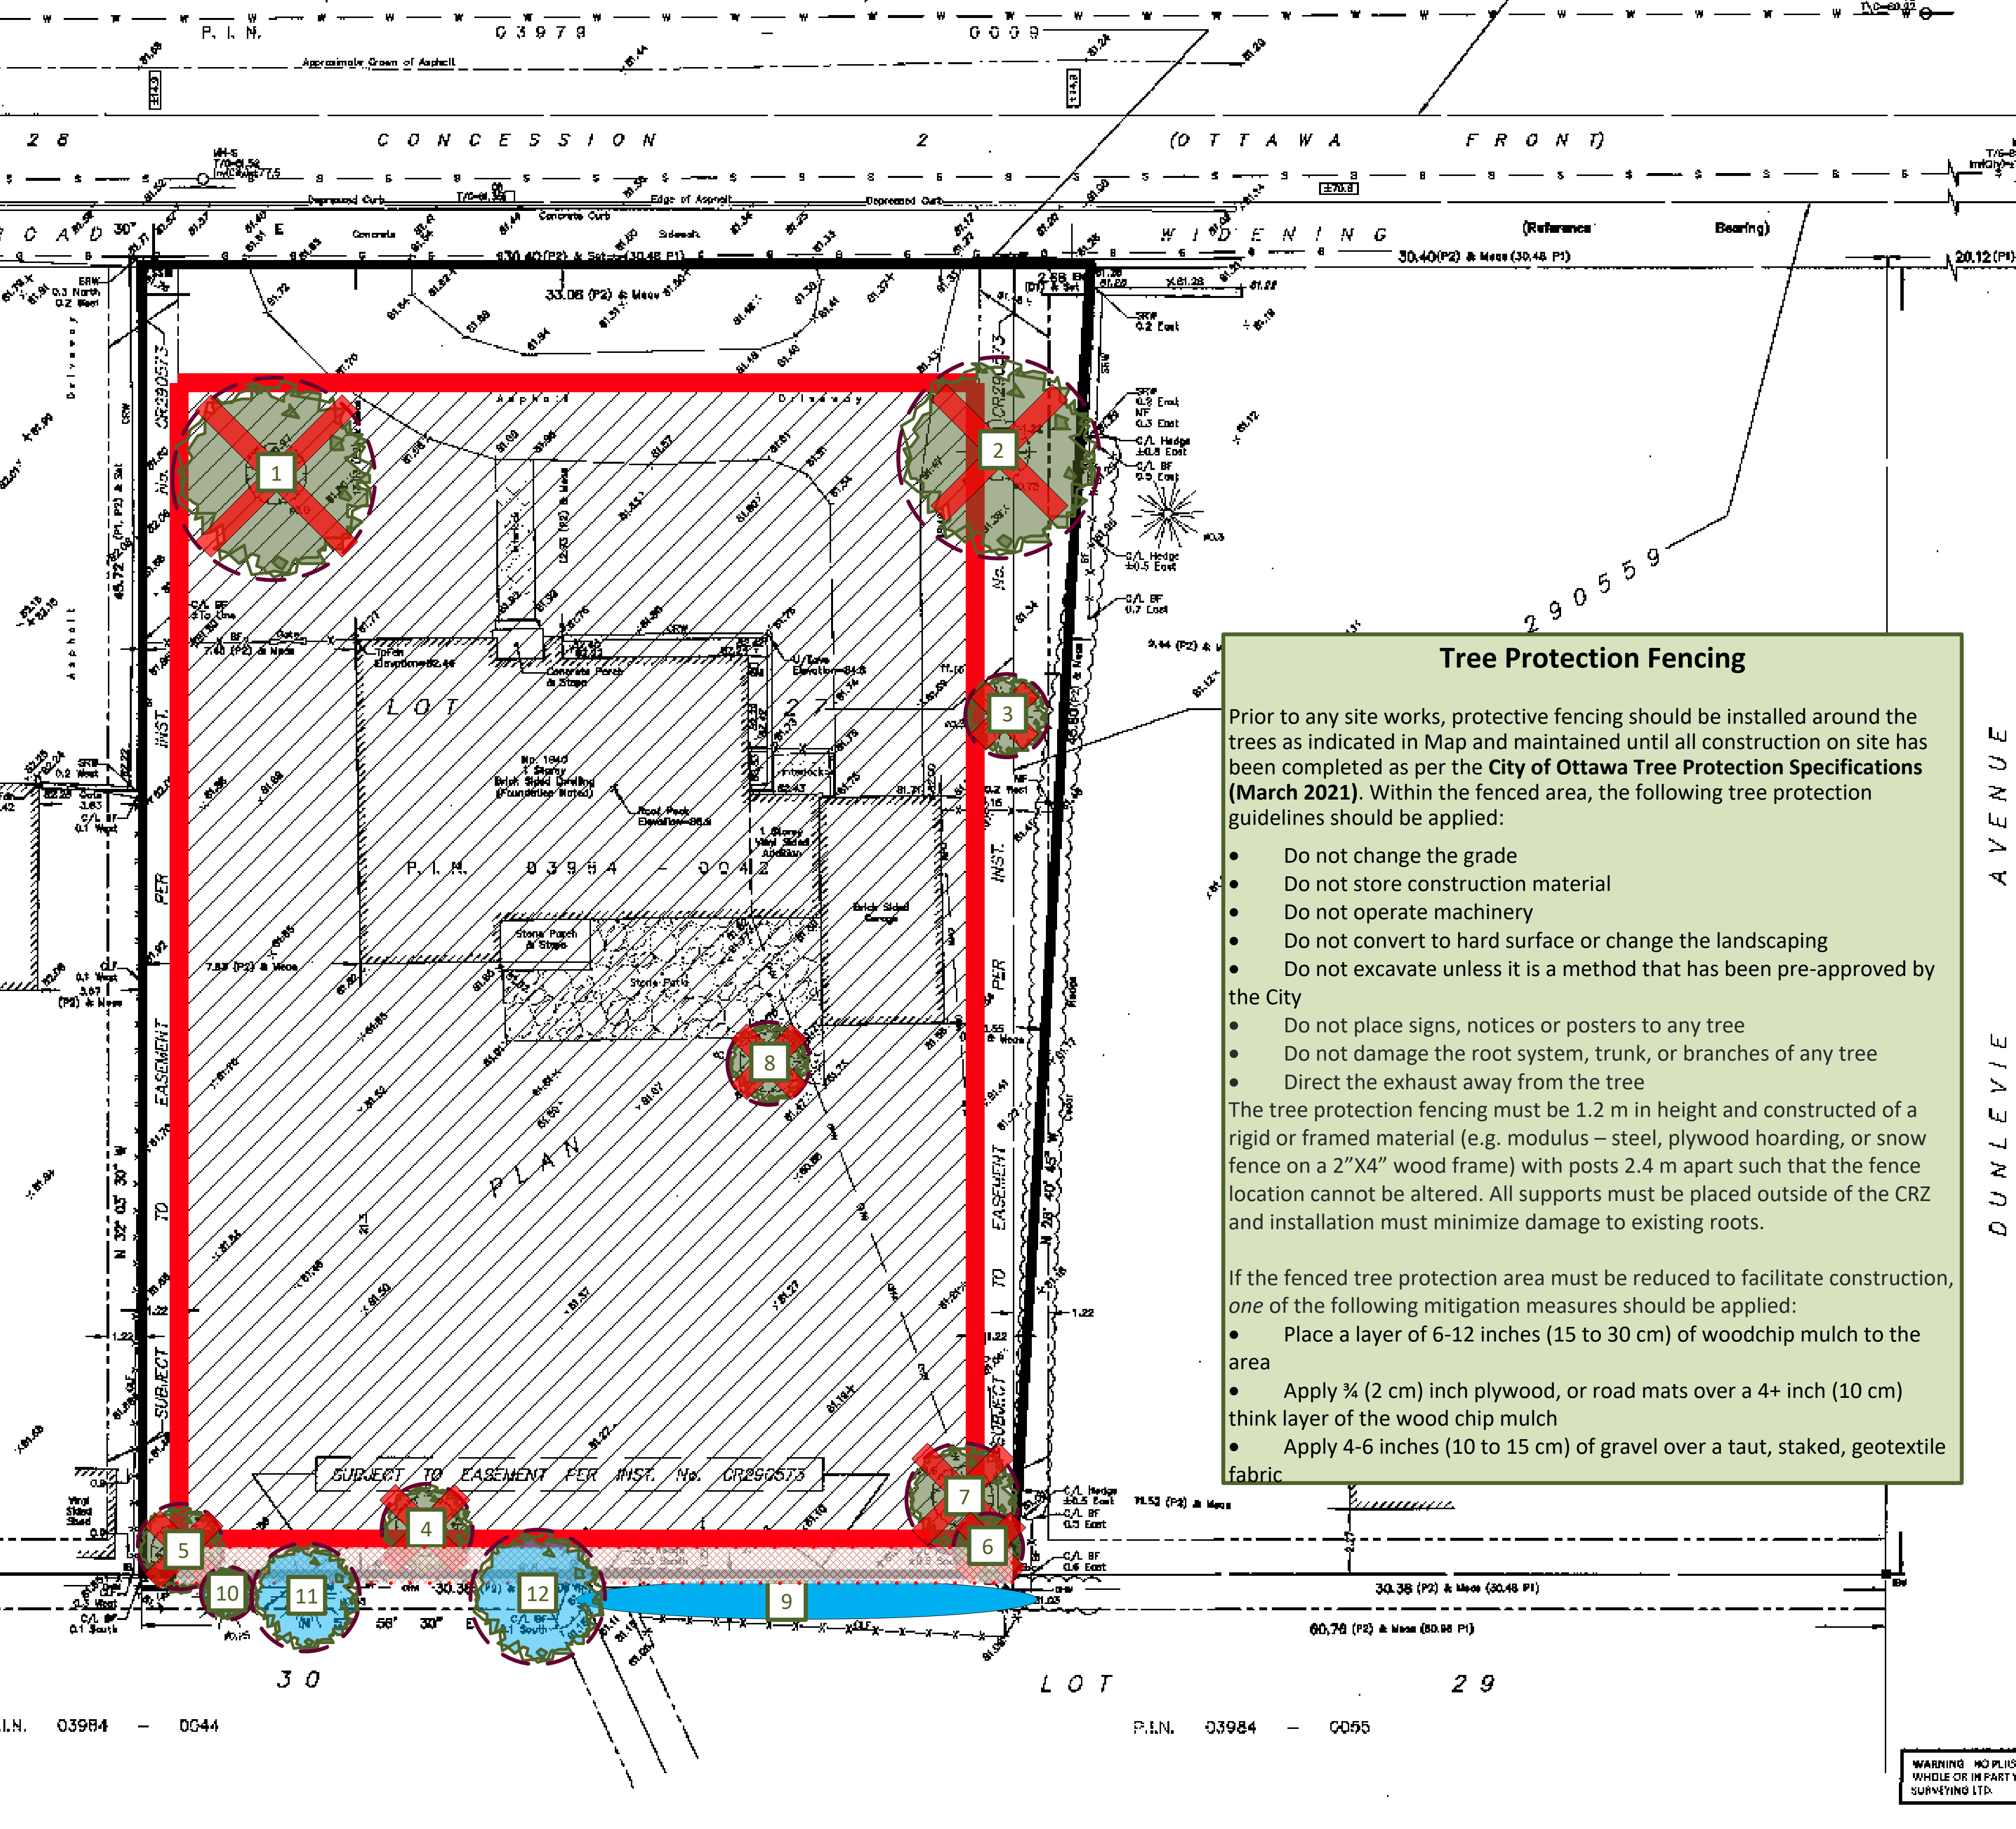
Tree Conservation Report – 1940 Carling
 Existing Conditions and Proposed Development
 Tree layer prepared by Dendron Forestry Services
 Version 2.0, July 8, 2022
 For more information, please contact info@dendronforestry.ca

The Existing Conditions and Proposed Development map shows the zone of excavation for the proposed development with the thick red line. All the trees on this property are located either within this zone of excavation or so close to it such that severing of the roots will make the tree(s) unstable. The only vegetation that is retainable on the property may be some buckthorn shrubs along the back fence line, although buckthorn is a non-native, highly invasive shrub, and retention of this species is not recommended. There are also some trees (10-12) and the cedar hedge on the adjacent property at 824 Dunlevie that may be impacted by the excavation. Tree protection measures for these trees are provided below.

Prior to any site works, protective fencing should be installed around the trees as indicated in Map and maintained until all construction on site has been completed as per the **City of Ottawa Tree Protection Specifications (March 2021)**. Within the fenced area, the following tree protection guidelines should be applied:

The tree protection fencing must be 1.2 m in height and constructed of a rigid or framed material (e.g. modulus – steel, plywood hoarding, or snow fence on a 2"X4" wood frame) with posts 2.4 m apart such that the fence location cannot be altered. All supports must be placed outside of the CRZ and installation must minimize damage to existing roots.
