Arborist Report

DATE: 2021-10-07

Object: Tree Health Assessment and Proposed Tree Protection Plan at Queenswood United Church (360 Kennedy Lane E, Ottawa, Ontario)

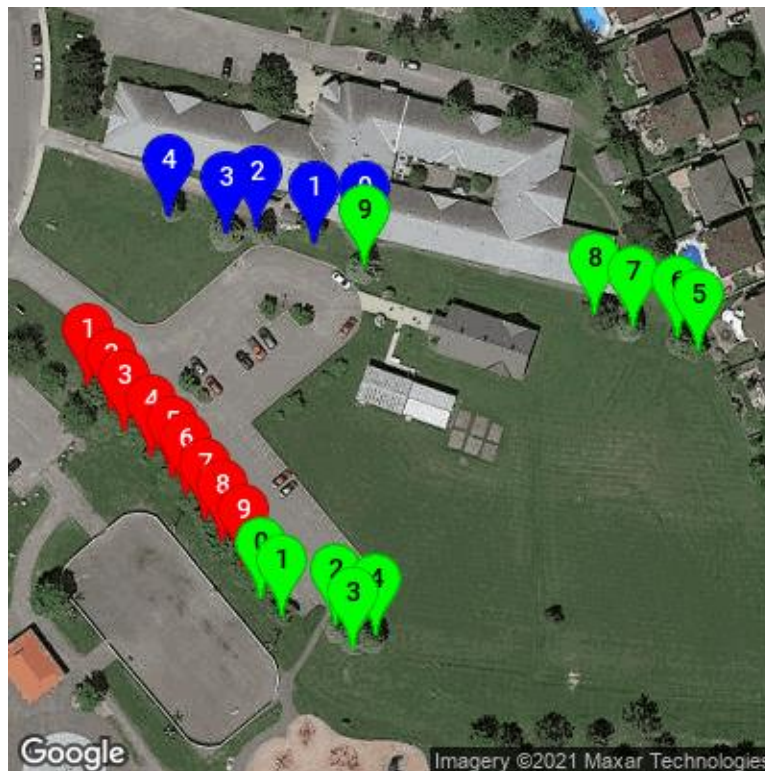
A total of 24 trees were assessed on the property. One Eastern White Cedar was observed, but its assessment was not required since it will have to be removed to make way for the construction project. The Amur Maples have multiple co-dominant stems, each one having a varying diameter at breast height of 5 to 20 centimeters. For the purpose of this assessment, their DBH was measured at the lowest point before codominance begins and each stem was measured at 1.3 meters from the ground. This was also the case for Colorado Blue Spruce #19. All other trees were measured at 1.3 meters from the ground.

- : 1-9
- : 10-19
- : 20-29

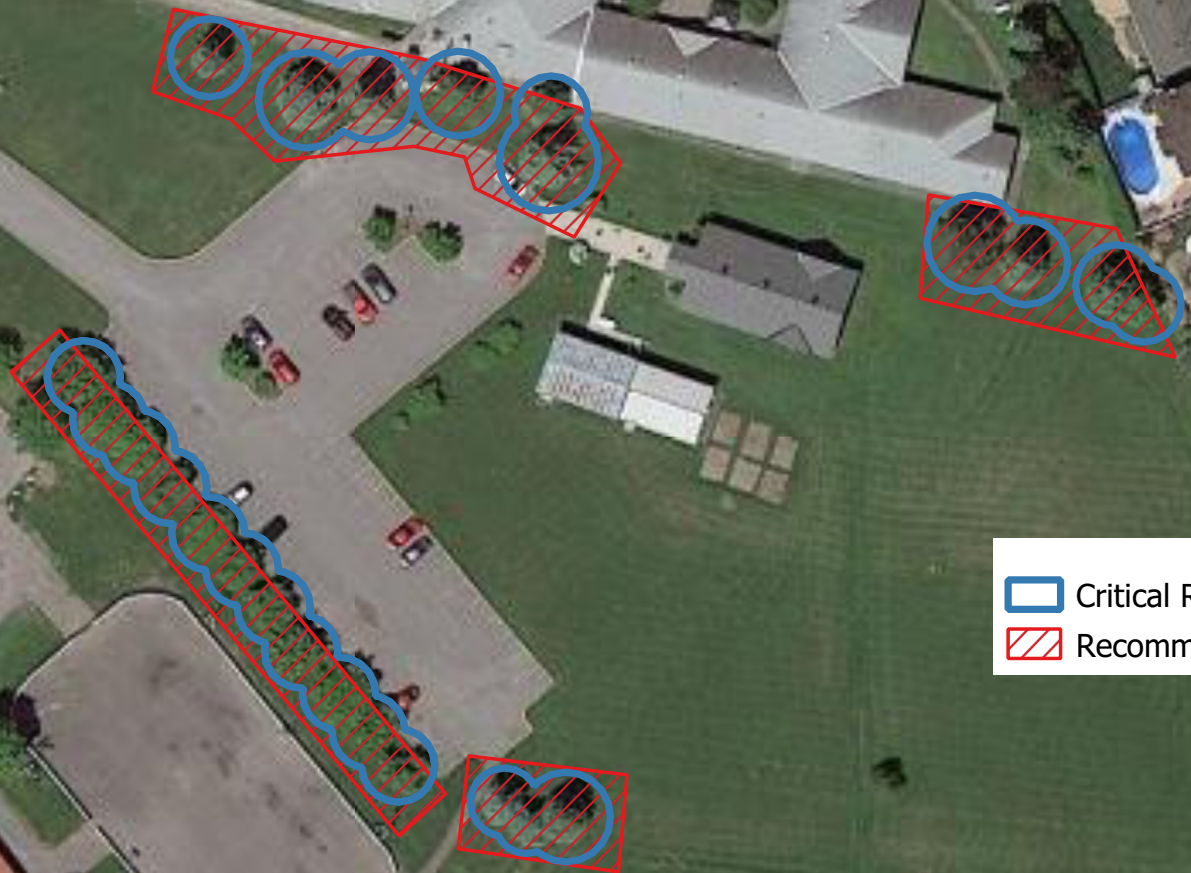
Proposed Tree Protection Plan for Queenswood United Church

The Amur Maples all have co-dominant structures. Using each stems DBH to establish the CRZ would be insufficient since it surely extends beyond that. Using the base DBH would be an exaggeration of the CRZ. We therefore recommend establishing a TPZ which would extend just beyond the canopy's drip edge. The parking lot will most likely need to be removed for construction. We would therefore recommend having the TPZ extend to the threshold of the parking lot.

We used a Multiplying factor of 12 for the Colorado Blue Spruces and Red Pine.

- Tree Protection Zone (TPZ)
 - Establish Tree Protection Zone perimeter that will not impede construction project and install tree preservation fence with signage. No heavy operations shall occur within this zone during the full duration of the project, including fence installation.
