## Arborist Report

DATE: 2023-02-22

### **Object: Tree Health Assessment and Proposed Tree Protection Plan at Queenswood United Church (360 Kennedy Lane E, Ottawa, Ontario)**

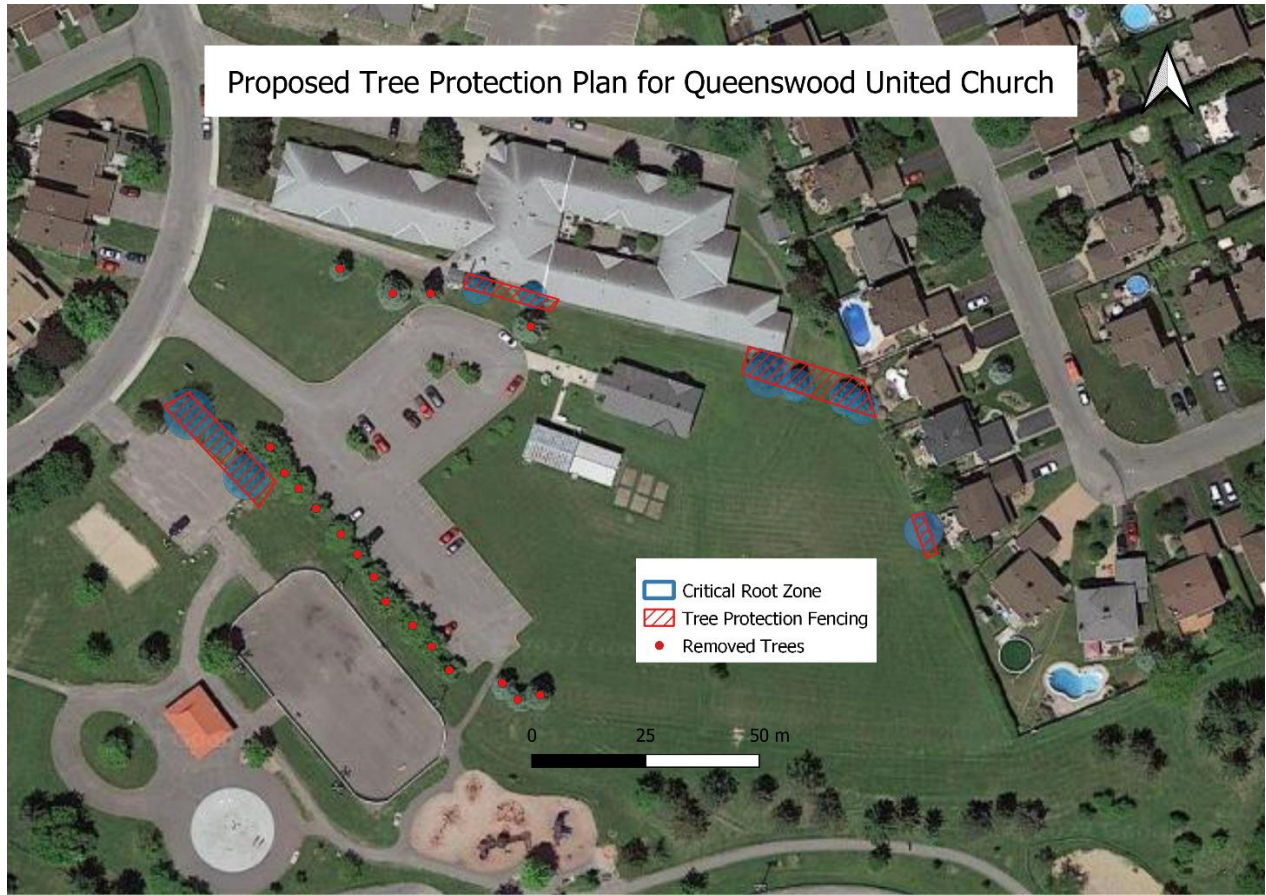
\*Dimensions for critical root zone are not exact. Refer to proposed tree protection plan and tree protective fencing table for recommended dimension
