June 6, 2019

Chmiel Architects Inc.
Attention Richard Chmiel
200-109 Bank Street
Ottawa, Ontario, K1P 5N5

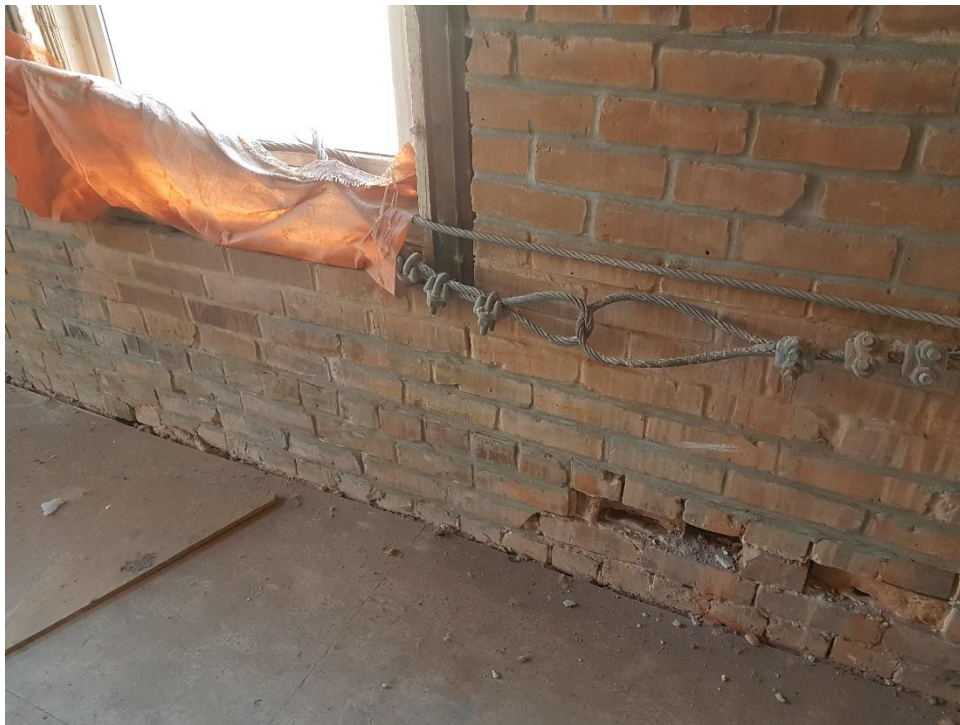
Photograph 10: Area of noted brick deterioration on the interior wythe of second floor, north wall.
