UPDATED CONSERVATION PLAN CHAMPLAIN OIL COMPANY SERVICE STATION 70 RICHMOND ROAD OTTAWA, ONTARIO

PREPARED BY: JOHN STEWART, COMMONWEALTH HISTORIC RESOURCE MANAGEMENT

Updated V5 April 2023

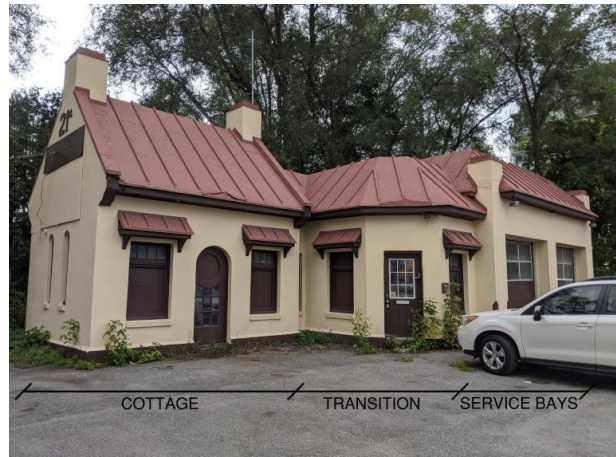
Figure 1: View of the Service Station with the 3 sections cottage, transition, and service bays.

The Champlain Oil Company Service Station has been vacant for a number of years with no maintenance undertaken on the structure. Based on the assessment from both John G. Cooke Consulting Engineers and Cleland Jardine Engineering Limited, the building is in poor to fair condition.

The floor construction is concrete slab on grade. A small portion of the floor in the administration area has a wood flooring with a shallow open pit below. The service garage floor is 1' lower than the rest of the building. The interior of the cottage has been completely gutted, exposing the wall and roof structure. A load bearing wall was removed under the western chimney and a built-up wood beam was installed at ceiling level to support the concrete block gable and chimney. The roof over the cottage section has a standing seam metal cladding with chimneys at the gable ends. It consists of rough sawn 2" x 9" horizontal ceiling rafters at 20" c/c supporting sloped rafters above. In the cottage area and the roof trusses appear to be in good condition.

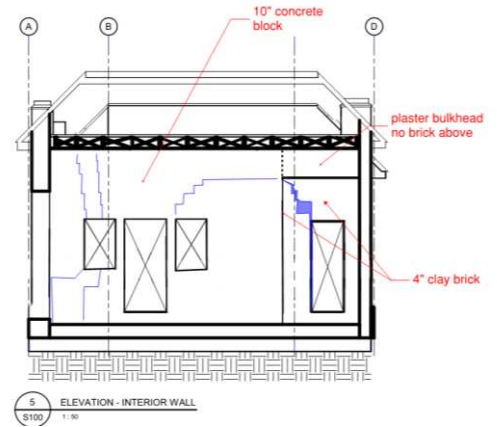
Figure 2: Interior dividing wall. Source: Cleland Jardine

The elevation plan and pictures (Figure 2) document the condition of the partition wall. The demolition drawing submitted as part of the application to move recommends its demolition. The three sections of the building – cottage, office, and garage (Figure1) are defined attributes in the designation, but it is not clear if the interpretation requires them to be separate spaces. The wall is in very poor shape. This wall is a load bearing wall and if it is removed support for the roof is required.

The wall between the cottage and the office was removed before designation, which suggests that there is some ambiguity. Given the poor condition and the client’s preference to have the wall removed, demolition is being recommended. This wall is a load bearing wall and with its removal there will be need to provide new roof support.

Options such as distinguishing marks on the floor and a dropped header with columns will be introduced as a means of interpreting the original three-part interior.

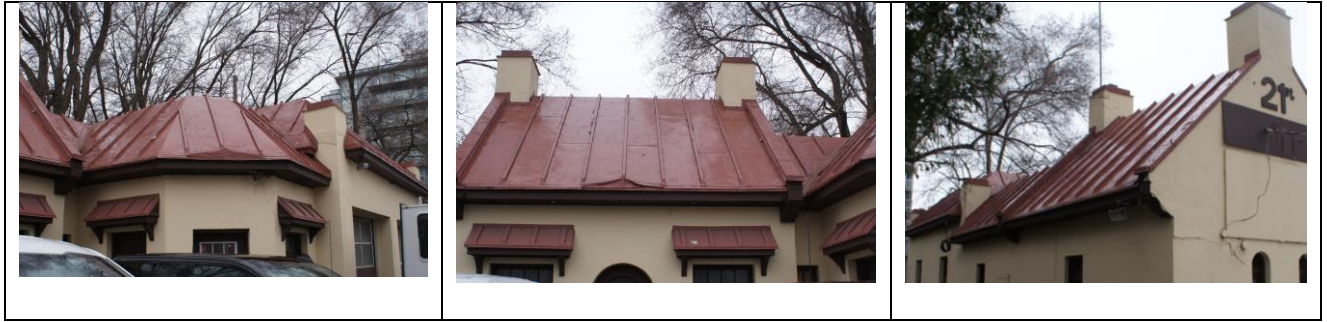
Figure 10: images of the standing seam roofs. Note the diverter flashing treatment above the doors.

The standing seam metal roof membrane is an important character defining feature and will be reconstructed. The flashings in the valleys of the roof and around chimneys and at junctions between roof forms have failed as is evident by the stained wood sheathing as noted in John Cooke’s review. A new standing seam metal roof will replace the existing. The distinctive standing seam metal roofs on the awnings above windows and doors will be preserved depending on condition following detailed inspection. Remedial work prior to the move includes patching of the existing roof to prevent further damage.

The roof membrane and decking will have to be replaced due to the deteriorated condition of the roof deck. The roof structure, in addition to requiring repairs, will also be subjected to snow loads from being at the base of the new mid-rise structure and seismic requirements will also need to be addressed. Along the west elevation the heritage building will sit flush with the new concrete shear wall structure supporting the projecting bay above at the third floor. There will be a requirement for a hopper to direct water coming off of the garage roof away from the shear wall.

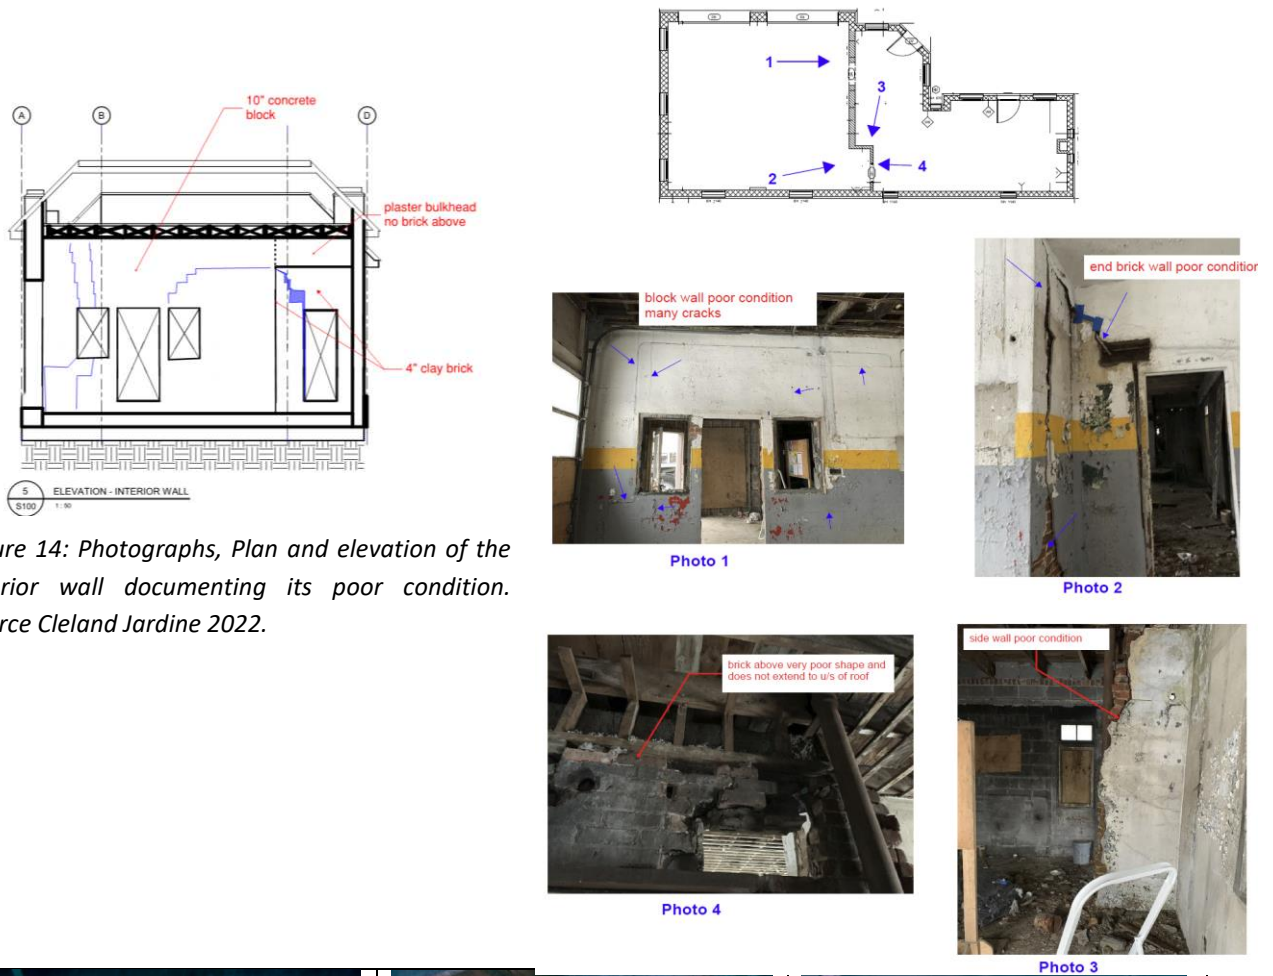
Figure 14: Photographs, Plan and elevation of the interior wall documenting its poor condition. Source Cleland Jardine 2022.

The elevation plan and pictures (Figure 19) document the condition of the partition wall. The demolition drawing submitted as part of the application to move recommends its demolition. The three sections of the building – cottage, office, and garage (Figure1) are defined attributes in the designation, but it is not clear if the interpretation requires them to be separate spaces. The wall is in very poor shape.

The wall between the cottage and the office was removed before designation, which suggests that there is some ambiguity. Given the poor condition and the client’s preference to have the wall removed, demolition is being recommended. This wall is a load bearing wall and with its removal there will be need to provide new roof support.

Options such as distinguishing marks on the floor and a dropped header with columns will be introduced as a means of interpreting the original three-part interior.
