UPDATED CONSERVATION PLAN CHAMPLAIN OIL COMPANY SERVICE STATION 70 RICHMOND ROAD OTTAWA, ONTARIO

PREPARED BY: JOHN STEWART, COMMONWEALTH HISTORIC RESOURCE MANAGEMENT

Updated V3 June 2023

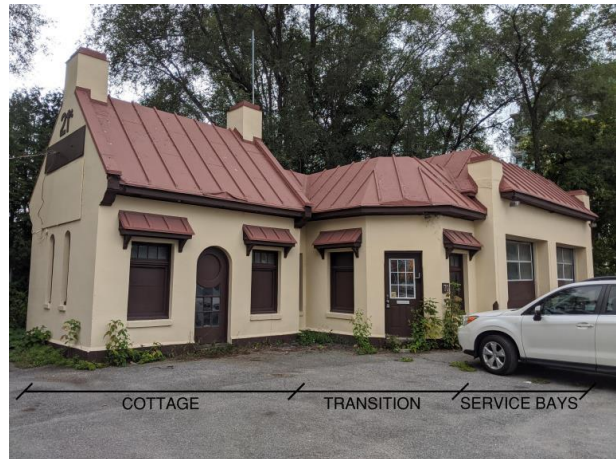
Figure 1: View of the Service Station with the 3 sections: cottage, transition (office), and service bays.

The Champlain Oil Company Service Station has been vacant for a number of years with no maintenance undertaken on the structure. Based on the assessment from both John G. Cooke Consulting Engineers and Cleland Jardine Engineering Limited, the building is in poor to fair condition.

The Service Station is a 100m², one storey structure constructed in 1937 (Patterson Group EA 70 Richmond Road Title Search Deed NP45576 Registered Feb 16, 1937, Champlain Oil Company). The structure is made-up of three parts - a cottage retail, administration office (transition), and a two-bay service area. The foundation consists of cast in place perimeter concrete walls with a chamfered stepped base approximately 12". It is assumed that the foundation extends down approximately 5' below grade and is supported on perimeter footings.

The floor construction is concrete slab on grade. A small portion of the floor in the administration area has a wood flooring with a shallow open pit below. The service garage floor is 1' lower than the rest of the building. The interior of the cottage has been completely gutted, exposing the wall and roof structure. A load bearing wall was removed under the western chimney and a built-up wood beam was installed at ceiling level to support the concrete block gable and chimney. The roof over the cottage section has a standing seam metal cladding with chimneys at the gable ends. It consists of rough sawn 2" x 9" horizontal ceiling rafters at 20" c/c supporting sloped rafters above. In the cottage area and the roof trusses appear to be in good condition.

The roof structure, over the administration section and service bay, consists of a built-up Montreal style standing seam Mansard profile. The framing consists of rough sawn 2" x 10" joists at 24" c/c supported on a steel beam running down the middle of the double bay. The metal roofing in the transitional area has failed and there is significant water infiltration. Cooke's report suggests that significant portions of the roof structure are deteriorating.

The service bay area is an open space framed by two exterior block walls, the interior brick wall and the north (front) wall with a single block pier and two large garage door openings. The interior cinder block loadbearing wall separating the transitional area from the service bay is in poor condition, with a large fracture across the doorway opening at the back of the building, and a variety of cracks in the wall at the front. The flooring in this space appears to be a concrete slab on grade. The exterior masonry walls are in fair to poor condition with localized vertical cracking noted in several locations. Based on a few limited areas, where holes in the masonry were noted, the masonry does not appear to be grouted nor reinforced.

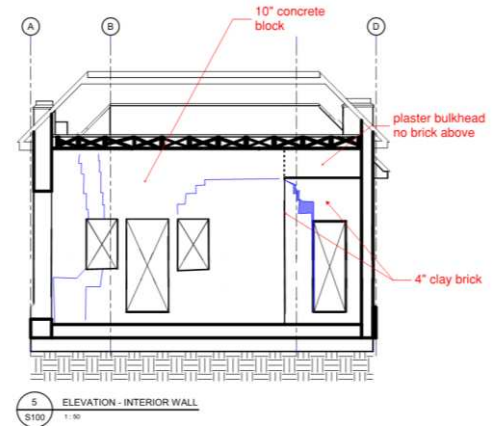
Figure 2: Interior dividing wall. Source: Cleland Jardine

The elevation plan and pictures (Figure 2) document the condition of the interior partition wall. The demolition drawing submitted as part of the application to move recommends its demolition. The three sections of the building – cottage, office, and garage (Figure1) are defined attributes in the designation, but it is not clear if the interpretation requires them to be separate spaces. The wall is in very poor shape. This wall is a load bearing wall and if it is removed support for the roof is required.

The wall between the cottage and the office was removed before designation, which suggests that there is some ambiguity. Given the poor condition and the client’s preference to have the wall removed, demolition is being recommended. This wall is a load bearing wall and with its removal there will be need to provide new roof support.

Options such as distinguishing marks on the floor and a dropped header with columns will be introduced as a means of interpreting the original three-part interior.

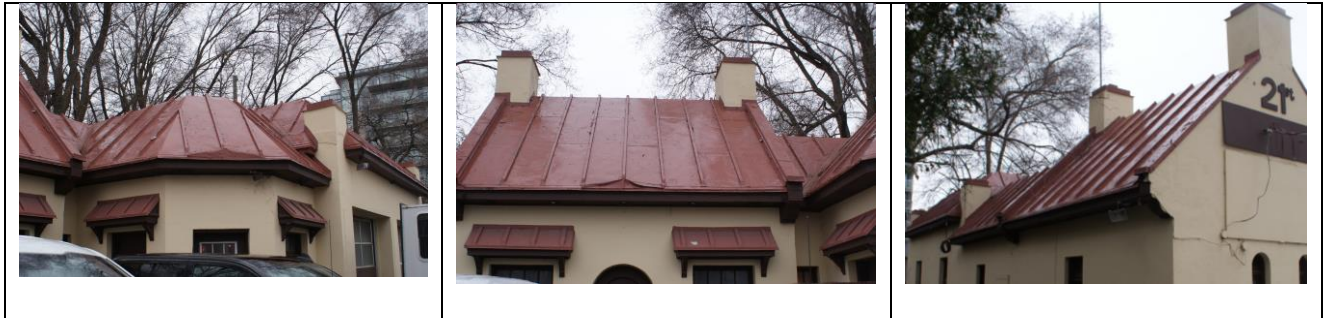
Figure 12: images of the standing seam roofs. Note the diverter flashing treatment above the doors.

The standing seam metal roof membrane is an important character defining feature and will be reconstructed. The flashings in the valleys of the roof and around chimneys and at junctions between roof forms have failed as is evident by the stained wood sheathing as noted in John Cooke’s review. A new standing seam metal roof will replace the existing. The distinctive standing seam metal roofs on the awnings above windows and doors will be preserved depending on condition following detailed inspection. Remedial work prior to the move includes patching of the existing roof to prevent further damage.

The roof membrane and decking will have to be replaced due to the deteriorated condition of the roof deck. The roof structure, in addition to requiring repairs, will also be subjected to snow loads from being at the base of the new mid-rise structure and seismic requirements will also need to be addressed. Along the west elevation the heritage building will sit 4” from the new concrete shear wall structure supporting the projecting bay above at the third floor. There will be a requirement for the architect to provide details to direct water coming off of the garage roof away from the shear wall.

1. Repair and Stabilize the existing flat roof framing and decking of the two sections of roofing. Reference Cleland Jardine Appendix A.
2. Remove existing metal roof membrane from the mansard, rounded, and cottage style sections.

3. Inspect existing 1" T&G board decking for condition. Replace deteriorated decking with 1" plywood. Inspect T&G board decking and secure decking to rafters if loose.

4. Install 7/16" OSB to existing roof decking.
5. Cut openings for passive attic vents.
6. Install peel and stick ice and water shield to valleys, eaves, and verges as per manufacturer's recommendations.

7. Install roof underlay as per manufacturer's recommendations.
8. Install valley flashings – 36" width.
9. Fabricate existing standing seam metal roof panels using the existing roof as a model including gage, size of panels, and profile. Include the window hoods and the diverters over each door.

10. Paint as per manufacturer's specification (colour determined based on paint analysis).
11. Install metal roof panels as per manufacturers recommendations.

12. Install trim – eave drips, verge drips, ridge and hip caps, passive attic vents, diverters, window hoods, and snow guards.

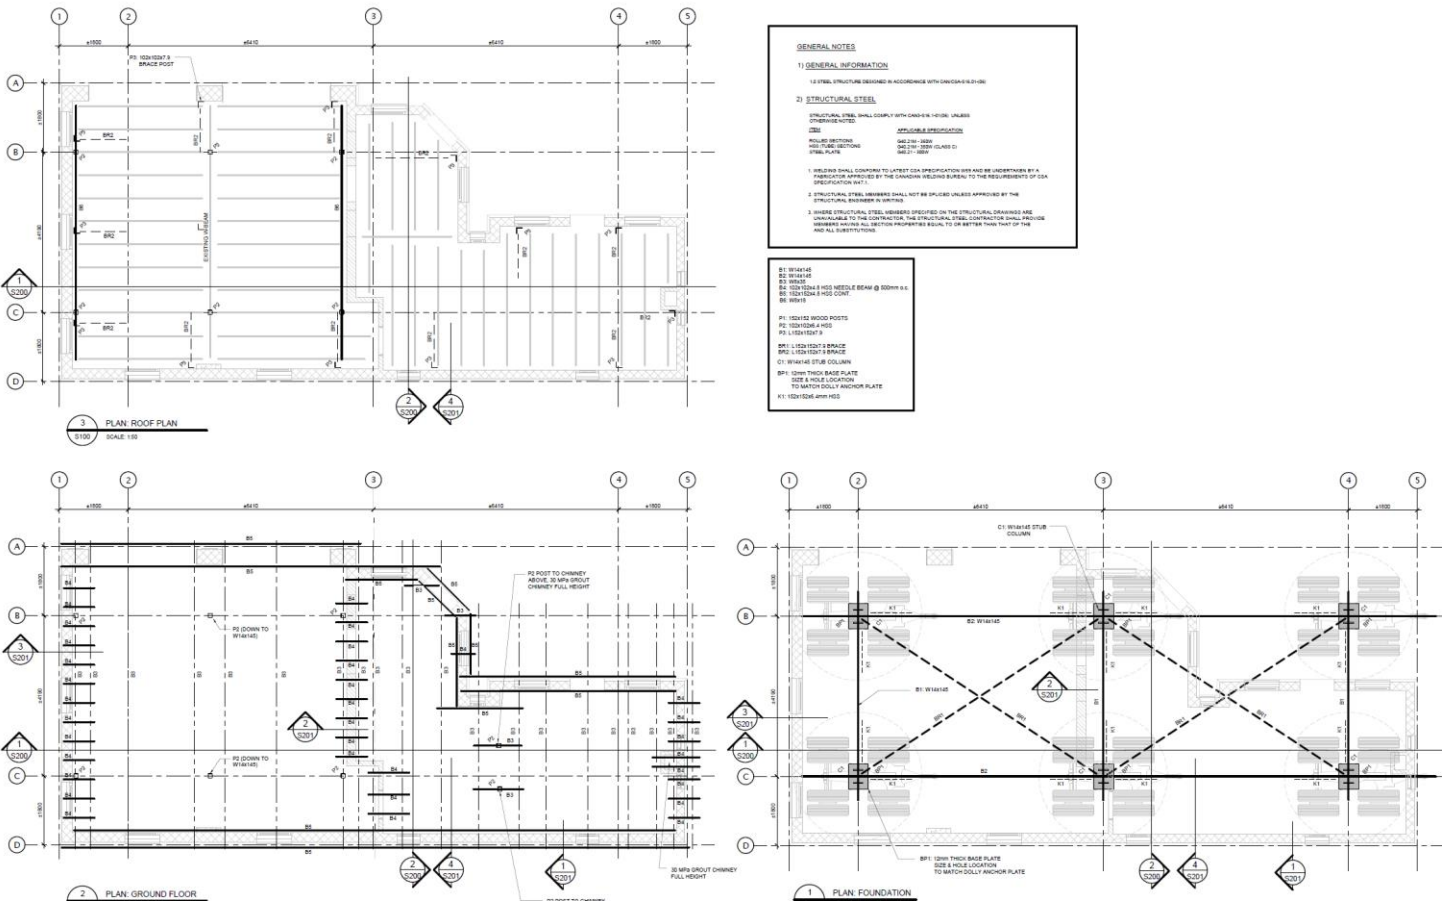
Figure 15: Positioning of structural steel and needles required to support the structure during moving. Source: Cleland Jardine Engineers. 2023.

Impact: Moving the Building will require the block walls to be consolidated with grout and a series of structural steel beams and pins to carry the load and secure the building for moving. The vertical cavities will be grouted at 32" c/c to increase the lateral resistance of the walls as they are currently very poor. The structural consolidation and the metal frame with pins and strapping will result in extensive damage to the lower sections of the walls. For a full discussion see Appendix B.

Structural Protrusions will not align with existing block coursing and removing full blocks in those areas will result in very large openings. For structural reasons, the openings should be as small as possible in order to leave as much masonry in place as possible. Since the stucco on the exterior will be patched and reparged, and the interior will potentially, be insulated and clad with drywall, openings should be cut out as required and later patched with new blocks and grout. Cleland Jardine Engineers. 2023.

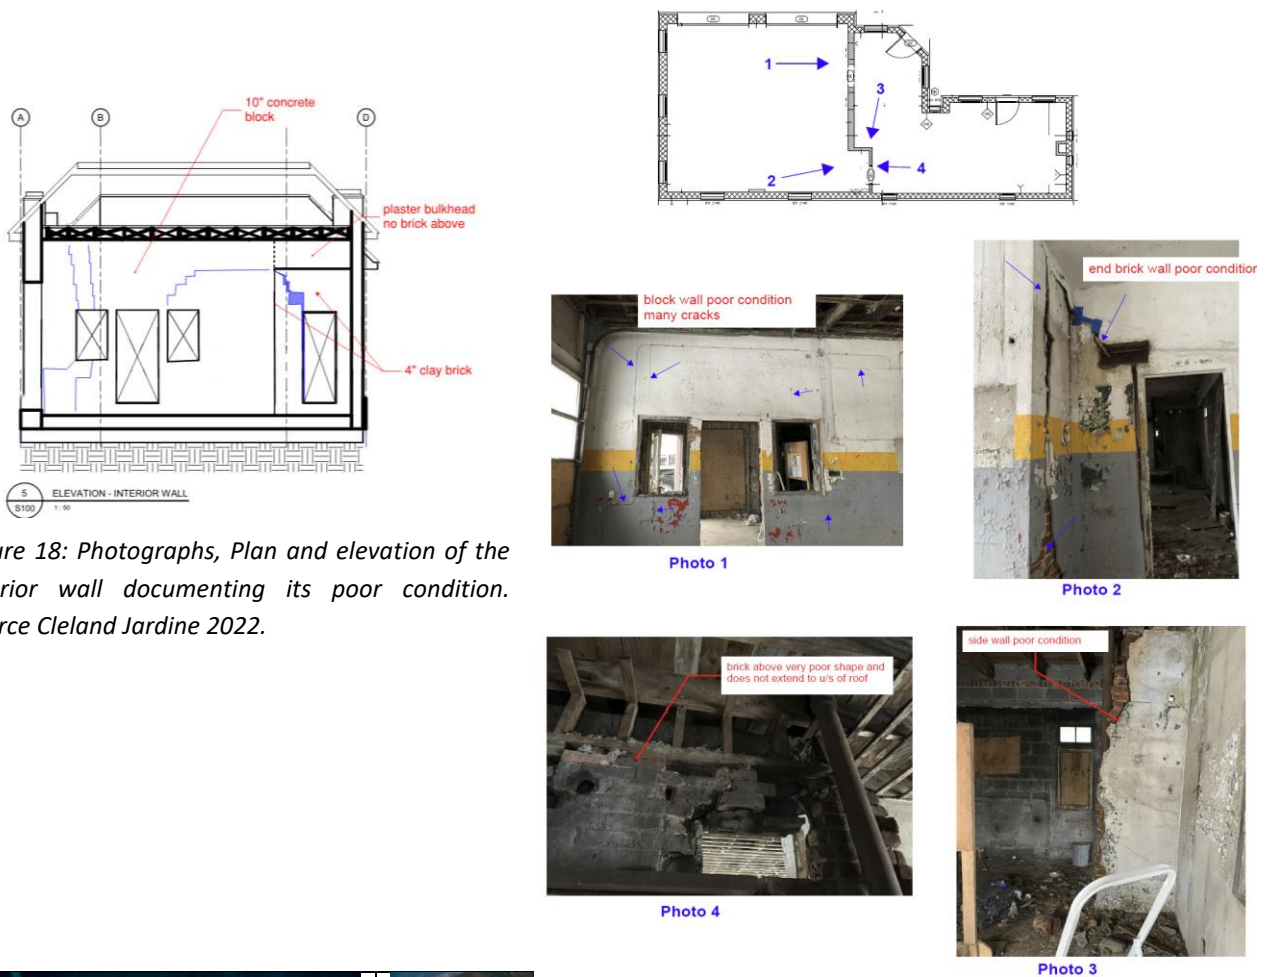
Figure 18: Photographs, Plan and elevation of the interior wall documenting its poor condition. Source Cleland Jardine 2022.

The elevation, plan, and pictures (Figure 18) document the condition of the partition wall. The demolition drawing submitted as part of the application to move recommends its demolition. The three sections of the building – cottage, transition (office), and garage (Figure1) are defined attributes in the designation, but it is not clear if the interpretation requires them to be separate spaces. The wall is in very poor shape. The wall between the cottage and the office was removed before designation, which suggests that there is some ambiguity. Given the poor condition and the client’s preference to have the wall removed, demolition is being recommended. This wall is a load bearing wall and with its removal there will be need to provide new roof support.

Options such as distinguishing marks on the floor and a dropped header with columns will be introduced as a means of interpreting the original three-part interior.

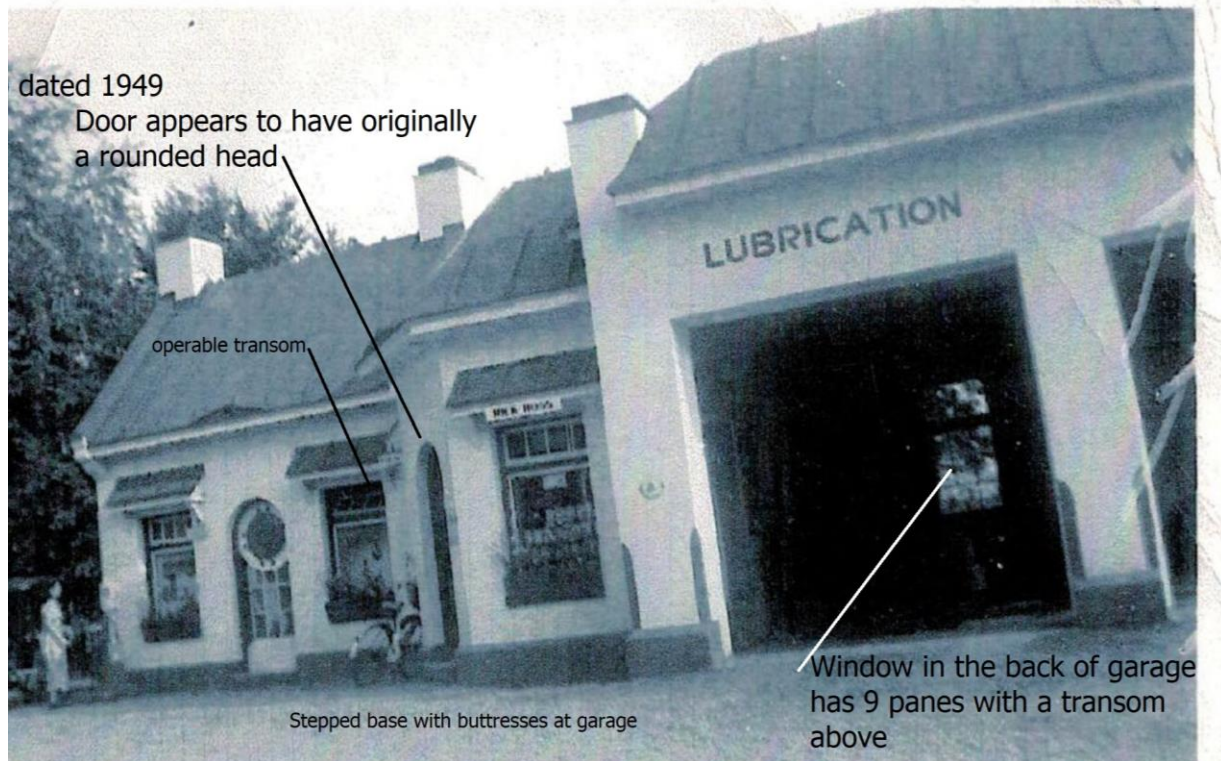
The distinctive entrance door to the office will be retained and preserved, as will the awnings above the windows and doors. The round-headed door will be repaired as necessary and used as a model for the reconstruction of the second door, which had been altered at some time.

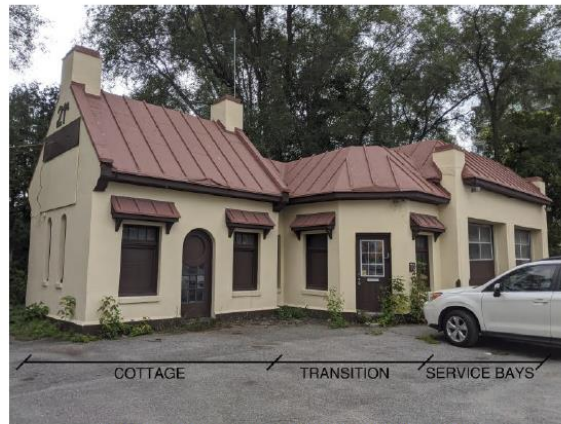
Photo 1: Overview of building [JCAL 2020]

In general there are three main spaces; the cottage, the transitional area and the service bays, see Photo 1. The transitional area and garage are divided by an interior loadbearing brick wall. The separation of these spaces is visible by the differing roof structures from the exterior.

The interior of the cottage has been completely gutted, exposing the wall and roof structure. At an unknown time in the past, a load bearing wall was removed under the western chimney and a built-up wood beam was installed at ceiling level to support the concrete block gable and chimney. There was no water damage visible in the cottage area and the roof trusses appear to be in good condition. There is a crawlspace under the flooring for utilities, this space was not accessible for review.
