A CONSERVATION PLAN

CHAMPLAIN OIL COMPANY SERVICE STATION

70 RICHMOND ROAD OTTAWA, ONTARIO

FINAL April 30, 2022

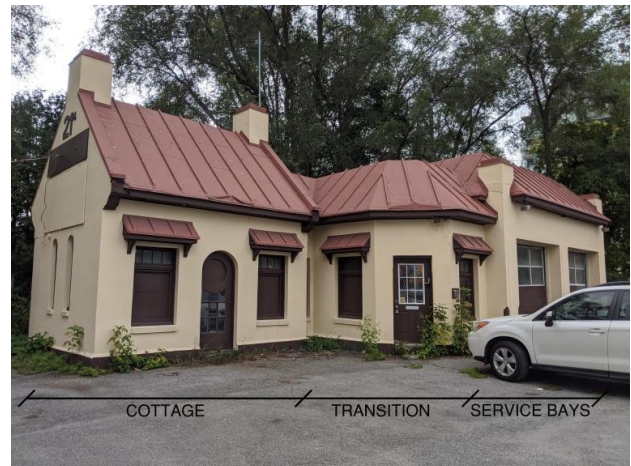
The Champlain Oil Company Service Station has been vacant for a number of years with no maintenance undertaken on the structure. Based on the assessment from both John G. Cooke Consulting Engineers and Cleland Jardine Engineering Limited, the building is in poor to fair condition.

Figure 1: View of the Service Station with the 3 sections cottage, transition, and service bays.

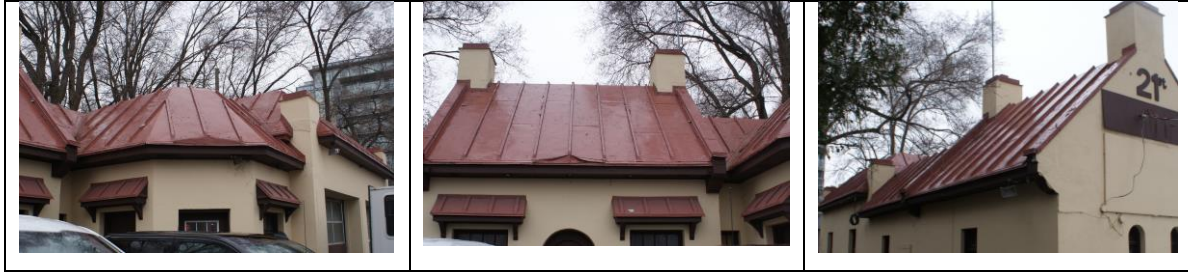
Figure 3: images of the Roof

The standing seam metal roof membrane is an important character defining feature and will be preserved to the extent that it is feasible. The flashings in the valleys of the roof and around chimneys and at junctions between roof forms have failed as is evident by the stained wood sheathing as noted in John Cooke’s review. The standing seam metal roof will be rehabilitated. The distinctive standing seam metal roofs on the awnings above windows and doors will be preserved as they are in good condition. Remedial work prior to the move includes patching of the existing roof to prevent further damage.

Portions of the roof membrane and decking will have to be replaced due to the deteriorated condition of the roof deck. The roof structure, in addition to requiring repairs, will also be subjected to higher snow loads from being at the base of the new mid-rise structure. It is recommended to reinforce the roof structure for this higher snow load at the same time as the repairs, since many of the solutions will address both.

- The distinctive standing seam metal roof will be retained and where necessary replaced with a similar material.

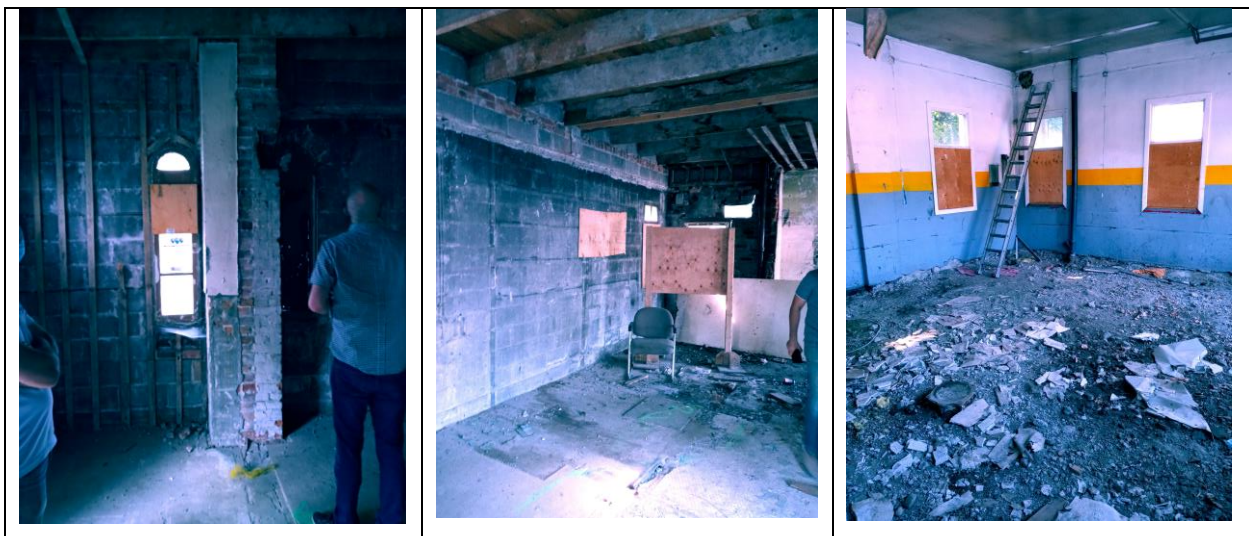
The exterior of the building retains its original form, detailing, and materials from its construction date in 1937. Major alterations are noted to the service bays and the interior of the entire building. At some point the interior was totally gutted with interior finishes removed and the wall between the house-form commercial section and the adjoining office area demolished. The plaster on the strapped interior walls contain asbestos.

Figure 6: Interior views illustrating the condition, with the interior stripped down to the block walls.

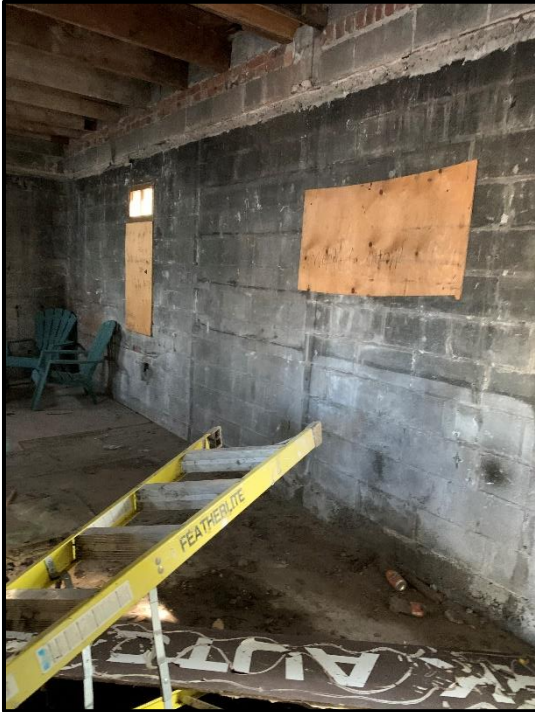
The masonry walls were in overall fair to poor condition with localized vertical cracking noted in several locations. Based on a few limited areas, where holes in the masonry were noted, the masonry does not appear to be grouted nor reinforced.

Exposed Masonry Wall Administration Area

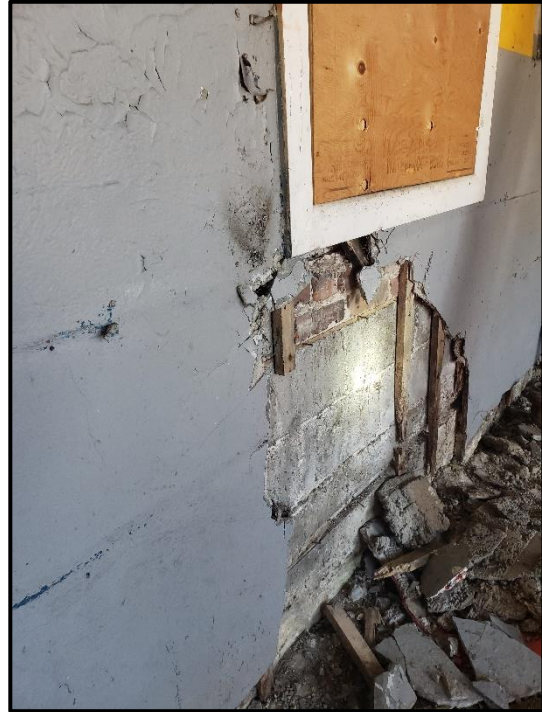
Masonry Wall Behind Plaster Lath - Service Bay

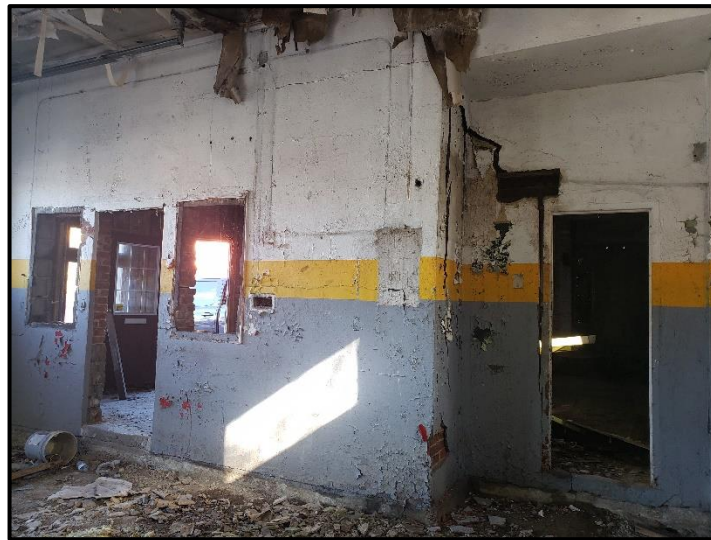
The load bearing masonry wall, between the service bay and administration area, is in poor condition with several cracks and major displacement (40mm) at the back portion.

Interior wall with major crack/displacement at door openings

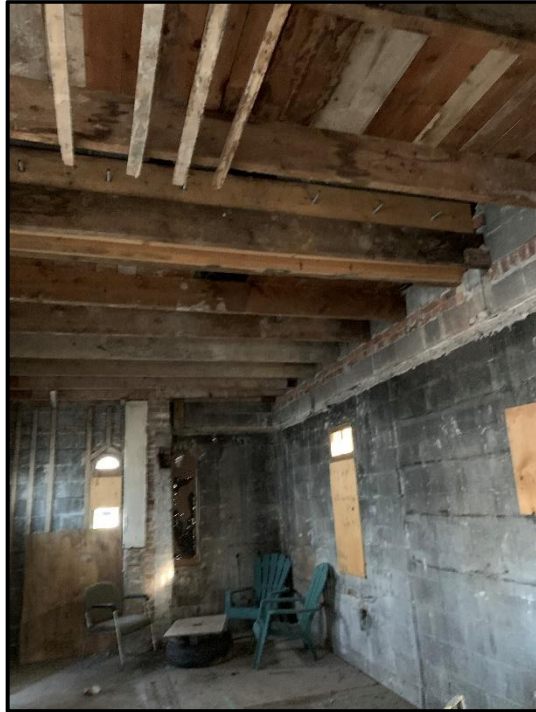
The roof framing has been subject to water infiltration and modification/patching over the years but remains in fair and sound condition.

Roof framing administration area
