Project:
50 THE DRIVEWAY
 50 THE DRIVEWAY
 OTTAWA, ONTARIO

Drawing:
TREE CONSERVATION REPORT

Scale: 1:200	Date: JULY, 2021
Design By: AC	Drawn By: SMc
Project Number: 2096-01	Sheet Number: TCR 01

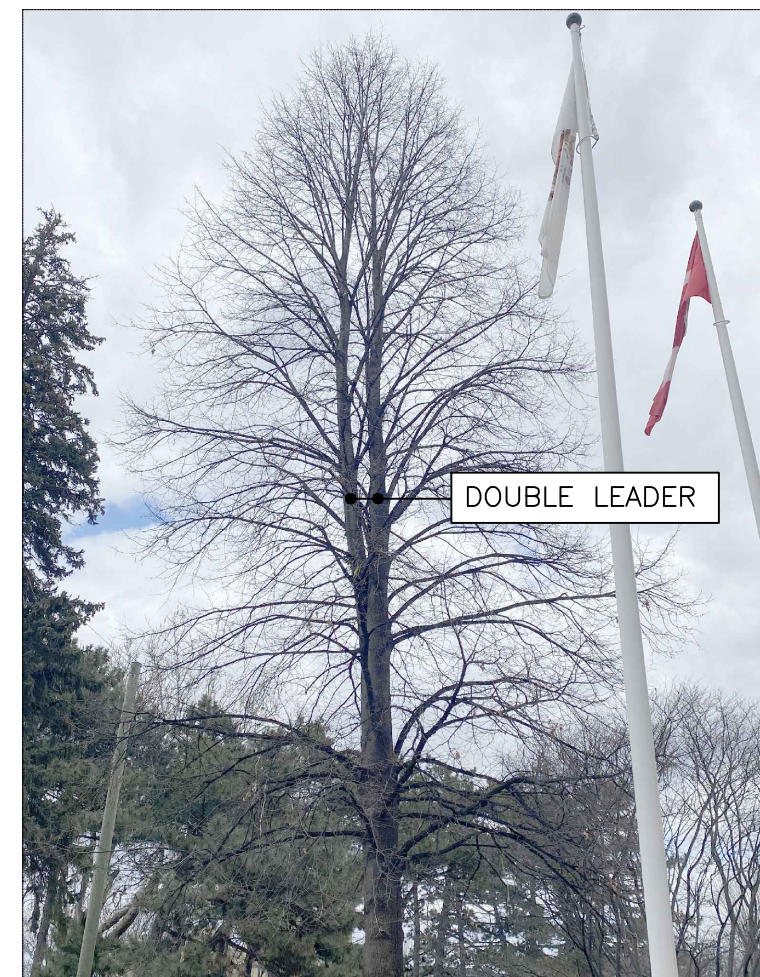
5 TREE #2 - PHOTOS

- Condition Rating: 'Good'
 No significant damage or disease, normal vigour, good form. Double leader with cracking constitutes a defect, though it may be mitigated.
 - Location Rating:
 Site Position and Contribution are good, however placement very close to property line is unfortunate.
 - Species Rating:
 Lower end of range of values was chosen due to invasive status of Tilia cordata in Ottawa region.

DOUBLE LEADER

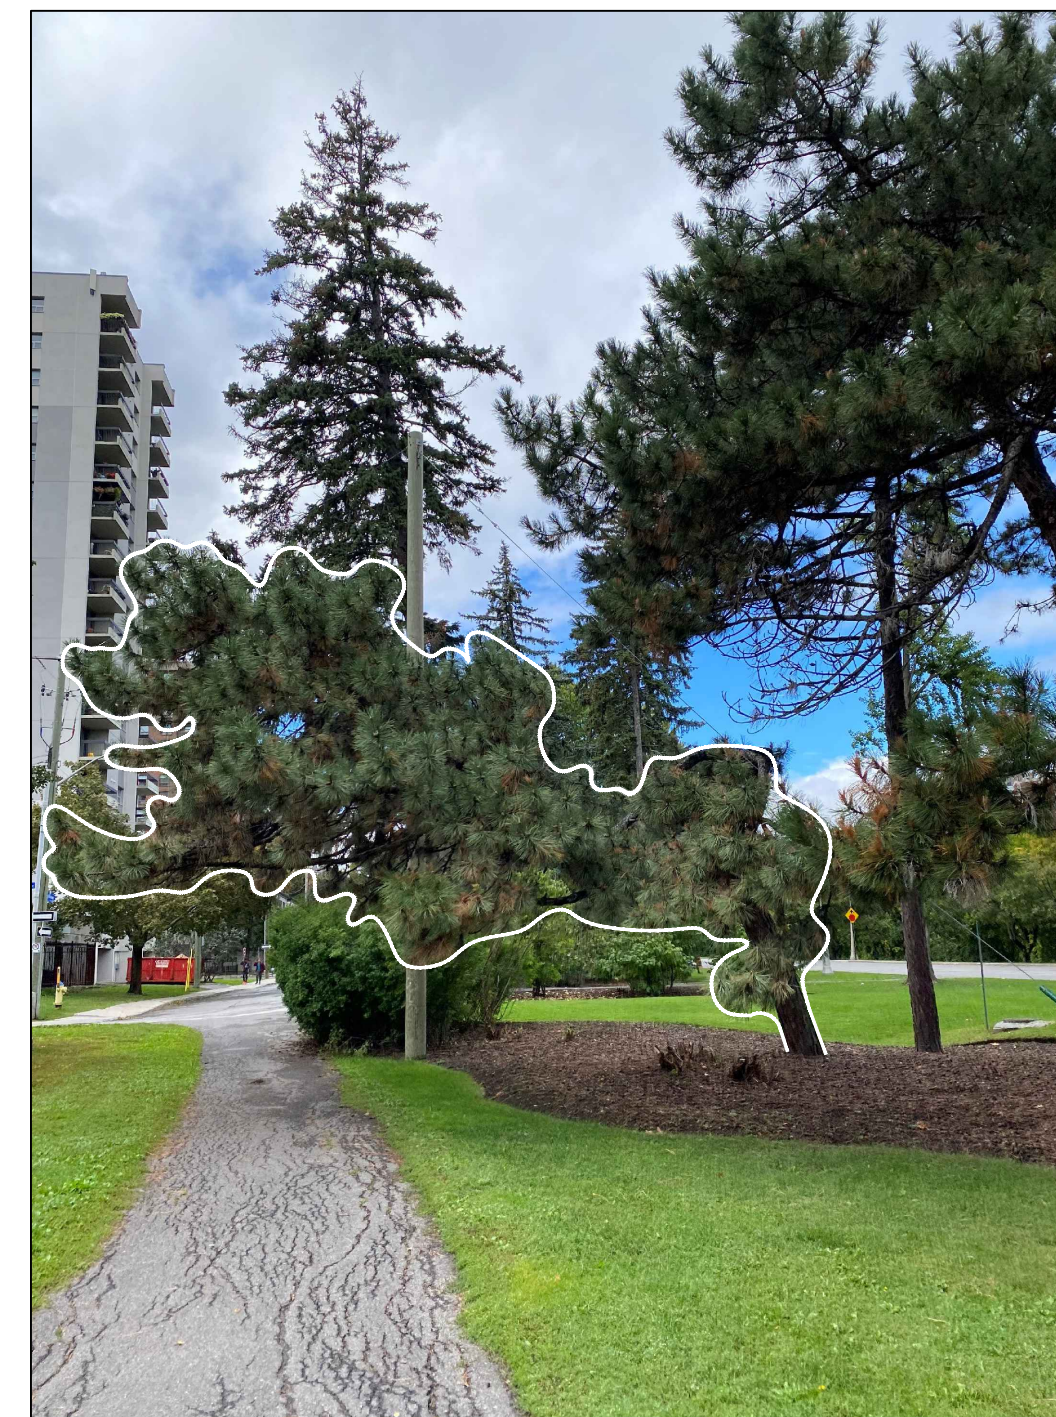
6 TREE #5 - PHOTO
CANOPY EXTENDS BEYOND CRITICAL ROOT ZONE - STAGING BOUNDARIES ADJUSTED FOR PROTECTION

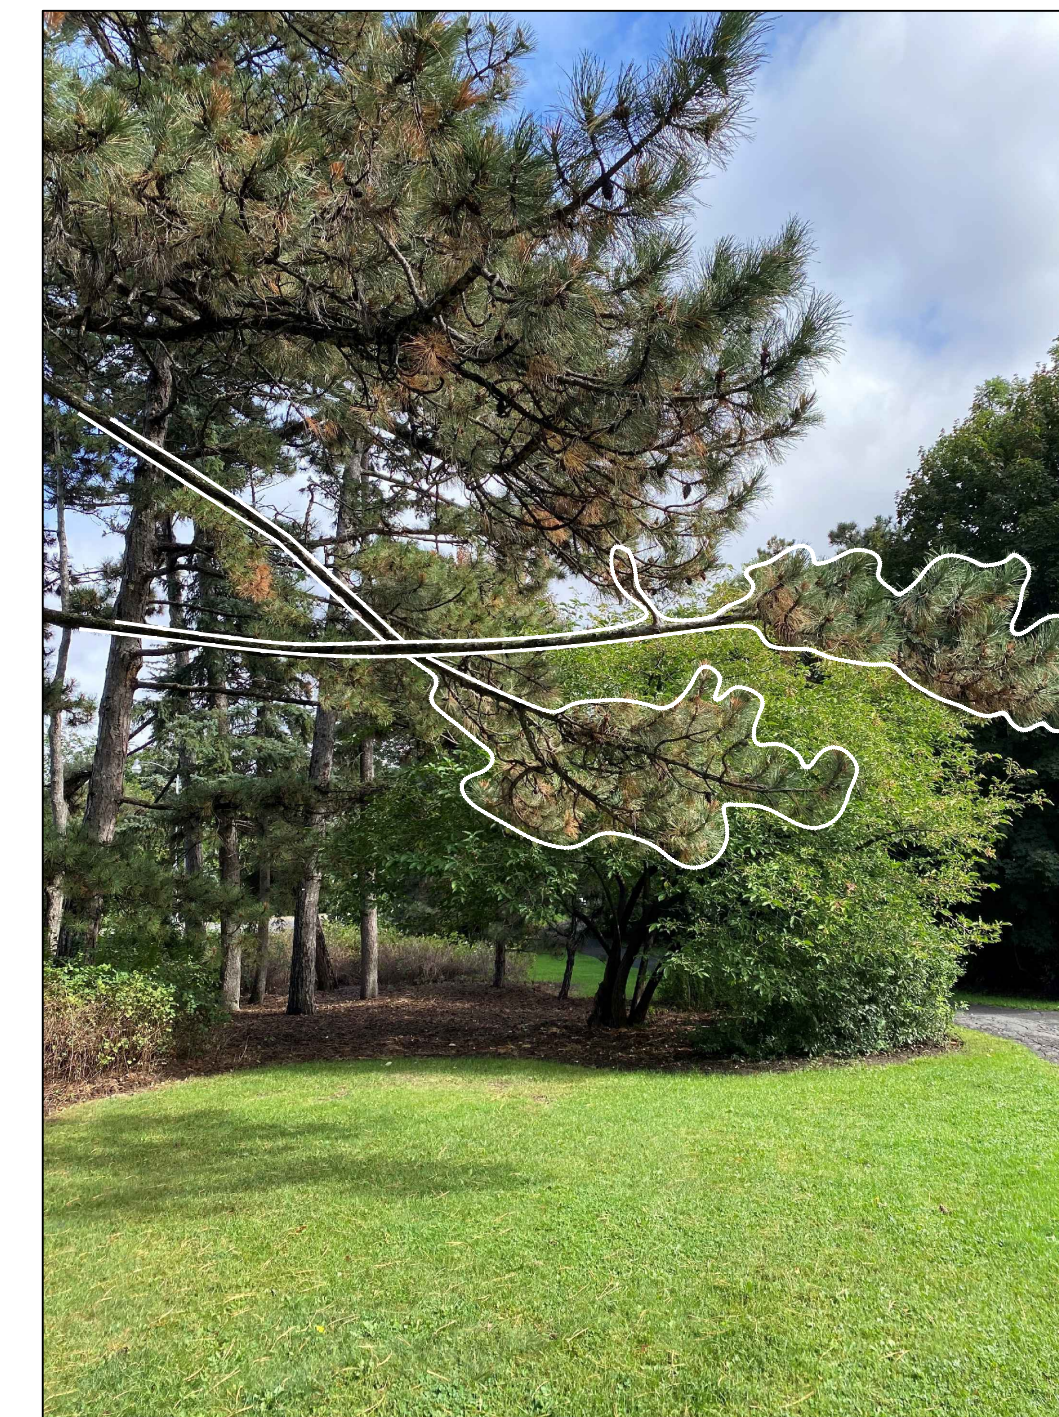
7 TREE #16 - PHOTO
LIMBS EXTEND BEYOND CRITICAL ROOT ZONE - PRUNING IS PROPOSED FOR STAGING AREA
