Project:  
**50 THE DRIVEWAY**  
 50 THE DRIVEWAY  
 OTTAWA, ONTARIO

Drawing:  
**TREE CONSERVATION REPORT**

Scale: 1:200	Date: JULY, 2021
Design By: AC/LM	Drawn By: SW
Project Number: 2096-01	Sheet Number: TCR 01

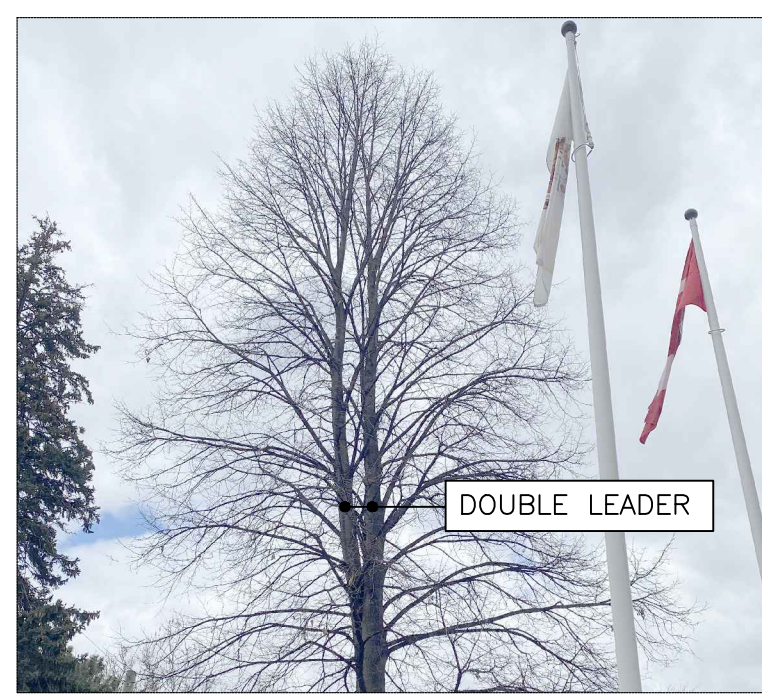
DOUBLE LEADER

- Condition Rating: 'Good'  
No significant damage or disease, normal vigour, good form. Double leader with cracking constitutes a defect, though it may be mitigated.

5 TREE #2 - PHOTOS

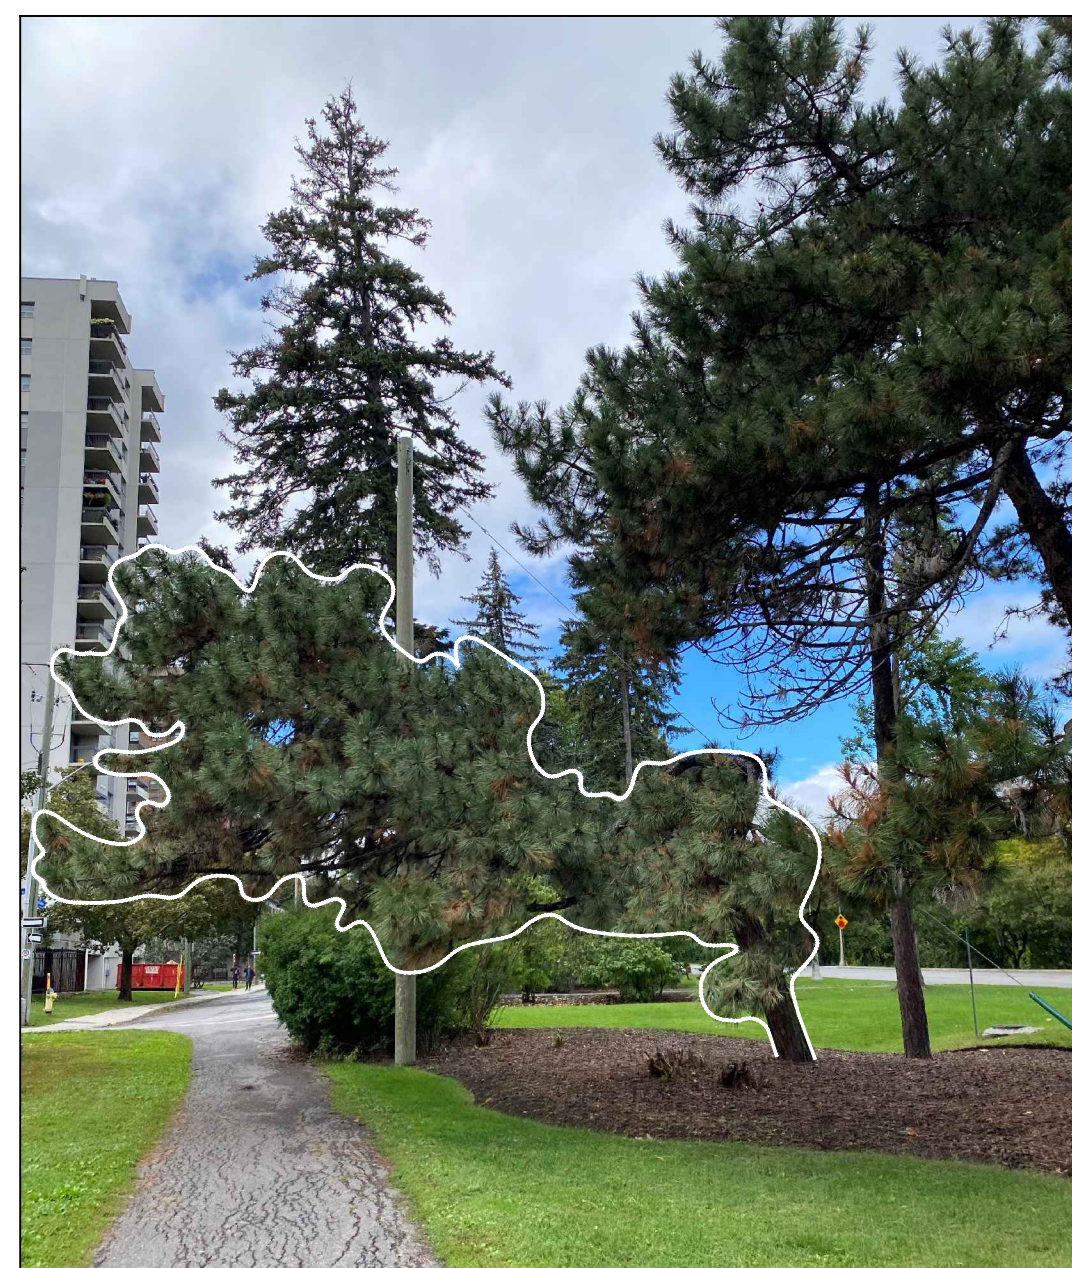
6 TREE #5 - PHOTO  
CANOPY EXTENDS BEYOND CRITICAL ROOT ZONE -  
STAGING BOUNDARIES ADJUSTED FOR PROTECTION

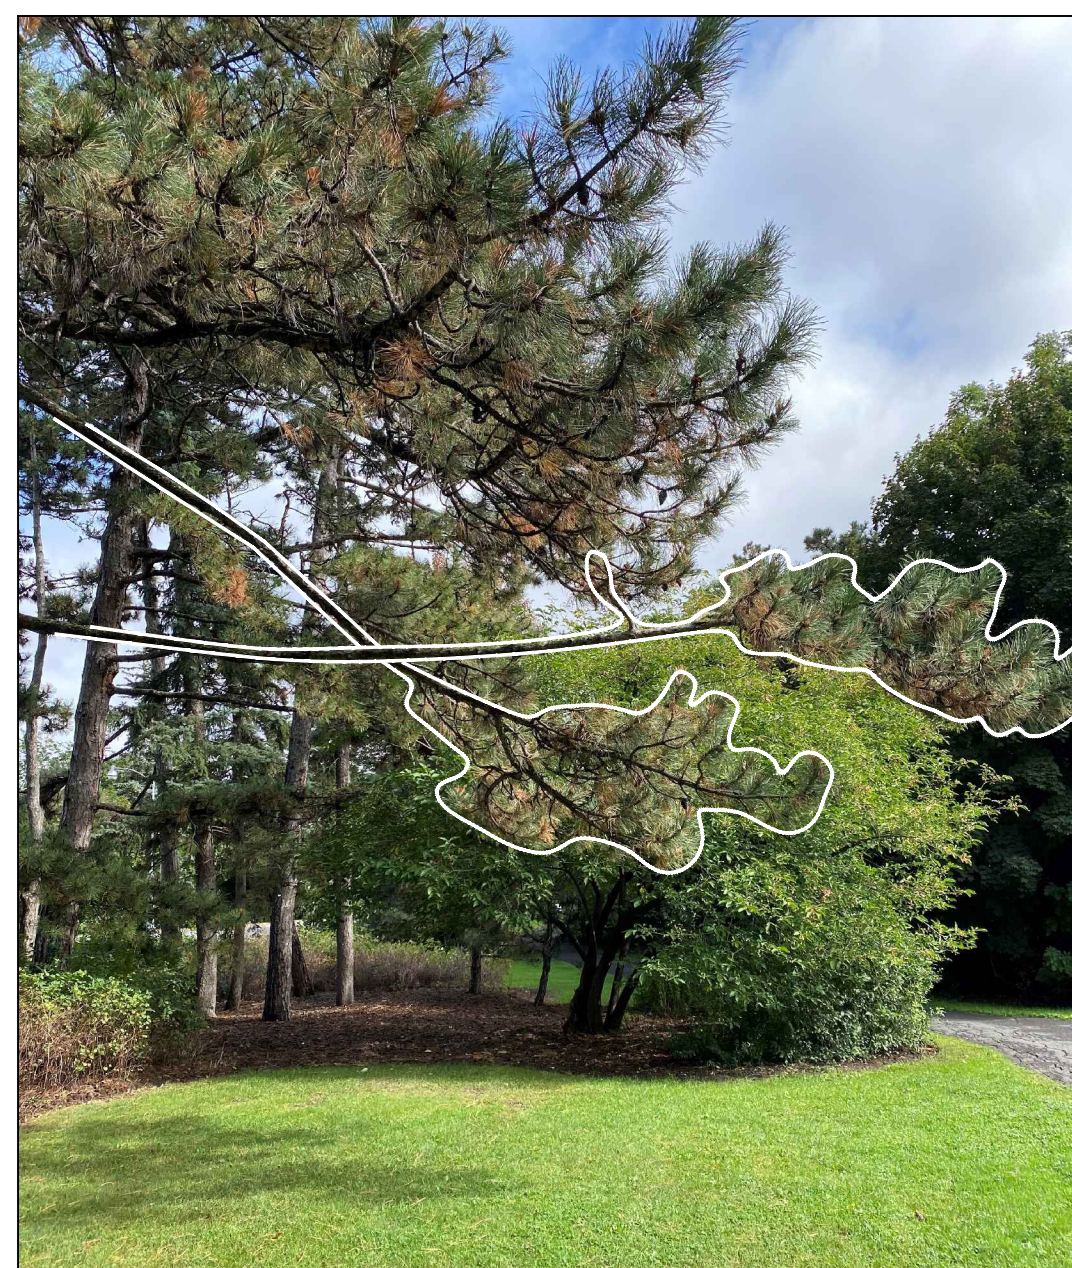
7 TREE #16 - PHOTO  
LIMBS EXTEND BEYOND CRITICAL ROOT ZONE -  
PRUNING IS PROPOSED FOR STAGING AREA
