PRE-CONSTRUCTION CCTV INSPECTION REPORT

PC-5226 29 RUSSELL AVENUE

July 18th, 2022

Sanitary

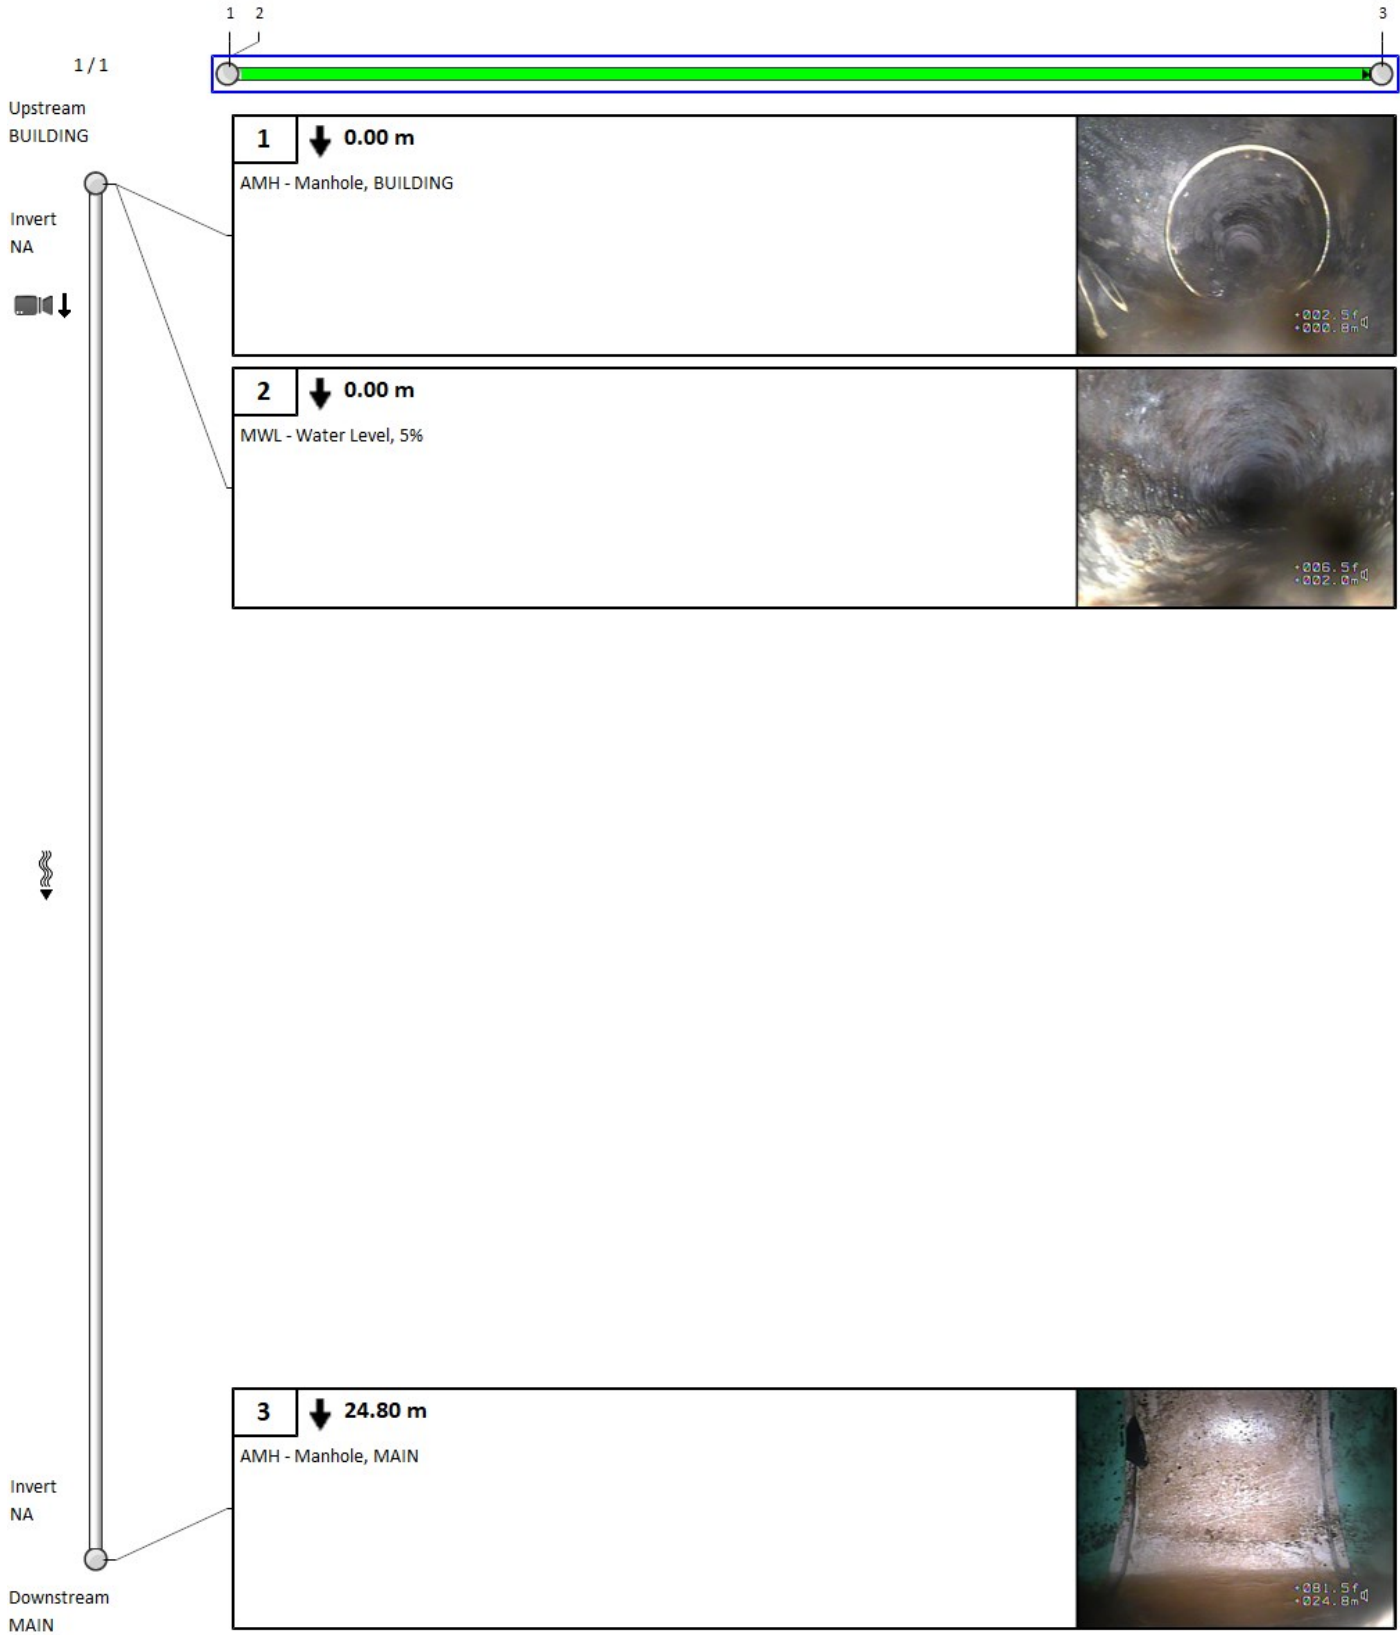
Pipe: BUILDING MAIN
 Direction of flow: BUILDING --> MAIN

Peak: 0
 Quick rating: 0000
 Score: 0
 Index: 0

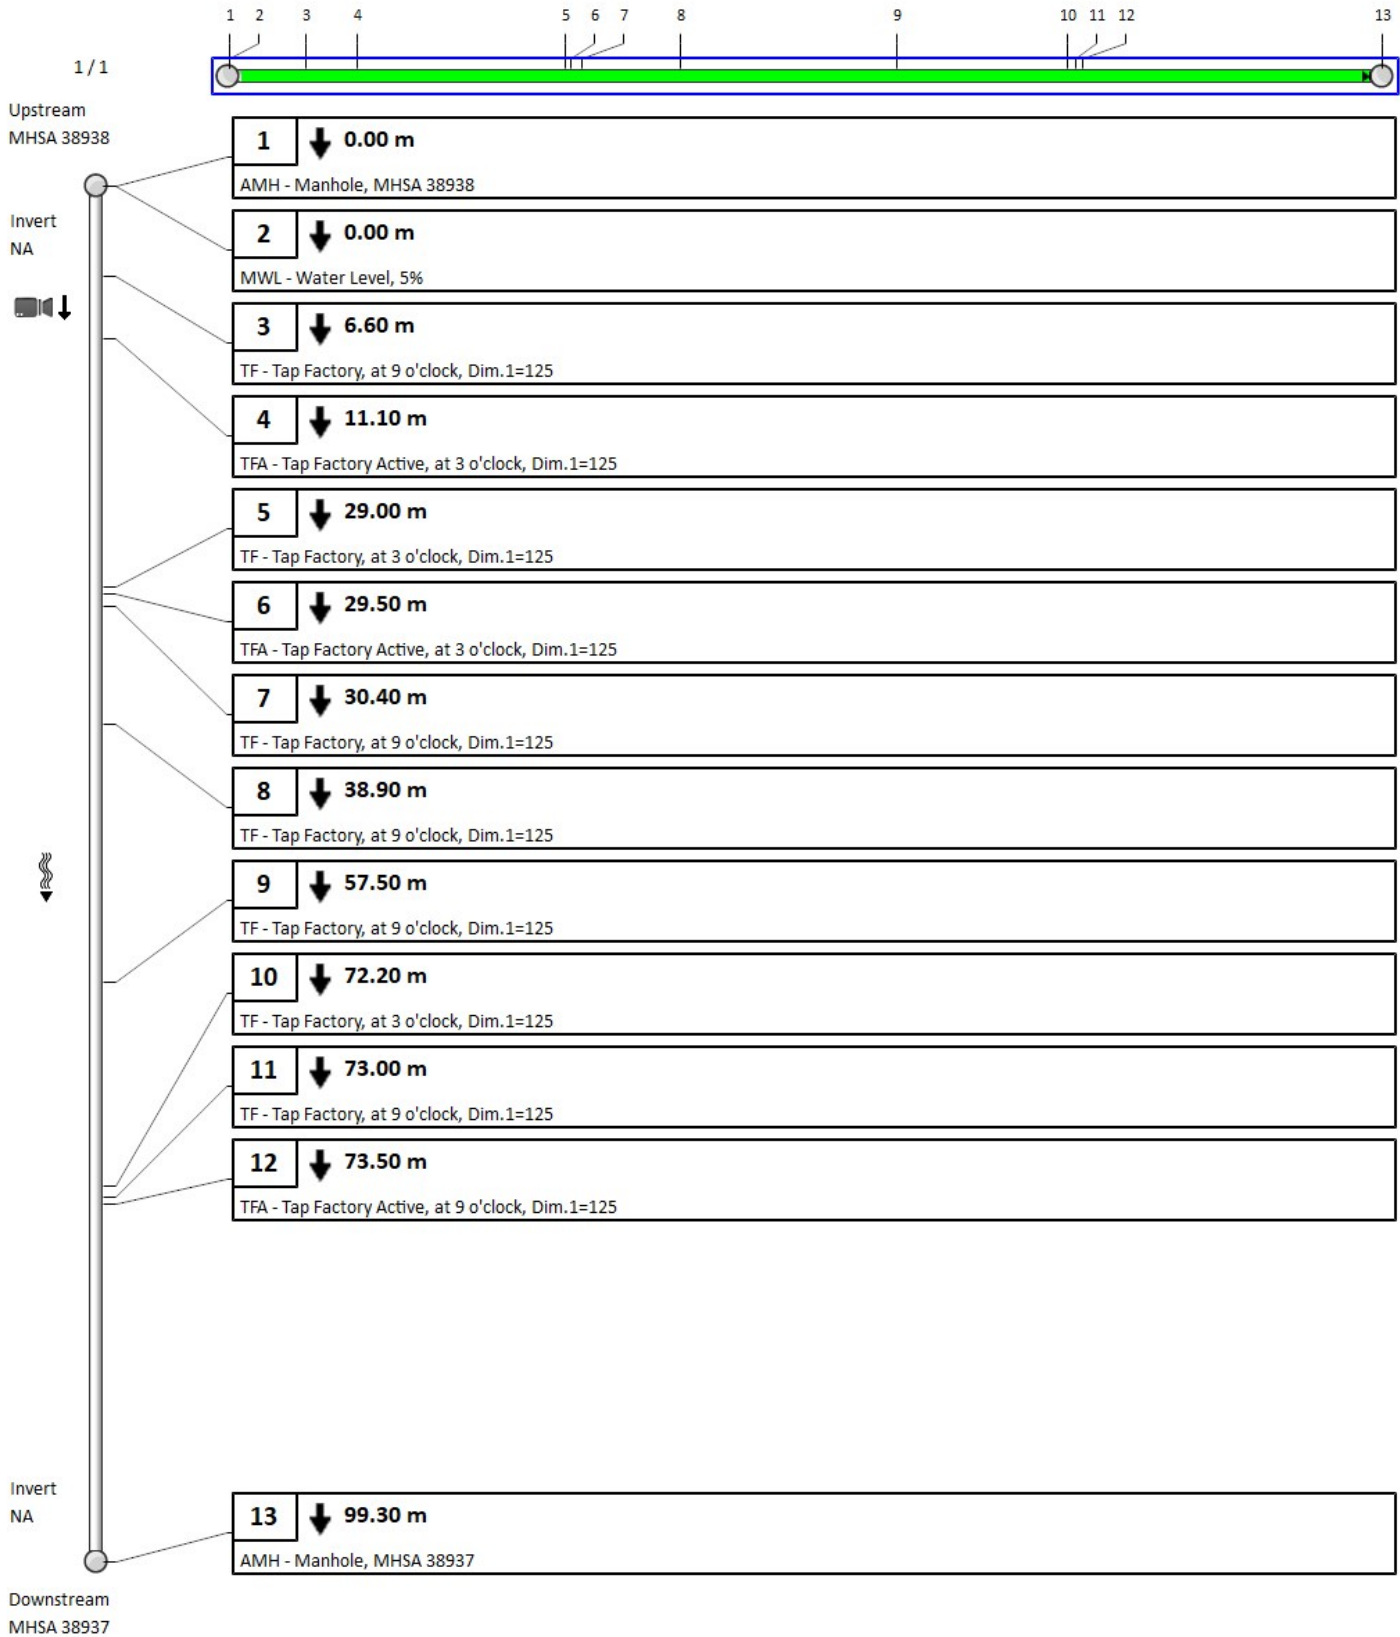
Pipe: MHTA 38938 MHTA 38937
 Direction of flow: MHTA 38938 --> MHTA 38937

Peak: 0
 Quick rating: 0000
 Score: 0
 Index: 0
